TECHNICAL SERVICE BULLETIN

NO. 181-001

AFFECTS: XL-12, SXL-A0

SUBJECT: ZAMA CARBURETOR PART NUMBER A-94953

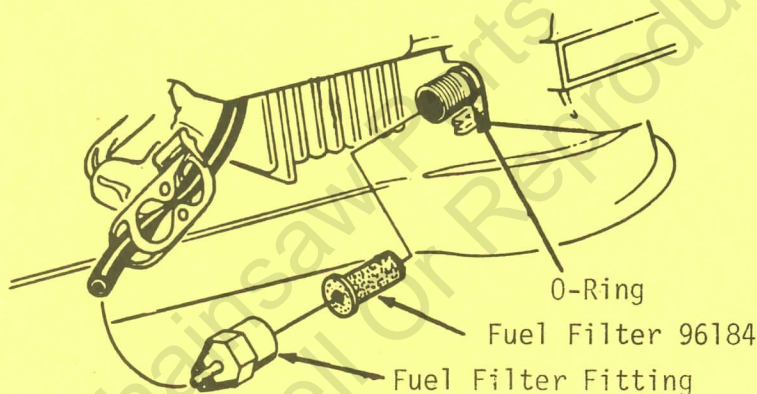
A new fuel filter 96184 made of ceramic material will supersede the felt fuel filter for the ST-80 and ST-100 string trimmers. When using the ceramic filter, the fiber gasket 65144 should be removed from the fuel filter fitting and discarded.

96184 Fuel Filter
(Ceramic)

95484-A Fuel Filter
(Felt)

TIP: To remove a felt filter that may be stuck in the carburetor housing, thread a #8 X 1 inch long sheet metal screw (pointed end) into the filter and pull it out.

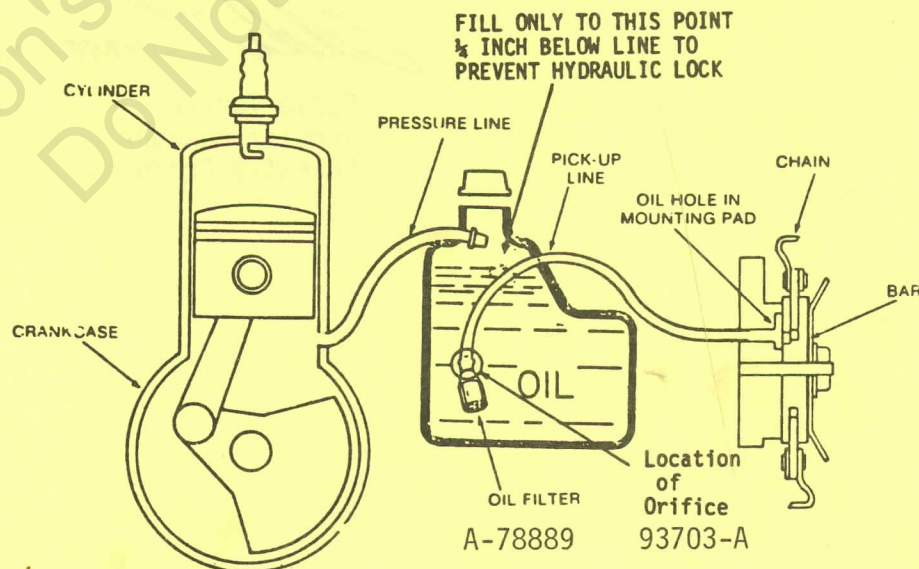
DIAGRAM OF THE XL PRESSURE FEED CHAIN OIL SYSTEM

In order to service units that "siphon" oil at the guide bar pad, we are introducing a new oil filter, part number A-78889. This filter contains a check ball and spring. After two pounds of pressure builds in the oil tank the ball will open and allow oil to flow to the guide bar pad. After the unit is shutdown the pressure in the tank must "bleed off" through the powdered metal connector that holds the duck bill valve to the pressure line. Once the pressure in the tank drops below 2 PSI the valve will close. Therefore, oil cannot leak at the guide bar pad. If the connector is not porous enough to allow a rapid bleed down of pressure, the unit will continue to oil after shutdown until the pressure drops below 2 PSI. This filter is a service item only at this time. When replacing the standard filter (A-68593) with this new filter, be sure to install the orifice (93703-A) into the new filter. This orifice is standard equipment on all XL's with the pressure oil system.

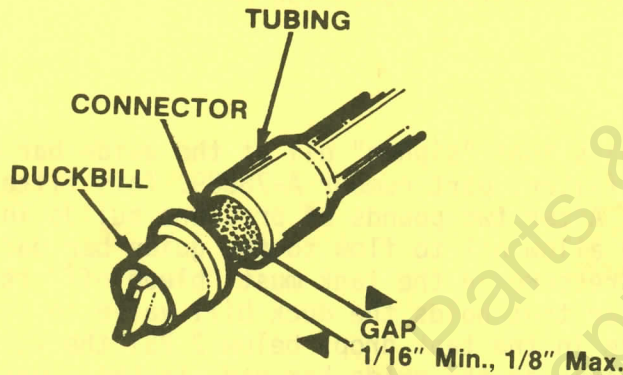
As mentioned in subject number 1, if the connector that holds the duck bill to the pressure line is not porous enough, too much pressure will build in the tank and therefore too much oil will be forced to the guide bar pad. If a unit over oils it will be necessary to install a new connector (69659-B). This new connector will allow the proper amount of pressure to bleed off while the unit is running and after it is shutdown. These new connectors will be made of stainless steel. The old connectors (69659-1A) were made of bronze. Therefore, they may be recognized by color as well as part number. Install the new connector in the location shown in the picture below.

After installing the connector, leave a gap between the duck bill valve and the tubing as indicated in the drawing above. All XL's with lot number X0340XXXX and above have connector 69659-B in the pressure line.

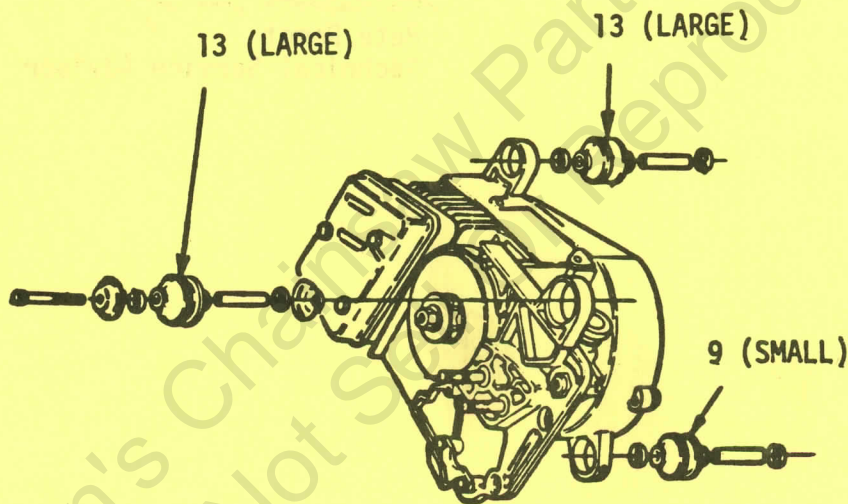
- 1) The isolator item numbers shown in the model 330 parts list (figure 2) are incorrect. Adjust your parts list according to the illustration below.

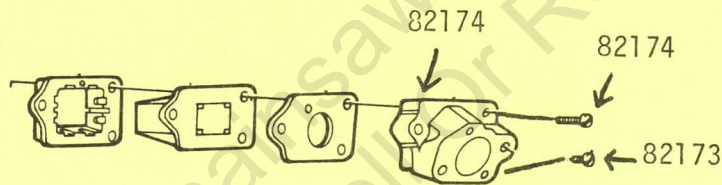
The three manifold retaining screws #82196 (1 1/8" long) have been replaced by two screws #82174 (1 1/4" long) and one screw #82173 (1" long). See the illustration below for the location of the new screws.

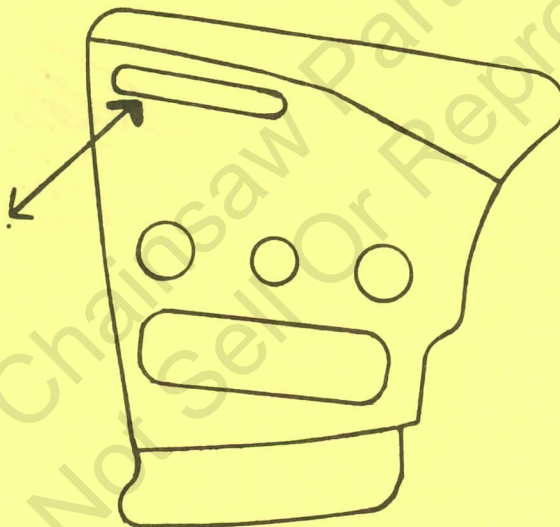
Some inner guide bar plates 56956-A were made with oil slots that are too long. The oil slot measures $1 \frac{5}{16}$ " in length. The correct length is $1 \frac{5}{32}$ ". (See Sketch).

Should measure
 $1 \frac{5}{32}$ " in length.

If the plate with the longer slot is used, not all of the oil will reach the guide bar. The longer slot allows the oil to leak between the guide bar and the drivecase pad.

We are now in the process of changing the tooling that makes this part. As soon as the new parts are available the part number will be 56956-B and will supersede 56956-A. Until these new parts are made the following option is available.

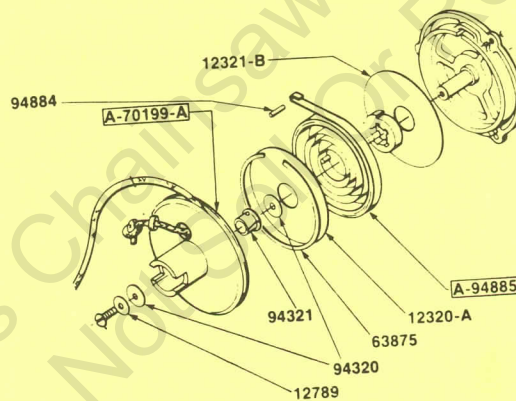
The rewind starter assemblies for the above mentioned models have been changed to eliminate the two pulley post bushings. Now only one larger bushing is used.

The illustration below details the new design and gives the new part numbers.

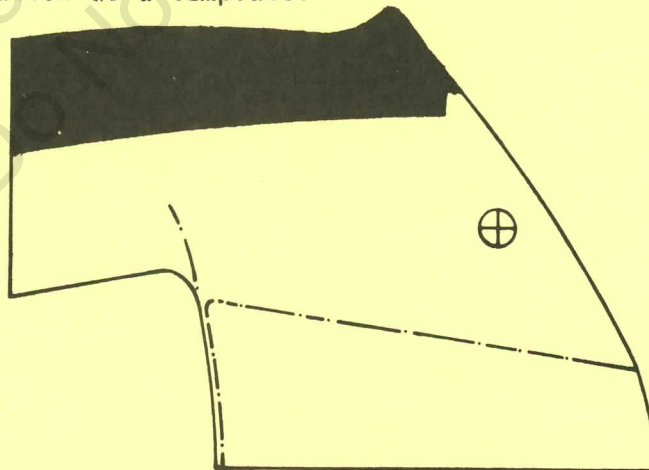
View shown is the guide bar side of the engine housing.

NOTE: If your XL, XL, or Super-2 does not have a hole in the engine housing for mounting the hand guard, it will be necessary to drill one. Drill a .180 diameter hole (#15 drill bit) in the location shown below, using the illustration as a template.

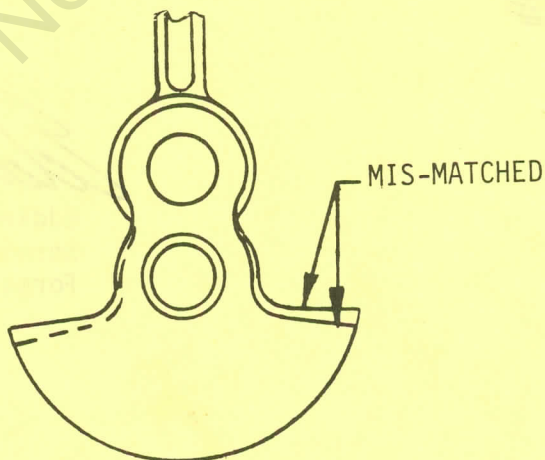
1. A new spark plug is now available for the 330. The part number is 96169. This plug is a DJ-7Y and replaced the 65130 in the 330 only.
2. There is a small hole (.040 diameter) located in the 330 crankcase, just under the reed valves. This "outlet" prevents the fuel from "puddling" in this area. If the fuel puddled in this area when the saw was suddenly turned on it's side the fuel would rush to the cylinder and flood the engine.
3. The throws on some 330 crankshafts used in production and service parts are not in line when viewed from either end as shown below.

A slight mis-match does not usually indicate that these shafts are defective. This mis-match is caused by assembling the crankshaft with two forgings that have slightly different throw profiles.

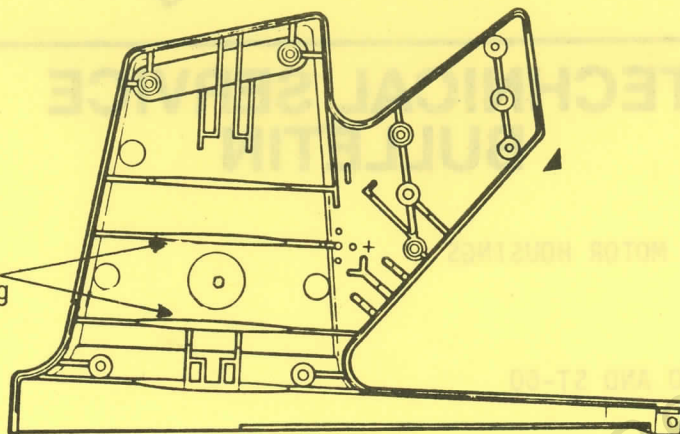
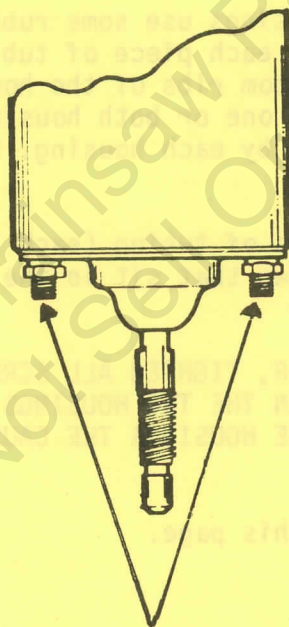
Location of
Rubbing Tubing

We have found some ST-40 and ST-60 motor housings that were not made to specifications. The ribs in these housings will not fully contact the motor. This loose fit allows the motor to vibrate and wear the ribs further. Replacing the housing may only temporarily solve the problem.

In order to repair these used housings use some rubber fuel or oil tubing cut into 3" lengths. Split each piece of tubing from end to end and place them on the two bottom ribs of the housing. Refer to illustration. This can be done to one or both housings, depending upon the amount of wear sustained by each housing. Use your own judgement in this repair.

CAUTION: AFTER MAKING THIS REPAIR, TIGHTEN ALL SCREWS SECURELY AND INSPECT THE SEAM BETWEEN THE TWO HOUSINGS IN ALL AREAS. IF A GAP EXISTS BETWEEN THE HOUSINGS THE CAUSE MUST BE FOUND AND CORRECTED.

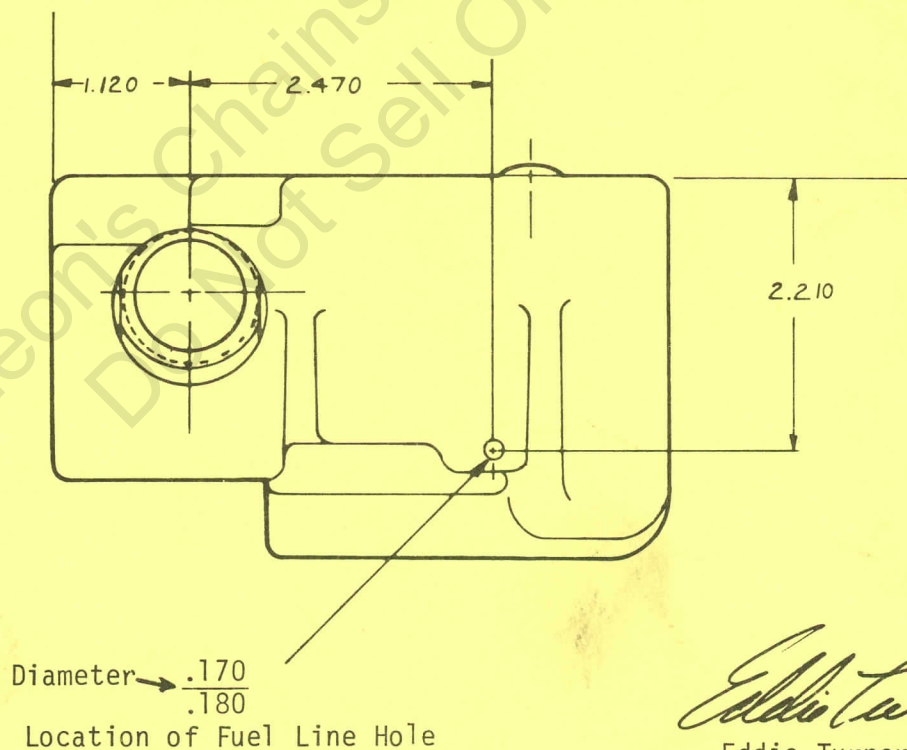
Some fuel tanks 94445-1 have the hole for the fuel line drilled in the wrong location. This results in a pinched fuel line when these tanks are assembled into a unit. If a new unit starves for fuel, suspect a pinched fuel line. See the illustration below for the proper hole location. The part number has been changed to A-94462-B.

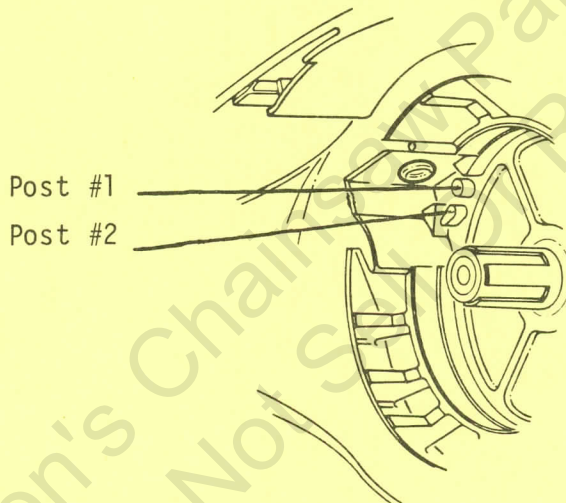
It has come to our attention that some starter housings are being replaced because of broken recoil spring posts. You will note that most housings have two posts located near the rope eyelet (see drawing). Each post is for a different type recoil spring.

The "round" post (#1) is for the recoil spring that is used in production. This spring is enclosed in a metal container. Post number 2 is for our service recoil spring, part number 69217.

If the production recoil spring post should break it is not necessary to replace the starter housing. Use recoil spring 69217 and mount it on post number 2.

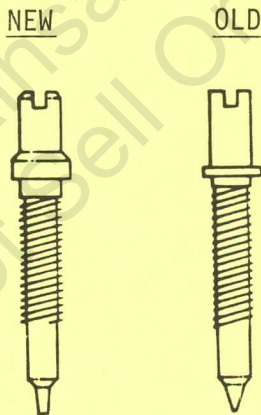
We have received complaints from the field that the 410 carburetor is difficult to adjust and that it loses its adjustment after a short period of use. These problems have been traced to the high speed needle. Due to the shape of the point on the needle the slightest movement affects carburetor adjustment.

In order to correct these problems the needle has been reshaped. This will make the carburetor easier to adjust and it will retain its initial setting longer.

All existing carburetors and repair kits in service will be reworked to include the new needle. The new carburetor part number is A-93393-B and the new repair kit part number is 95893-A.
