TECHNICAL SERVICE BULLETIN

NO. 182-001

SUBJECT: GUIDE BAR INSERT KIT #A-96612

AFFECTS: 360 CHAIN SAW

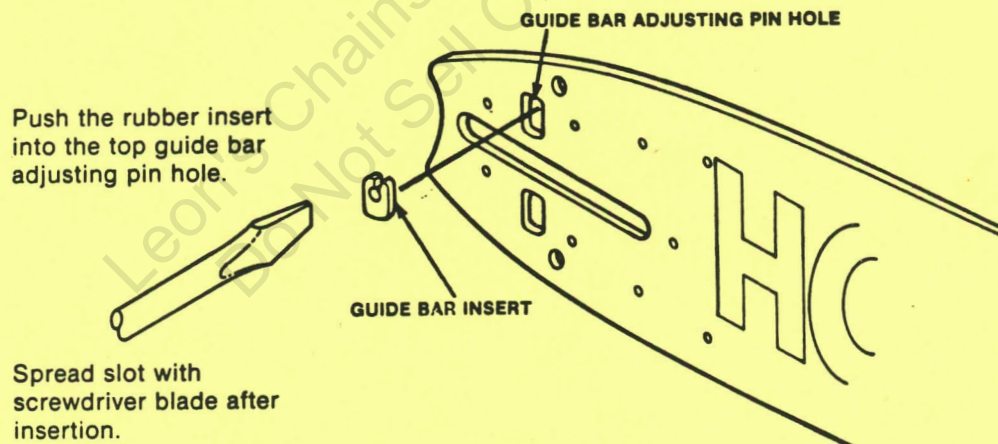
INSTALLATION OF GUIDE BAR INSERT FOR 360 CHAIN SAWS

We have had reports from the field that when guide bars longer than 16 inches are used on 360's a minimal amount of oil is getting to the chain. In order to improve the oil flow to the chain a rubber insert for the chain adjusting pin hole of the guide bar has been designed. (See illustration). This insert will route the oil from the oil slot in the guide bar pad directly to the groove of the guide bar.

This insert will be in the new 360 owners kit. If extra inserts are needed order part number A-96612. This kit will contain 5 inserts and 1 instruction sheet.

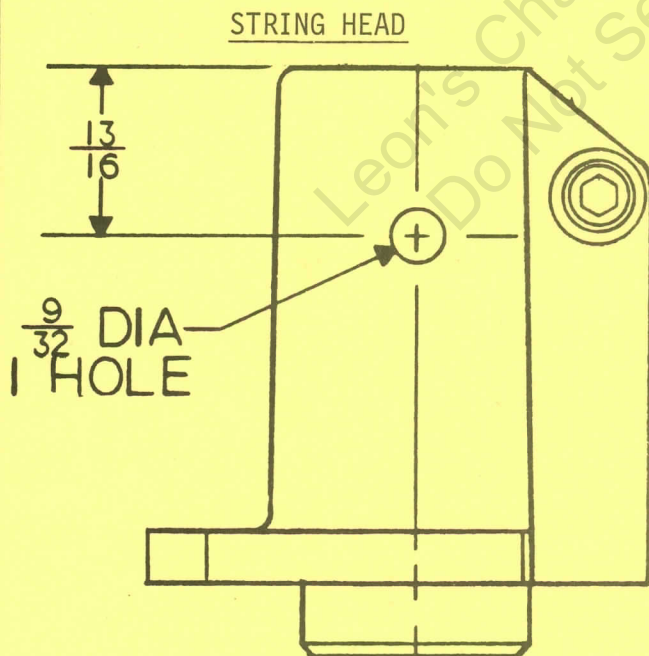
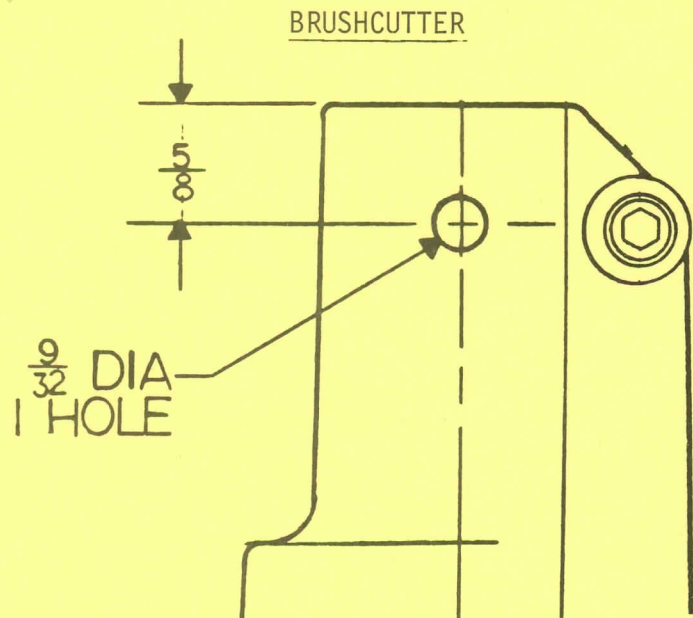
Before the 1982 season all ST-200's were built with the locating hole for the brushcutter or string head in front of the tube. Some tubes of this type broke just above the brushcutter or string head. In order to correct this in the 1982 season, the locating hole was moved from the front to the side and raised closer to the top of the brushcutter or string head housing.

All units built in 1982 have the hole on the side of the tube. A problem arises when a new 1982 ST-200 (hole in side of tube) is matched with an old brushcutter (hole in front of housing). In order to solve this problem use the templates below to drill a new locating hole in the side. Use a $9/32$ " (.2812) drill bit.

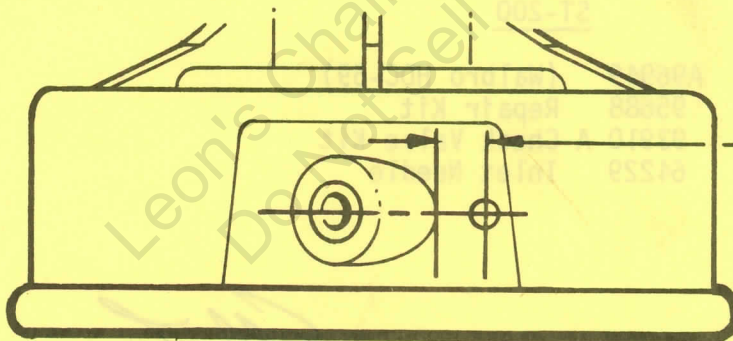
1. As stated in a previous bulletin, the Weldnot tubes are now retained to the stringhead with a cotter pin. A hole is drilled through the stringhead near the string eyelet. The pin is then inserted into the hole and spread apart. This keeps the Weldnot tube from "pounding" the eyelet.

Old stringheads can be updated to accept the new Weldnot tubes. A hole must be drilled near the eyelet for the cotter pin. Refer to the drawing below for the location of this hole. The hole diameter is $1/8"$ ($.125$). The distance from the eyelet to the center of the hole is $1/4"$ to $3/8"$.

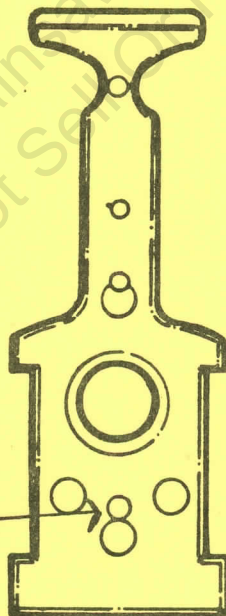
Drill Through
#43 Drill Bit

Your customer may complain that the trimmer floods too easily and that he cannot hear the engine "fire" the first time. This can be remedied by drilling a small hole in the choke. See the illustration below for size and location.

The hole will allow more air to enter the carburetor venturi creating less vacuum and therefore drawing less fuel into the engine.

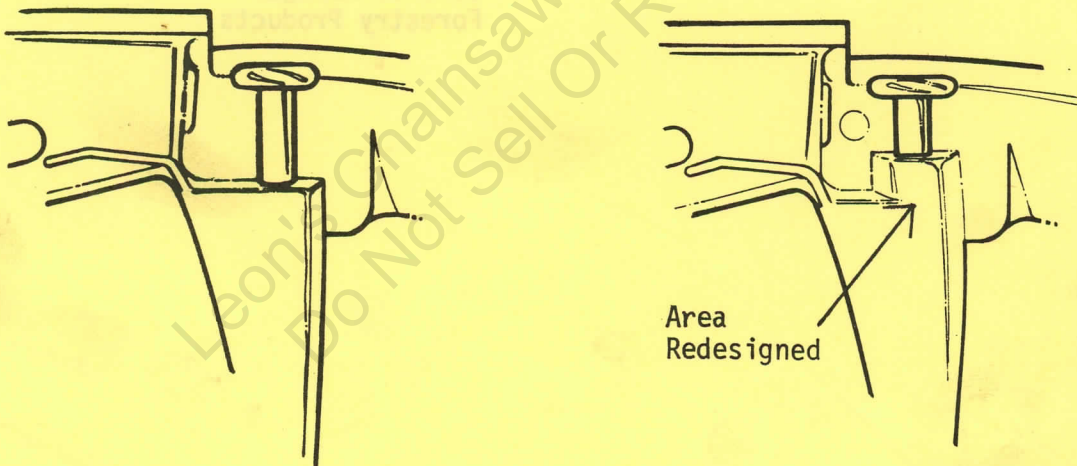
1. The throttle handle has been redesigned to lengthen the bore for the manual oil pump plunger (see illustration). This was done to minimize the "side to side" movement experienced by the plunger when the user depresses the button. The part number did not change. The current number is A93926. This change is effective with the serial number 0D2250000 and above.

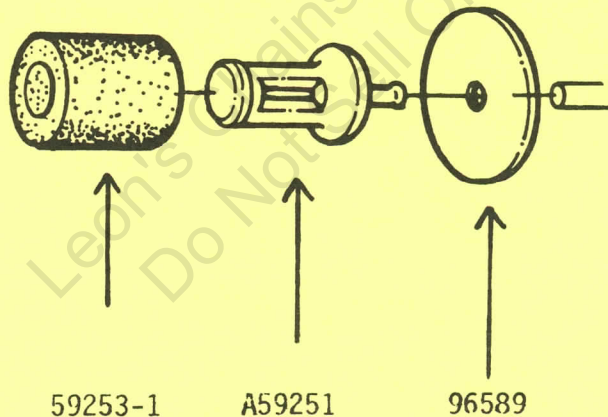
1. The fuel cap material has been changed to prevent deterioration that may occur when gasohol is used. Also, an extra thread was added for better sealing. The new part number is A93420-A.
2. A new rim sprocket 95058 is available from Service Parts. This new rim will supersede sprocket 63284. Both sprockets are 3/8 inch pitch and have seven drive link slots.
3. Plastic washer 96589 has been added to the fuel filter to keep the filter from "hanging up" inside the fuel tank. See picture below.

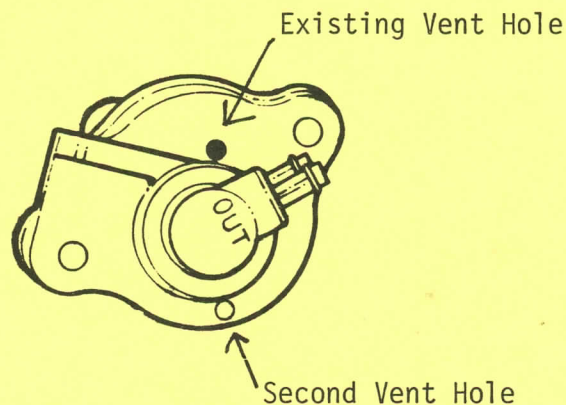
Any excess oil will be discharged through the existing vent hole (see illustration below) soon after the saw is put into operation. This situation is normal and should stop after a short while. However, in very cold weather, the oil under the diaphragm may stiffen and reduce the efficiency of the pump. If this happens, disassemble the oil pump, clean it, and lubricate only the plunger before reassembly.

There have also been a few reports that oil is again discharged through the vent hole, even after the cleaning of the pump. Such a situation would be indicative of an internal leak, in which case the oil pump should be replaced. If a new pump is not immediately available, a second vent hole, drilled with a 3/32 inch (2,5 mm) drill 180 degrees from the existing vent hole will prevent excessive oil build-up in the diaphragm chamber.

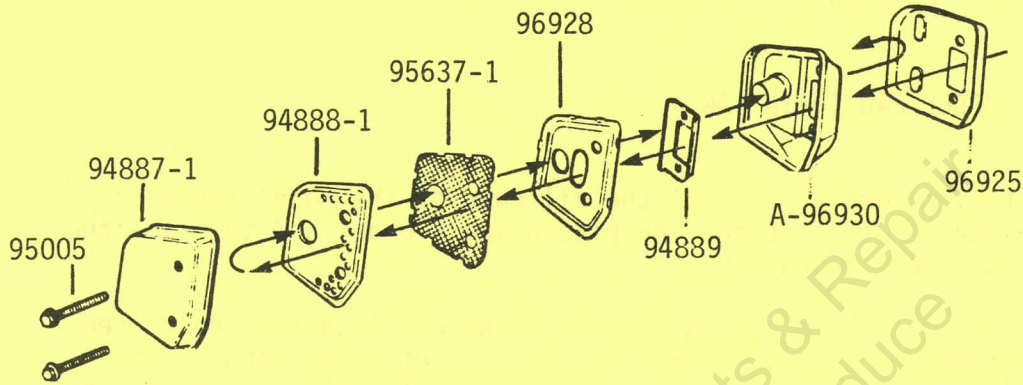
2. A new muffler is used on all 240 chain saws above serial number XD200XXXX. The exhaust is now directed to the rear of the muffler and exits near the cylinder.

NOTE: The muffler cap does not have holes for the exhaust to escape through.

Arrows indicate direction of exhaust flow.

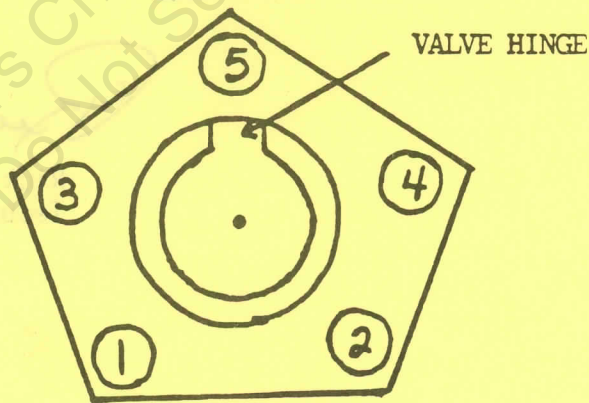
FIGURE "A"

Proper field assembly of the discharge fitting and check valve on the FP-250 has been a problem. Improper assembly may result in an air leak which will prevent the pump from priming properly.

1. Coat both the faces of the pump body and the discharge fitting with a lubricant. Dow Corning number 4 compound, Homelite number 22636-B is used in the factory, and has been found to be the most effective.
2. Snug up the bolts in sequence shown in figure "A" but do not torque at this point.

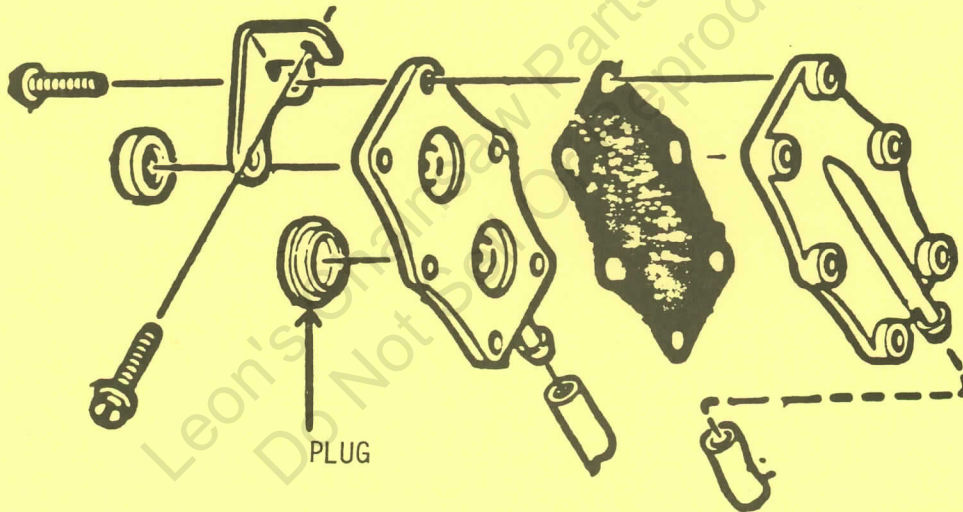
The plug (part number 95789) on the air pump (HB-680) can pop out after a few hours of operation. If this happens there will be a loss of pressure in the fluid tank and the sprayer will not work. The plug must be installed back in place making sure that an adhesive is applied evenly around the outer diameter of the plug (we recommend Zip Grip adhesive, part #70627).

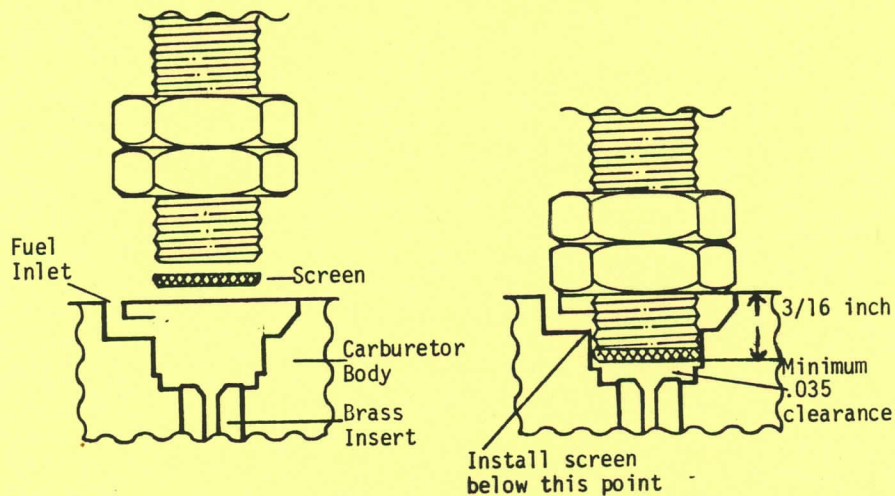
We have had a few reports of lean running or no start conditions due to fuel starvation. First check the inlet screen in the carburetor. The very fine screen was installed to ensure complete filtration of the finest particles that may slip by the filter in the gas tank. The dirty screen must be replaced with a new screen #97098 as it is so fine it can't be easily cleaned.

If the screen comes in contact with the brass insert, the area of filtration is reduced to only the size of the brass inlet hole. This means that the smallest amount of foreign material can prevent the unit from starting. The space between the screen and brass insert is necessary to be sure that the complete area of the screen is used.

Use the two nuts to maintain the 3/16 inch depth. This allows the screen to be set in place without blocking the fuel inlet hole, or touching the brass insert pressed into the carburetor body.
