# TECHNICAL BULLETIN INDEX

## TECHNICAL SERVICE BULLETIN

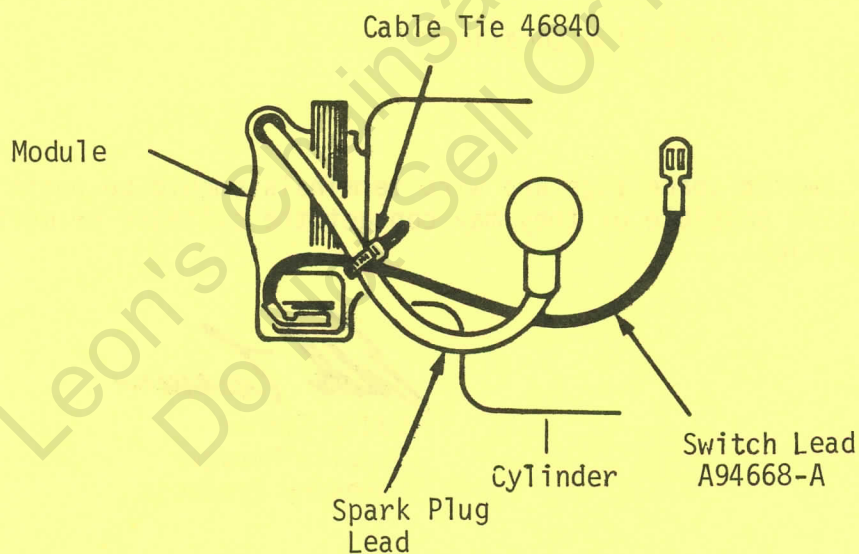
If a 330 should "die out" or "misfire" while cutting (particularly when underbucking), it may be because the muffler is coming into contact with and burning through the switch wires.

When this occurs it is because these wires are not routed properly.

Below is an illustration showing the correct routing of the switch wire #A-94668-A from the module to the switch.

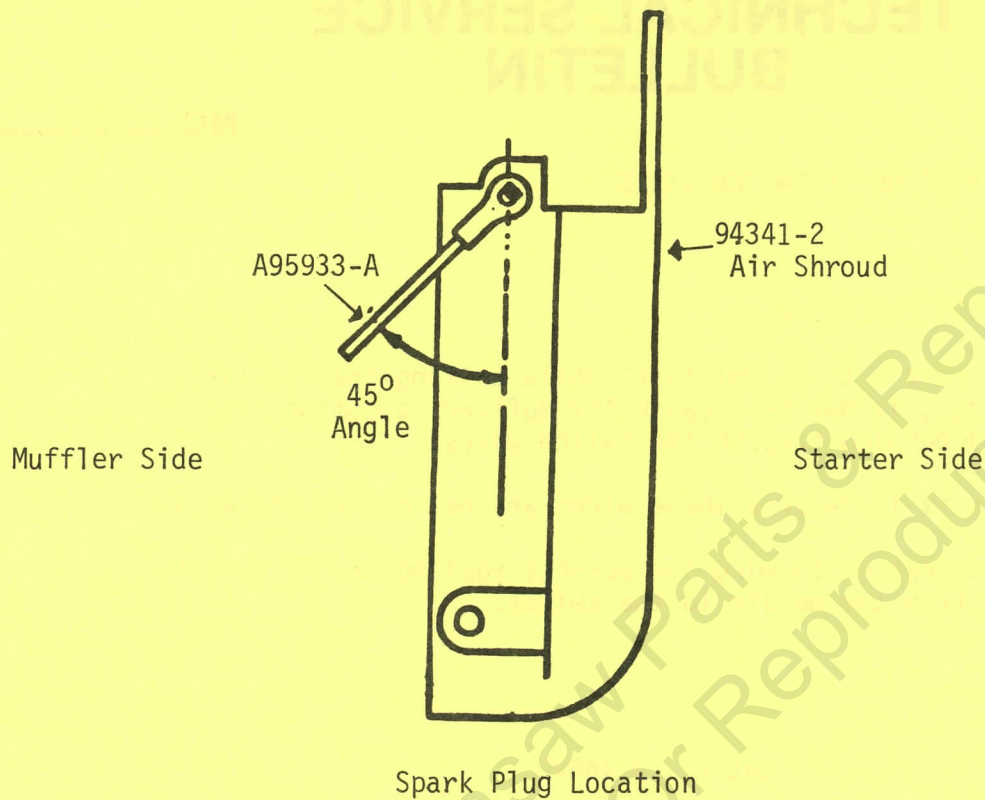
Another illustration indicates the correct position of the switch ground wire #A-95933-A.

NOTE: The on-off switch spade lugs and wire terminals should be positioned as straight as possible or they may contact the cylinder or muffler during operation.

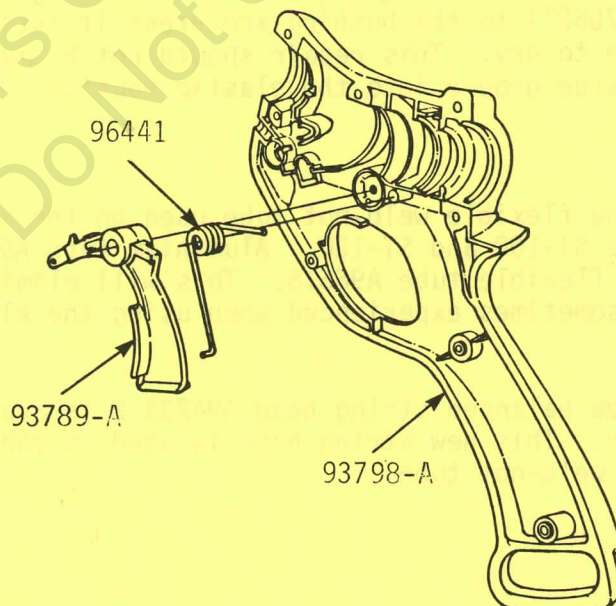
1. New Trigger and Spring Assembly - In order to ease acceleration and to improve the throttle interlock, for easier starting, a new trigger requiring a spring and a new right handle is available. See the illustration below for part numbers.

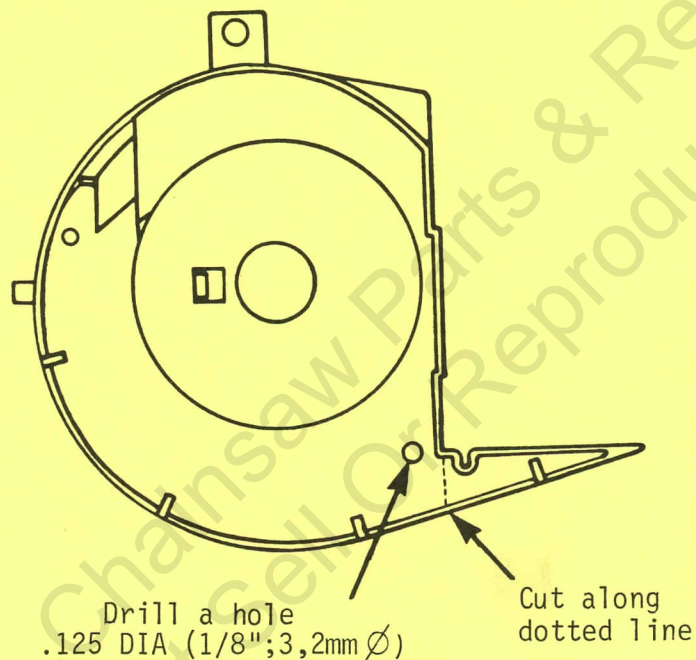
2. Air Cover Modification - When grass packs around the solid state module, the module may over-heat and fail. The air cover has been modified so that grass taken in through the starter housing can be discharged past the module. Currently, this modification is being made to air cover 94693-B. See the illustration below to modify air covers on older trimmers. The 94693-B (not modified) will be supplied through service parts until 94693-C (with modifications) is available.

INSERT CABLE TIE (46840) THROUGH HOLE TO  
SECURE GROUND WIRE TO AIR COVER.

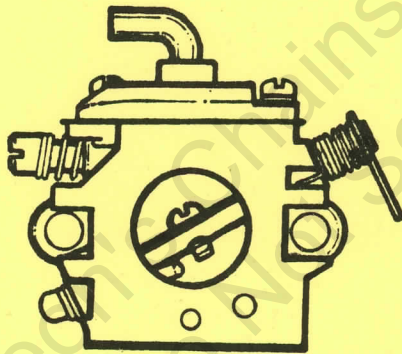
Figure A

If the cable is out of adjustment, the trimmer will not reach maximum speed and the string will not advance. Also, it may stall and "die-out" at wide open throttle.

With the trigger fully depressed remove the air filter cover and observe the carburetor venturi. A properly adjusted cable stops the throttle shutter in the center of the venturi. See Figure A. A cable that is not adjusted properly allows the shutter to travel past center which creates first, maximum R.P.M.'s and then reduced R.P.M.'s. See Figure B.

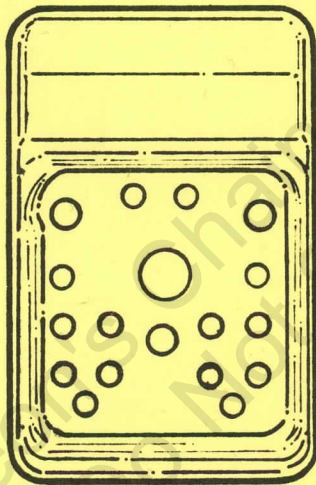
Figure 1

If a new 410 sounds muffled or has low power it may contain the wrong muffler cap. The correct cap is pictured below in Figure one.

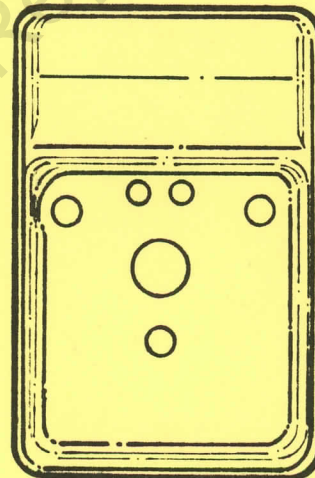
A special muffler cap (See Figure 2) was designed to meet the lower noise levels required by the French government. Some of these caps were placed on saws that were shipped within the United States.

The cap shown in Figure 2 is to be used in France only.

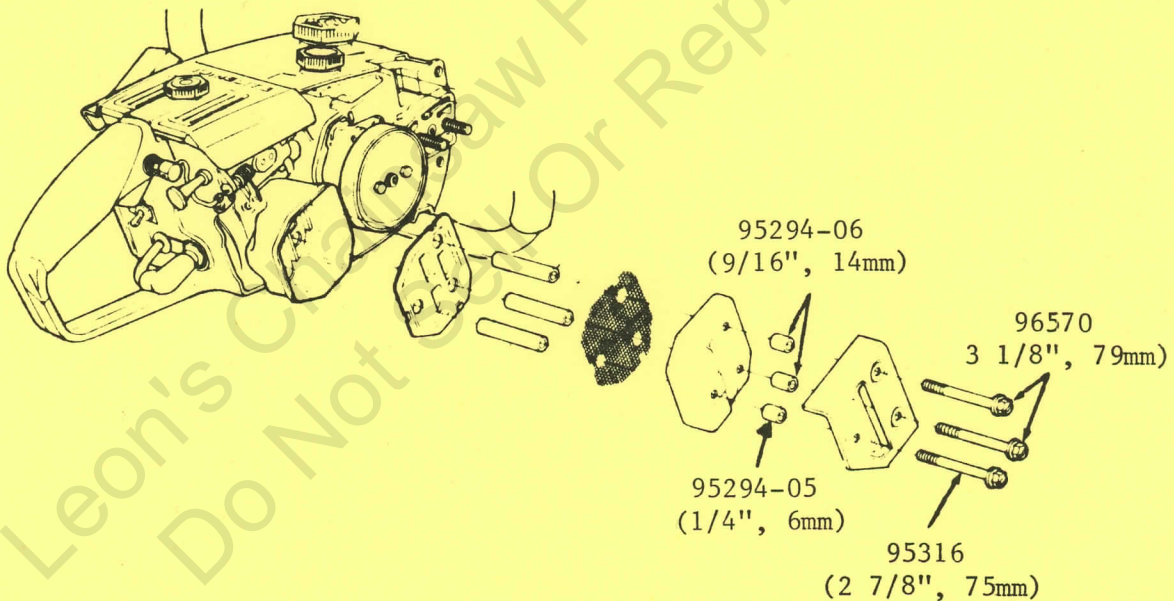
In order to decrease the temperature of the muffler deflector, the distance between the muffler deflector and the muffler cap was increased. This was done by lengthening the two existing spacers and adding a third spacer.

The illustration below indicates the part numbers of the new spacers and longer screws necessary for this change.

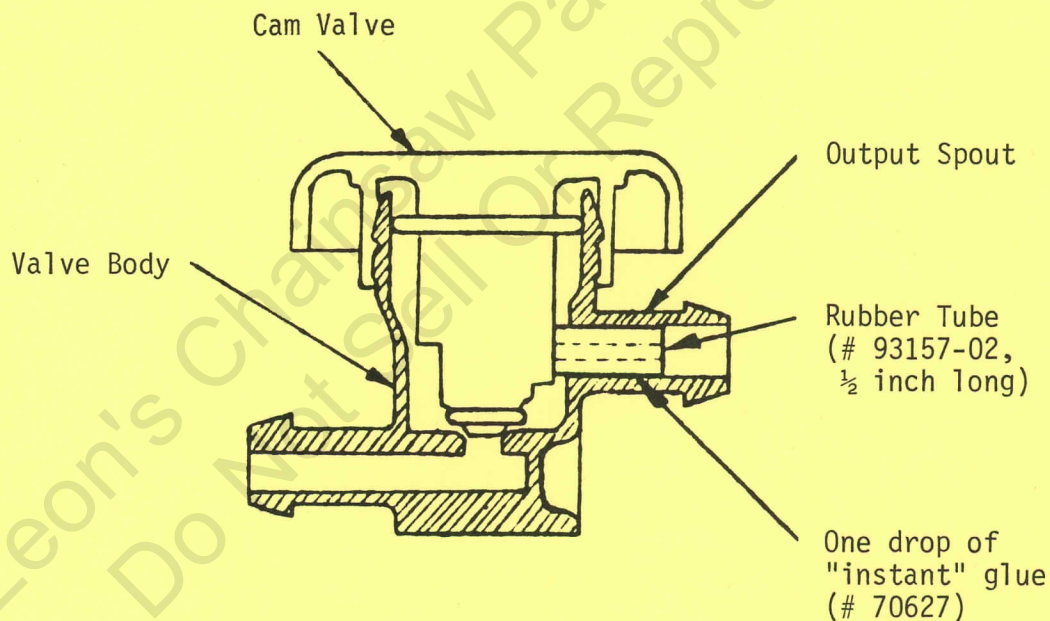
We have had reports that the fluid tank on our HB680 empties too fast for certain applications. Enclosed is a cross section picture of the control valve with a piece of tubing (part number 93157-02) in the output spout. A tank of fluid will last twice as long by installing this tube in the valve. Be sure to install the rubber tube as described below.

With the cam valve in place, align the number 1 on the valve cap with the output spout. Insert the rubber tube until seated. Apply one small drop of "instant" glue (part number 70627) between the rubber tube and the inner wall of the output spout.

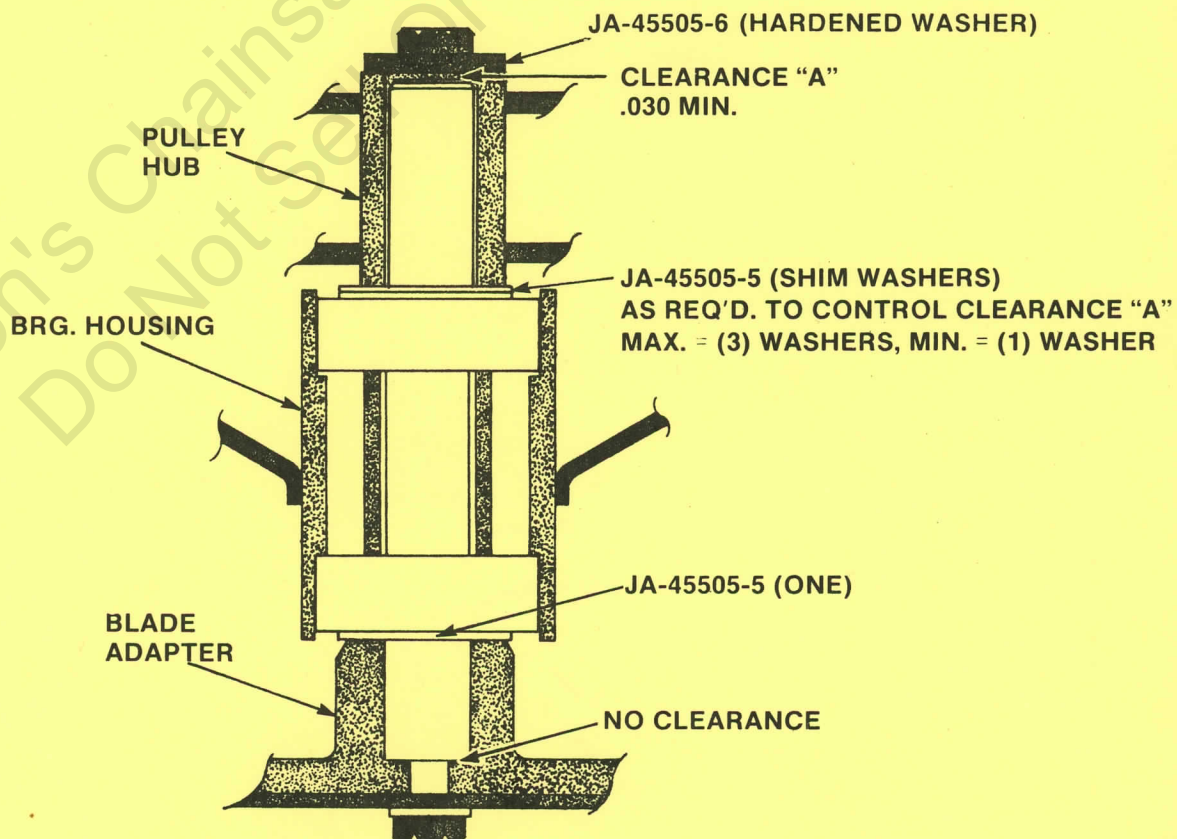
Manufacturing tolerances have allowed some center arbors to be produced with loose pulleys. To correct the problem shim washers have been added between the pulley and the bearing. The washer on top of the pulley has also been changed to a hardened washer.

1. Install blade adapter and key on arbor shaft and secure with lockwasher and bolt. Tighten bolt to 35-40 ft. lbs. Check for presence of one shim washer.
2. Install 2 shim washers on upper arbor shaft.
3. File any burrs that may be on the pulley hub. Install pulley on arbor shaft.
4. Check to see that the arbor shaft is at least .030" below the pulley hub. If shaft is above pulley hub add another shim washer.
5. Install key and secure pulley to shaft with lockwasher, bolt and hardened washer. Tighten bolt to 35-40 ft. lbs.
