NO. 184-001

SUBJECT: WORN CARBURETOR INLET NEEDLE LEVERS

AFFECTS: 240 CHAIN SAWS

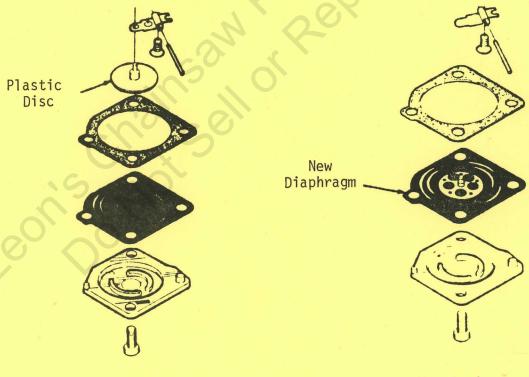
Early Zama carburetors, used on the 240 chain saw, incorporated a plastic disc (see figure 1) underneath the main diaphragm to operate the fuel inlet needle. The 240 carburetor is mounted directly to the power head and the vibration causes the plastic disc to wear the lever.

01d Design

New Design

The plastic disc has been replaced by a diaphragm with a riveted metal disc, in order to prevent this wear. See figure 2. This improved diaphragm is available in repair kit 96646-A and carburetor A-96352-A.

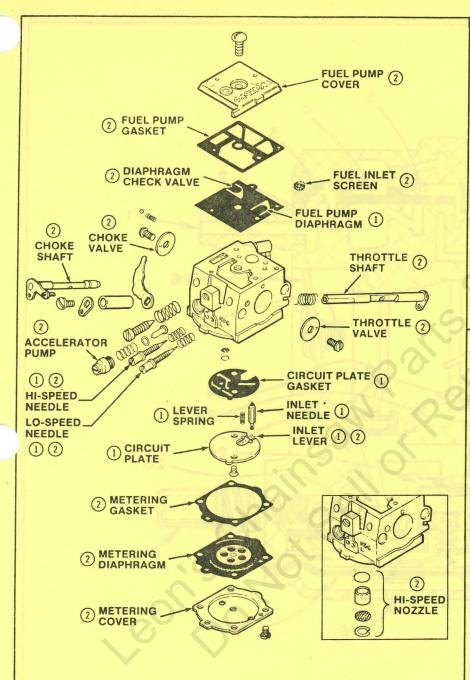
FUEL SYSTEM TROUBLE SHOOTING CHART

When troubleshooting a fuel related problem, the entire fuel system should be checked using a systematic series of tests and inspections.

Areas often overlooked within the fuel system include the air filter, fuel cap and vent, fuel filter, fuel line, loose carburetor screws, torn gaskets, and the condition or installation of the manifold assembly (gaskets, reeds, spacer).

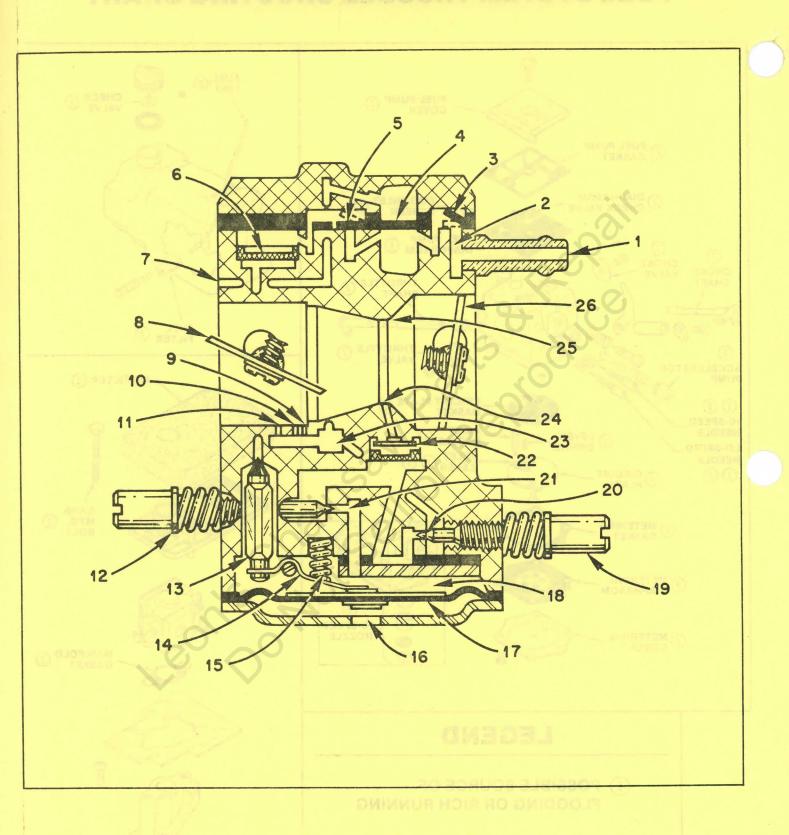
HDC CARBURETOR SCHEMATIC

- FUEL INLET FITTING
 Pressure test for air leaks press
 fit should be tight.
- SURGE CHAMBER Should be clean, check for debris or metal chips.
- INLET CHECK VALVE Should lie flat on carburetor body look for tears or wrinkles.

- 4. FUEL PUMP DIAPHRAGM
 Should be flexible not stiff or stretched. Replace if diaphragm is porous.
- 5. OUTLET CHECK VALVE
 Should lie flat on carburetor body look for tears or wrinkles.

- 6. FILTER SCREEN
 Check for dirt or debris. Debris on screen indicates possible problem with fuel filter or fuel line.
- 7. ENGINE PULSE PASSAGE
 Make sure carburetor pump cover and
 carburetor body are drilled for pulse.
 Make sure mounting gasket & pulse
 passage align with manifold.

- 8. THROTTLE VALVE
 Check for proper alignment in venturi.
 Check throttle shaft for wear-source
 of air leaks.
- 9,10,11. IDLE PORT HOLES
 Check for dirt & debris, clean with compressed air only.

- 12. HI-SPEED NEEDLE
 Remove & inspect needle & seat for damage.
 - 13. INLET NEEDLE VALVE
 Inspect rubber tip for wear. If
 needle seat is damaged replace
 carburetor.

- 14. METERING LEVER
 Check for wear at metering diaphragm
 contact point. It must turn freely on
 fulcrum pin. Check for proper adjustment.

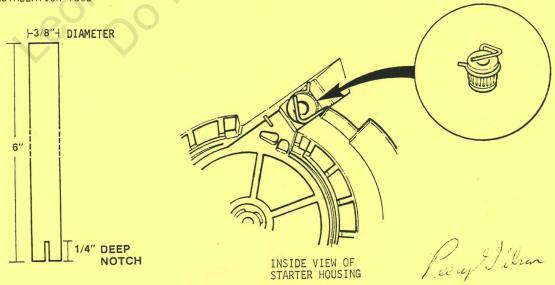
INSTALLATION TOOL

A rope bushing and guide kit (A-97796) is available to service the models ST-80, 100, 120 starter housings. This rope guide (retained by the bushing) will prevent the rope from slipping out of the pulley groove and being cut by the starter pawls during recoil.

To install the bushing and guide kit in older string trimmer starter housings containing the small brass or steel bushing, drill through the existing bushing with a 3/8" (9,5mm) drill bit. Apply a quick set adhesive (Homelite part number 70627) to the bushing (with rope guide) and press it into the housing from the inside. Allow the adhesive to dry. This repair should not be made if the rope has worn a deep groove into the starter housing. In this case, replace the starter housing.

Refer to the diagram below for the proper assembly sequence and location of the bushing and rope guide. Assemble the rope guide onto the bushing (as shown in inset drawing) before installation in the starter housing. An installation tool (see diagram) can be made by using a 6" X 3/8" steel rod, bolt, or wooden dowel and cutting a 1/4" deep notch in one end.

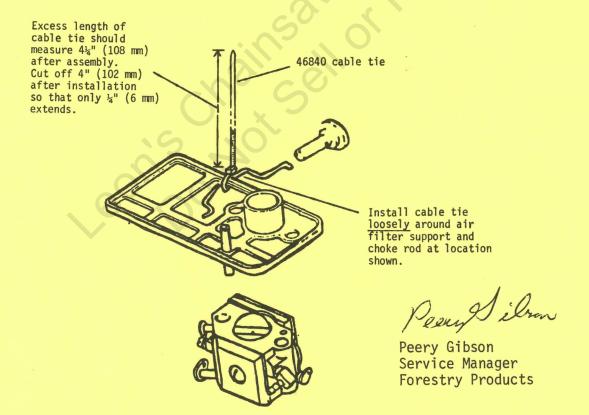
Reports have been received concerning some units of the subject model string trimmers being hard to start when cold. If this is the case, suspect the choke plate not closing completely.

This can be determined by removing the air filter and cover and inspecting the choke plate action. Should the choke close completely only when the choke knob is twisted slightly counterclockwise, improved choke action can be obtained by installing a cable tie (46840) <u>loosely</u> around the air filter support and choke rod (see diagram below).

This "field fix" will prevent the choke rod from falling down causing the linkage to bind, improving the action of the choke plate.

Follow the instructions below when installing the cable tie (46840).

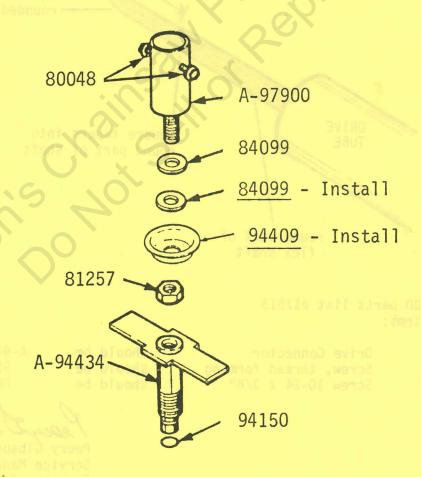
1) Whenever the lower head housing assembly (A-97900) is replaced on the subject model string trimmers, shield (94409) and a second flat washer (84099) should be added to the assembly (see diagram below). Addition of these two parts will prevent grass from wrapping around the shaft resulting in premature bearing failure. Without the above modification, early bearing failure can be expected to occur.

Use shaft holder tool (94482) to aid in the removal and installation of the drive connector and jam nut. Turn drive connector and jam nut clockwise (left hand thread) to remove.

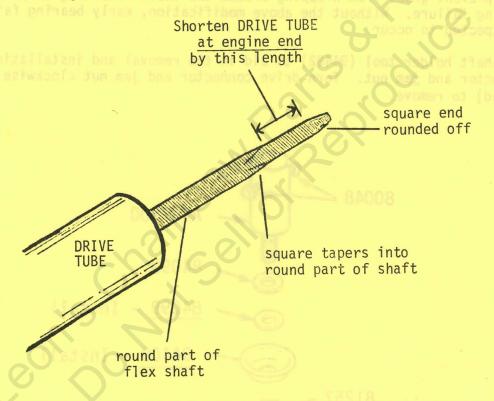
2) It has been reported that some drive tubes must be shortened to prevent the end of the flexible drive shaft from rounding off due to lack of full engagement in the square adapter. When this type of failure is encountered, the drive tube should be shortened (at the engine end) before reassembly with a new flex shaft or a similar failure will occur.

The length of the rounded off portion of the flex shaft indicates how much the shaft was engaging the adapter. The remaining, undamaged (not rounded off) length of the square determines how much the drive tube should be shortened to assure <u>full</u> engagement in the adapter.

Measure the undamaged length* of the square end as shown in the diagram below.

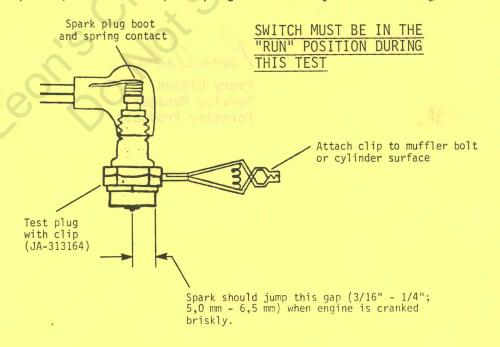
Spark plugs are often overlooked as the cause for ignition problems. Before testing an ignition system for spark, check the condition, electrode gap - .025" (0.65 mm) and heat range of the installed spark plug. Remember, a spark plug which fires in open air may not fire under compression.

Homelite recommends use of the surface gap spark plug tester (p/n JA-313164) when checking ignition modules for spark (see diagram below)*.

Solid state ignition modules produce an orange "pin-like" spark best seen in low light. The engine must be cranked briskly when checking for spark (remove the spark plug from the cylinder during this test).
