NO. 187-001  
287-001**SUBJECT:** TECHNICAL SERVICE BULLETIN LISTING**AFFECTS:** 1986 TECHNICAL SERVICE BULLETINS

# TECHNICAL SERVICE BULLETIN

**HOMELITE  
JACOBSEN**

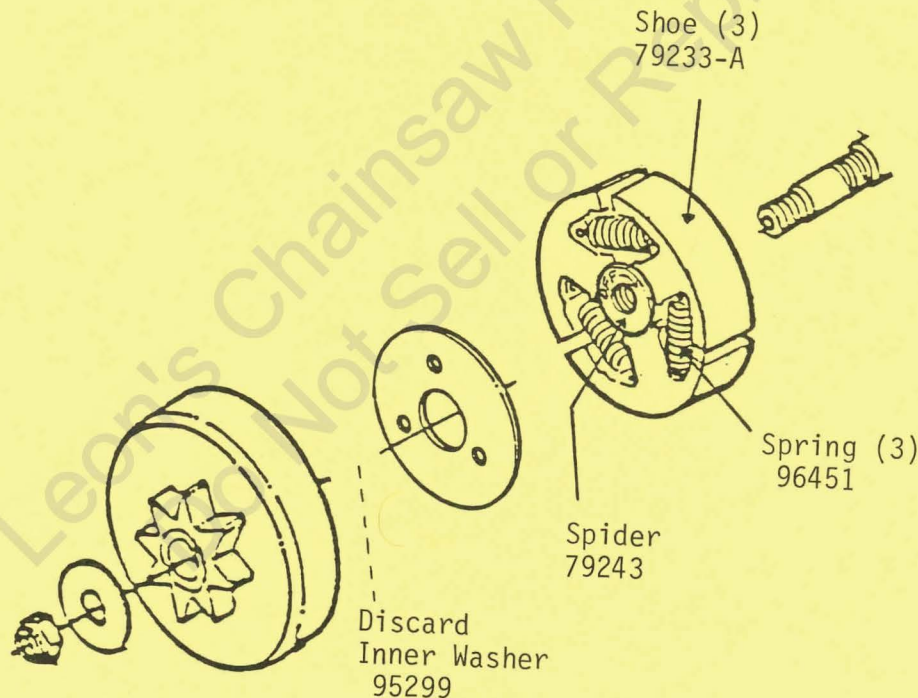
A three-shoe unlined clutch assembly A-98129 has replaced the S-Clutch on the Model 240 and the three-shoe lined clutch on the Model 245. Refer to the diagram below when ordering parts for this new clutch assembly.

For Model 240 - Discard clutch cover 69915-1, screws (2) 97605, and inner washer (1) 95299.

For Model 245 - Discard clutch cover 96919-1, screws (3) 97605, and inner washer (1) 95299.

Use clutch tool A-24060 to install clutch assembly onto crankshaft.

Install clutch assembly A-98129 with the "OFF→" facing out. Torque clutch assembly to 250 - 300 in.lbs. (28,2 - 33,9 Nm).

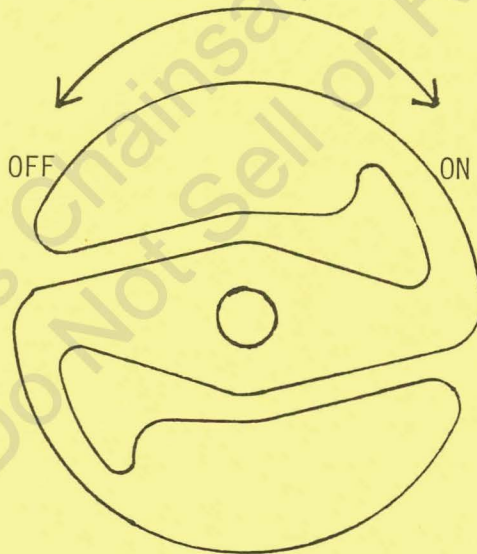
The subject model trimmer/brushcutter units use two (2) 1/8" thick S-clutches installed one on top of the other. These S-clutches must be REMOVED one at a time by turning COUNTERCLOCKWISE (R.H. Thread).

Use clutch tool A-93791 to remove and install each S-clutch.

During installation, torque each S-clutch to 80-100 in.lbs. (9,0-11,3 Nm).

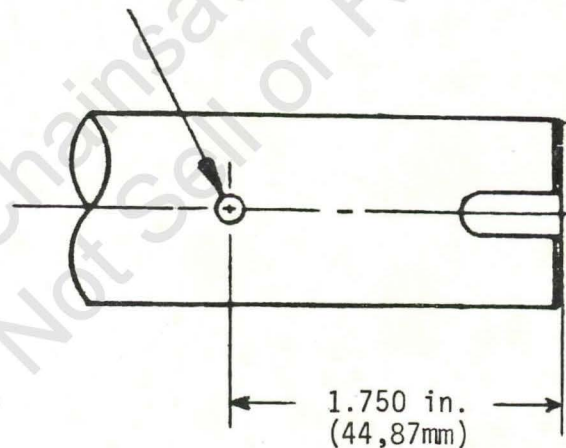
.147 in. (3,77mm) use #26 drill bit

The models ST-155 and ST-175 trimmers built starting with Lot #I064 use a #10 x 3/8" sheet metal screw and clamp 98802-A to secure the engine housing to the driveshaft housing. The driveshaft housing also has a .147" diameter hole to accept the new screw.

When drilling hole in driveshaft housing do not pierce inner star liner or flexible driveshaft.

Trimmers built prior to Lot #I064 can be modified by drilling a .220" (7/32" drill bit) hole in the existing clamp (or using clamp 98802-A), drilling \*a .147" (#26 drill bit) diameter hole in the driveshaft housing as shown in the diagram below, and using a #10 x 3/8" sheet metal screw. The diagram below may also be used as a template.

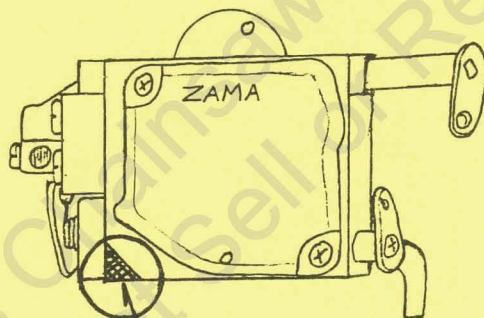
View Shown is  
From Metering Side

Models 240 and 245 chain saws exhibiting hard starting, poor idling, and erratic operation should be checked for proper carburetor (Zama Only) seating on the intake manifold. It is possible that the top left manifold mounting screw may be preventing the carburetor from seating.

In order to insure proper seating, one corner of the carburetor (see diagram below) may have to be filed away.

File off this corner  
of the carburetor casting

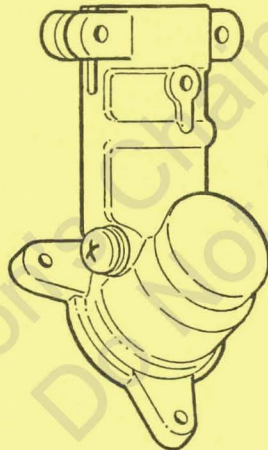
UT-15040  
A-98844

A new gearhead assembly (A-00436) is now being used on the ST-385 trimmer/brushcutter. Although this gearhead assembly (A-00436) will interchange with the previous gearhead assembly (A-98844), the associated parts (flange washers, retaining nut, and stringhead shaft adapter) are not interchangeable.

**NOTE:** Service will supersede the old gearhead (A-98844) to assembly A-00535 which includes the new gearhead A-00436 and shaft adapter 00490.

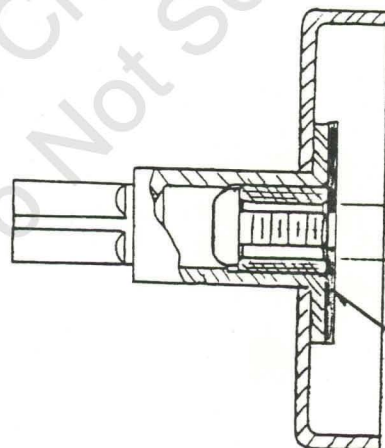
- 1) The clutch drum & connector assembly is retained to the adapter shaft by a Torx head screw. The clutch drum is removed by using Torx bit (P/N 24982-03). This bit has a 1/4" shank and is 6" long allowing access to the screw through the square connector.
- 2) Several reports have been received concerning the clutch drum & connector moving forward resulting in the bushing coming out the drum. All production (starting with S/N HI1051927) and service drum & connector A-00252 now have a thin flat washer welded to the drum after the bushing is installed. This washer has a smaller I.D. to retain the bushing in the drum.

Washer welded to  
drum retains bushing.

Any service drum & connectors (A-00252) in your stock which do not have the washer to retain the bushing welded to the drum should be returned to the address below for replacement.

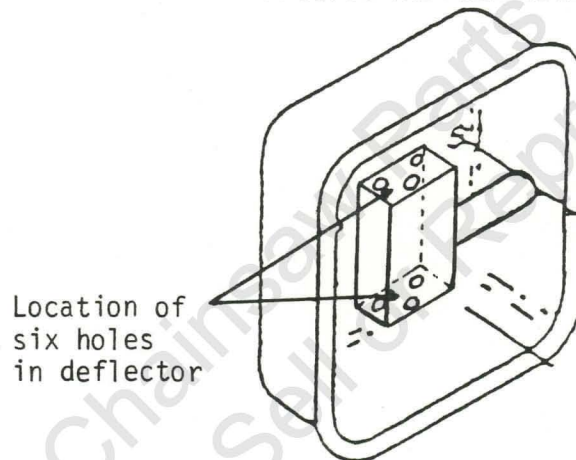
A-98780 MUFFLER COVER

Any of the above subject units exhibiting symptoms\* of low power, low no-load RPM, and/or hard starting should be checked to see if the deflector welded inside the muffler cover (Part #A-98780) has the correct number of holes drilled in it.

There should be a total of six (three in the top and three in the bottom) 5/32" diameter holes drilled in the deflector (see illustration below).

\*NOTE: We have heard of several cases where mud dauber wasps have built nests in the round exhaust tube of the muffler cover. If this occurs the symptoms will be similar to those described above. The cleaning of these mud dauber nests out of the muffler cover is NOT A WARRANTABLE FAILURE.

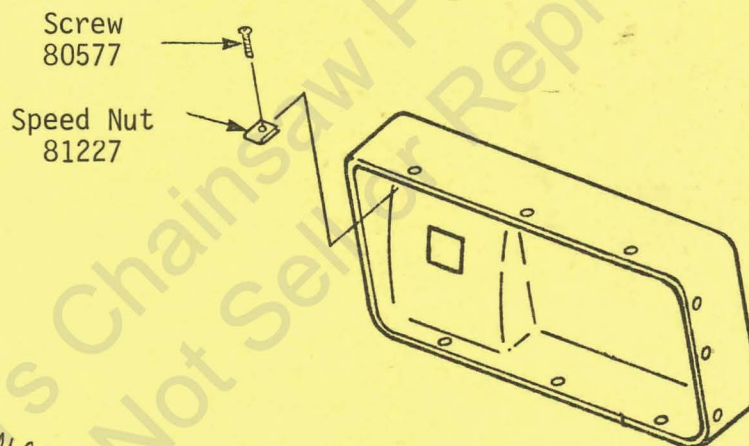
The DC Battery Charging lead for the HG3500 was not included in the parts list. The part number for the DC Lead is A-49380. The speed nut and screw for the panel cover are also missing from the parts list. Please correct your parts list accordingly.

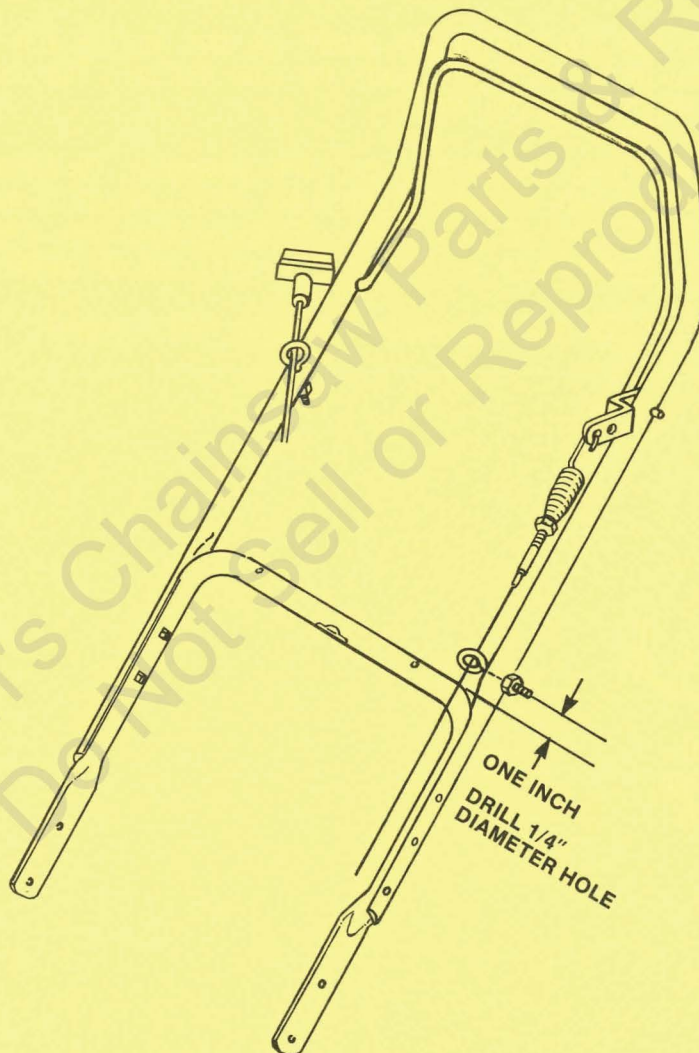
## SERVICE ASSEMBLY EYEBOLT AND NUT PART NUMBER JA-99236-5

If the tie straps that hold the cable to the handle are not properly installed they will be cut through by the cable. The cable will then cut through the upper cowling.

To prevent this from happening, service assembly JA-99236-5 has been issued. This service assembly consists of an eyebolt and nut and requires the drilling of one hole. Instructions are provided with the service assembly and .3 hours labor will be allowed for the job.

- 1) Locate and drill a  $\frac{1}{4}$ " (.250) diameter hole in left handle 1" above intersection of the cross bar and lower handle.
- 2) Install eyebolt in hole with eye toward inside of handle and open part of eye facing down.
- 3) Route clutch cable through eye.
