SUBJECT: STARTER ASSEMBLY A-00793**AFFECTS:** DM40 AND 410

TECHNICAL SERVICE BULLETIN

NO. 188-003

SUBJECT: TOGGLE SWITCH & PLATE ASSEMBLY

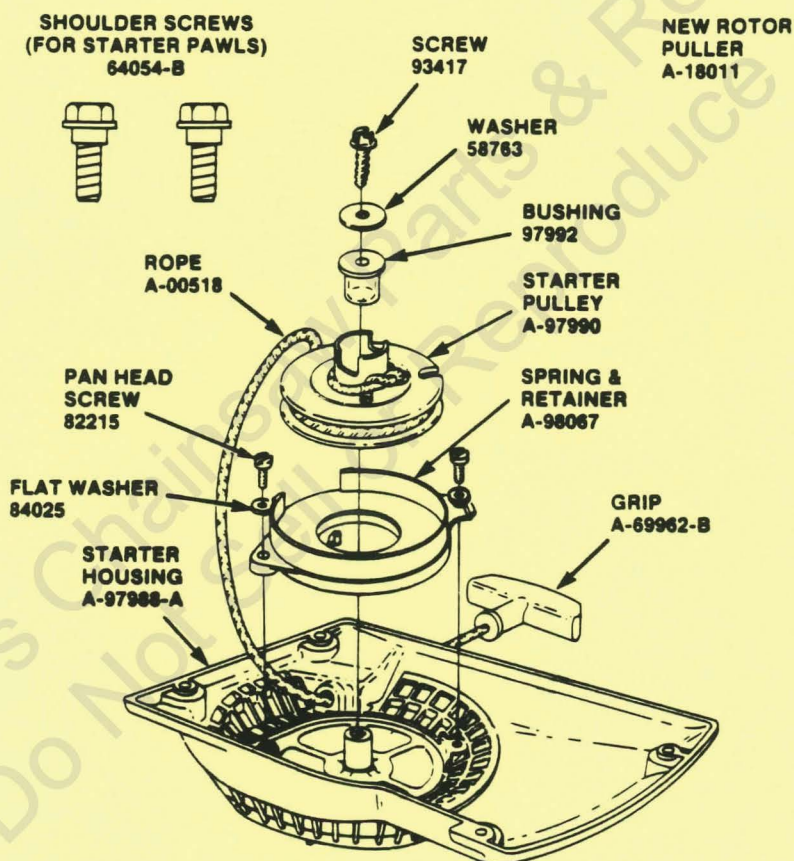
Both the spring and retainer (P/N A-98067) have been improved. The hole in the center of the retainer is smaller which retains the spring when fully wound. The hook on the spring has been reformed to match the diameter of the hub.

It is important that you use the new pulley (P/N A-97990) with the A-98067 Spring and Retainer. The new pulley has been modified to retain the spring hook better than the old pulley (See Technical Bulletin 186-017). The rope is double wrapped around the hub with a metal ferrule installed on the end. This will prevent the rope from pulling out of the starter. New shoulder screws (P/N 64058-B) MUST be installed with this starter assembly. The new shoulder screws do not have the threaded studs. If shoulder screws with threaded studs are used the studs will catch on the starter rope and damage the starter assembly. A new rotor puller (P/N A-18011) is available for units using the new shoulder screw.

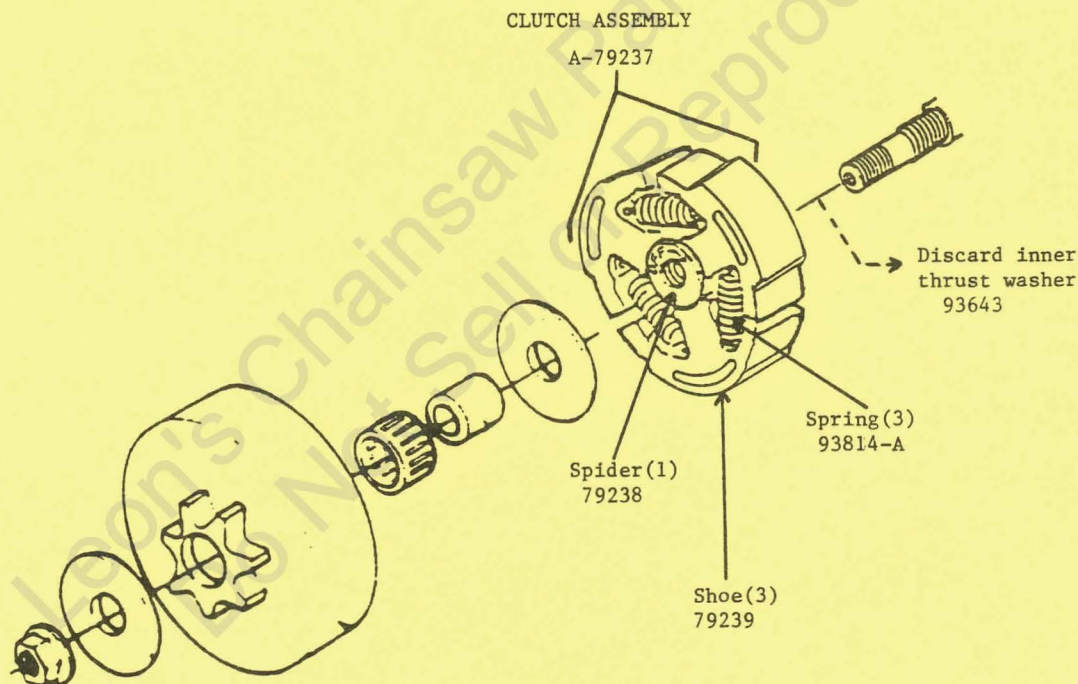
A three-shoe unlined clutch assembly A-79237 has replaced the three-shoe lined clutch on the Model 330 chain saw. The older spider 94374 will supersede when exhausted to the unlined clutch assembly. Refer to the diagram below when ordering parts for this new clutch assembly.

Installing a clutch assembly backwards (with the counter bore facing out) could result in breakage of the crankshaft.

Discard inner thrust washer 93643 (located between clutch assembly and crankshaft) when installing the new A-79237 clutch assembly.

Use clutch tool A-24060 to install clutch assembly onto crankshaft.

Install clutch assembly A-79237 with the "OFF→" facing out. Torque clutch assembly to 250 - 300 in.lbs. (28,2-33,9 Nm).

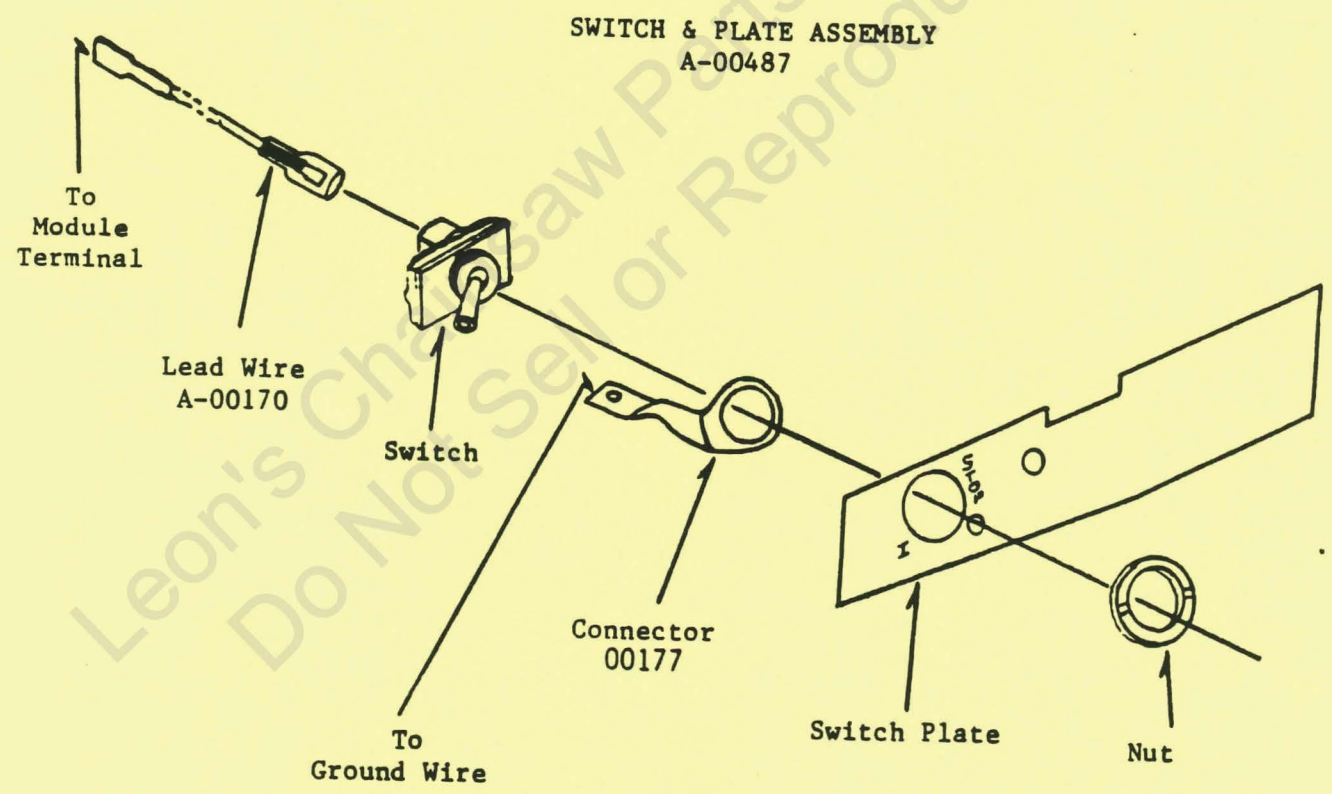
The plastic on-off switch 98377 used on the subject model chain saws has been superseded by a new toggle switch and plate assembly A-00487. This assembly is supplied with a new module lead wire A-00170 and ground connector 00177 in order to retrofit older units.

Refer to the diagram below when assembling or ordering parts for the new switch assembly.

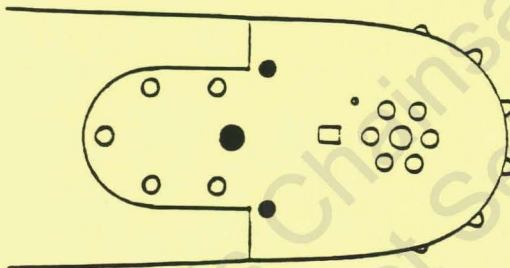
FIVE RIVET NOSE ASSEMBLY used on
H2 and H5
Windsor style SP series guide bars

3/8" Pitch - A-98586
.404" Pitch - A-98585

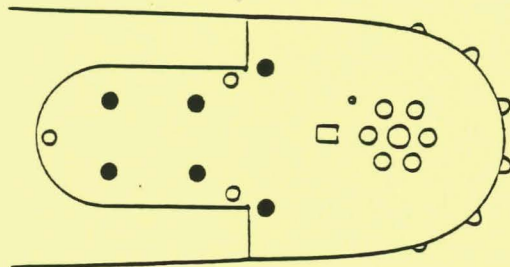
THREE RIVET NOSE ASSEMBLY used on
A2 thru G2 and A5 thru G5
Windsor style SP series guide bars

3/8" Pitch - A-69921-A
.404" Pitch - A-69922-A

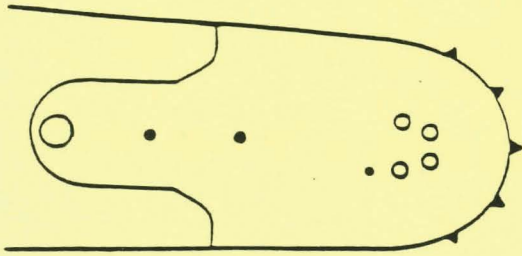
ONE RIVET NOSE ASSEMBLY used on
H5
Oregon style SP series guide bars

3/8" Pitch - A-00489

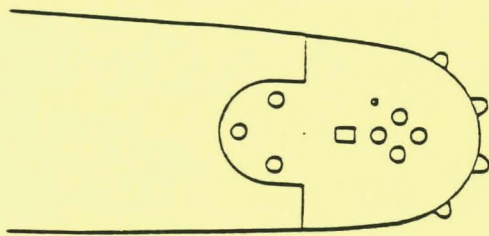
THREE RIVET NOSE ASSEMBLY used on
H6
Windsor style SP series guide bars

3/8" Pitch - A-98619

.325" Pitch - A-79339

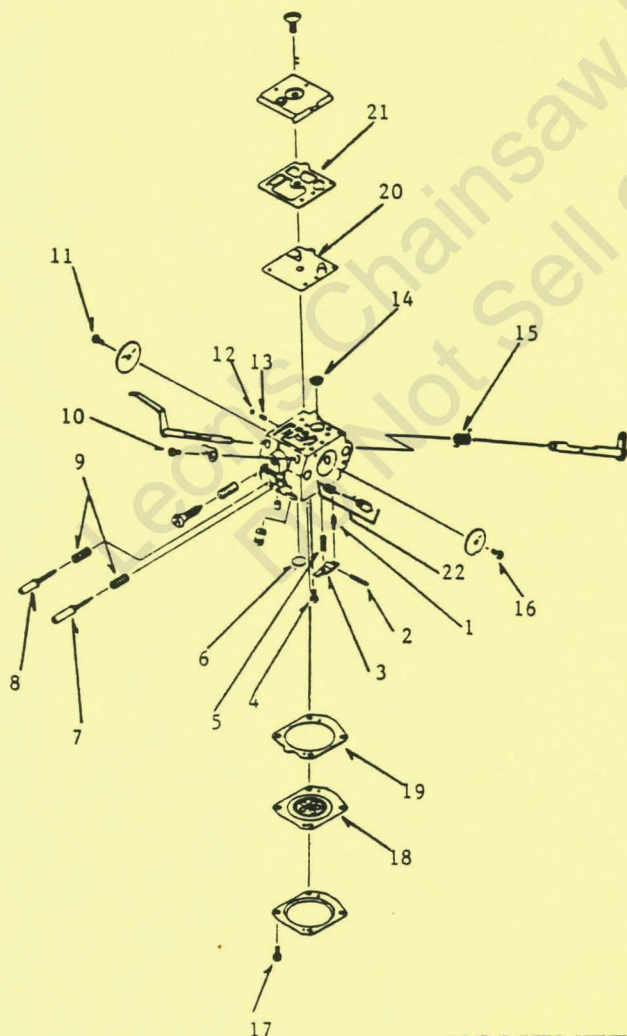
- 1) The Walbro Model HDA series carburetors are now being used on the XL family of chain saws. Improved idling and acceleration characteristics have been achieved with the use of an accelerator pump (see item 22 below) on these new carburetors.

Repair parts for the older HDC series will not interchange with the new HDA carburetors. Refer to the illustration below when ordering repair parts for the HDA series.

A-00964 Repair Kit
(includes items
1 thru 21)

00513 Gasket/Diaphragm Kit
(includes items
18 thru 21)

A-00965 Accelerator Pump Kit
(item 22)

00978 Inlet Needle
(item 1)

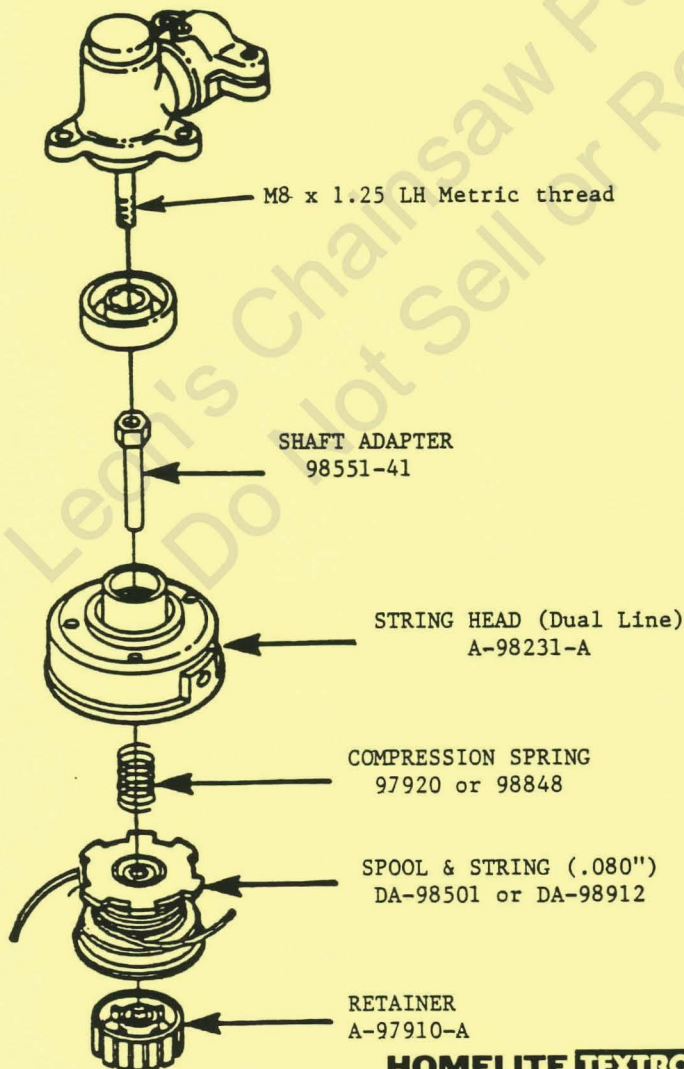
A shaft adapter P/N 98551-41 is available to convert * the subject model trimmers/brushcutters to the E-Z-Line string advance system. This shaft adapter will only fit units which have a gearhead with male metric (M8 X 1.25LH) threads on the splined shaft.

Early ST-385 (UT-15040) units with a 5/16-18 LH male splined shaft (see Technical Service Bulletin 187-009, 6/87) and 1985 model HK-24 and 33 units with a female splined shaft CANNOT BE CONVERTED.

Refer to the diagram below when ordering the necessary parts to make the conversion.*

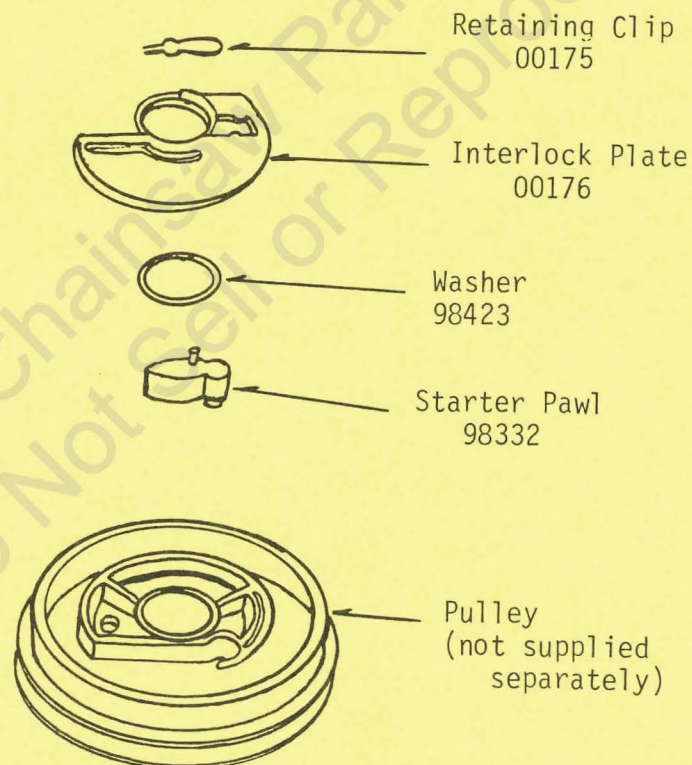
A-01093
PULLEY CONVERSION KIT

1. The starter pulley on the subject model chain saw has been revised to include an interlock plate (00176) and new retaining clip (00175). The older pulley 98329 will supersede, when exhausted, to a pulley conversion kit A-01093. The parts contained in pulley kit A-01093 are illustrated below.

The "dog-leg" retaining clip 98334 will still be available to service older units. Both retaining clips 00175 and 98334 will be supplied in starter rope kit A-98485.

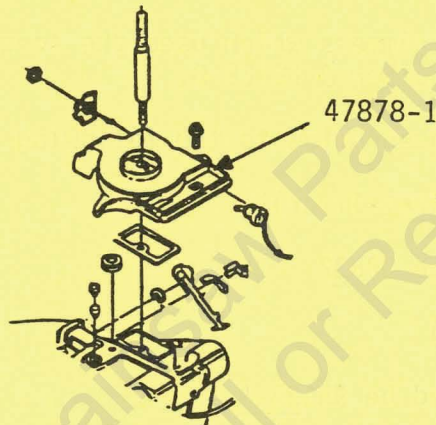
The air filter support part number was never shown. The part number is 47878-1 (see illustration below)

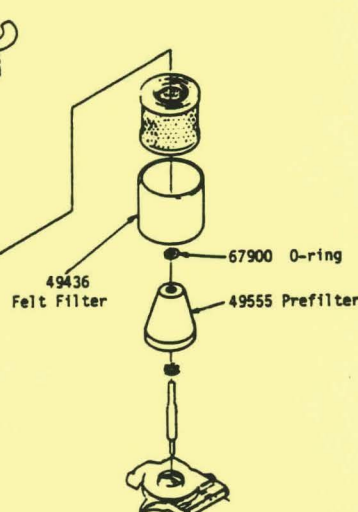
2. The DM-40 Multi-Purpose saw is now being produced with the three-stage air filter system. This system includes the velcro closure air filter felt 49436 and the felt pre-filter 49555.

When ordering parts for later production units or when converting a unit to the three-stage system refer to the diagram below.

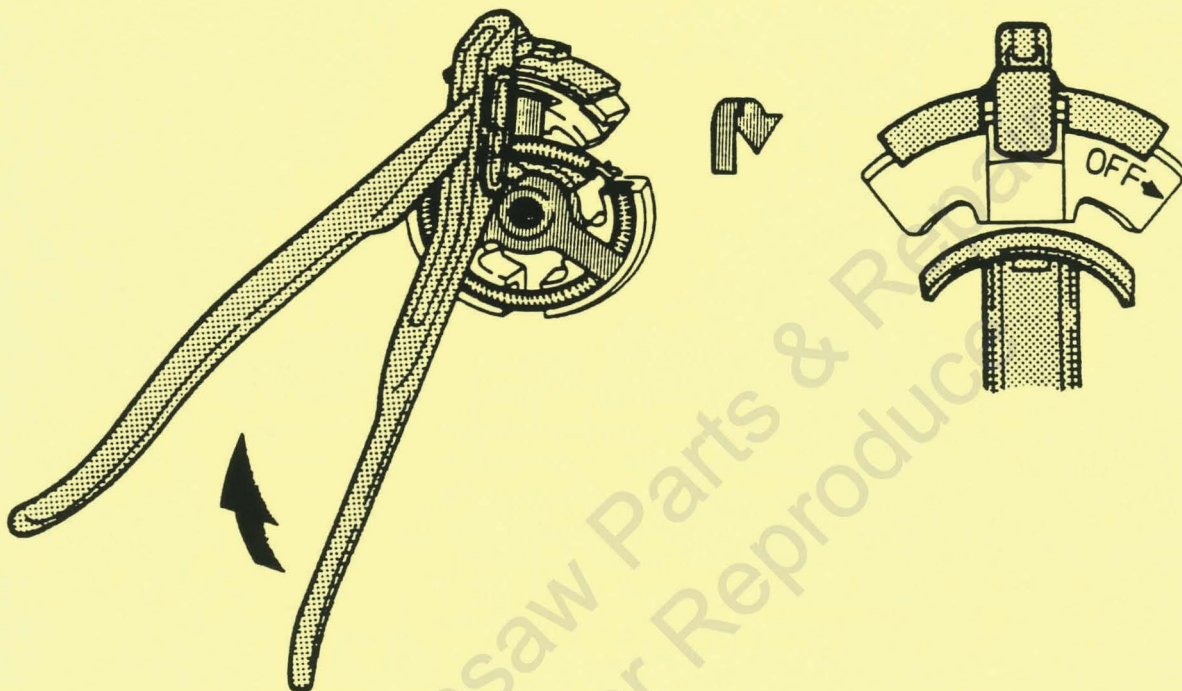
3. A clutch spring installation tool 18080 is available to aid in the installation of the spring on 290, 340, and 540 clutch assemblies. This tool is illustrated below.

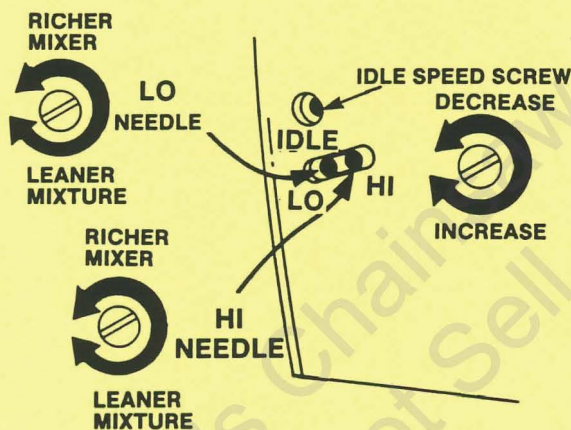
DO NOT TRY TO REMOVE THE SKIPPING BY ADJUSTING THE HI-NEEDLE SCREW ON THE CARBURETOR. THE PISTON WILL SEIZE IN THE CYLINDER.

ALWAYS KEEP THE HI-NEEDLE SCREW 1 1/8 TO 1 1/4 TURN OPEN. IF THE HI-NEEDLE IS NOT AT THE ABOVE SETTING THE PISTON WILL SEIZE IN THE CYLINDER DUE TO A LEAN RUNNING CONDITION.

The procedure below shows how to adjust the Hi and Lo mixture screws.

HIGH ALTITUDE OPERATION: If the saw is used at high altitudes (above 5000 ft.) it may be necessary to change the carburetor setting slightly. If the idle speed is low, raise it by turning the idle speed screw to the right (clockwise). Turn the HI NEEDLE to the right (clockwise) 1/8 turn. The new basic settings should be:

HI NEEDLE: 1-1 1/8 turns open.

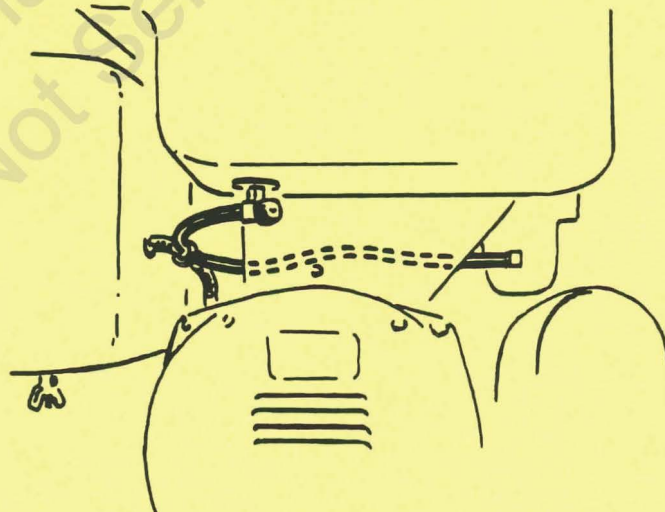
1. OPEN/TOP
2. ENGINE KILL WIRE
3. GROUND

2. Brush head terminal. Remove cover and fan to inspect terminal. Terminal should be bent toward generator not toward fan.
3. Fuel line should be held in place by the tie at the back of the control panel.
