SUBJECT: PRIMER REPAIR PARTS FOR 25cc ENGINES

AFFECTS: 25cc STRING TRIMMERS & BLOWERS

TECHNICAL SERVICE BULLETIN

NO. 189-002

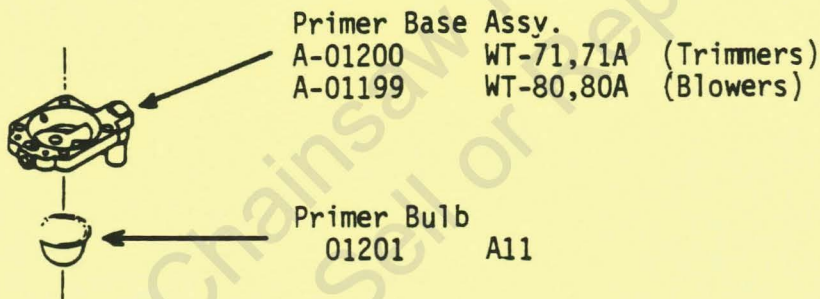
WALBRO

Parts are available to service the primer systems on both the Walbro & Zama carburetors used on the subject model units.

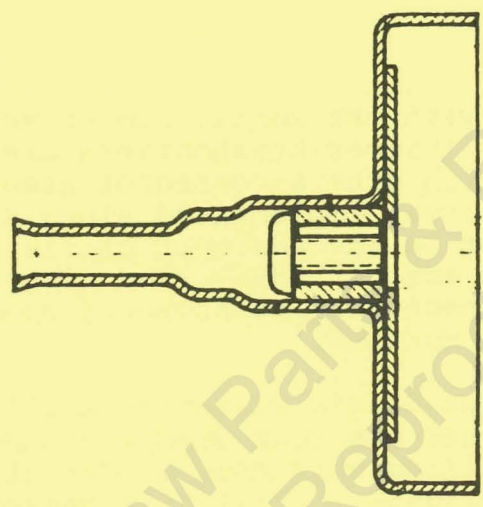
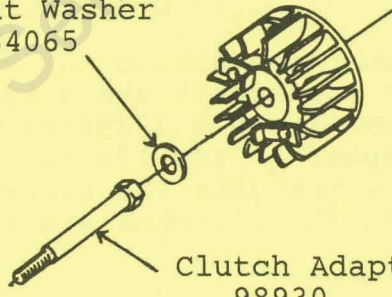
Drum & Connector
A-00585-1

Effective with the serial number shown above all clutch model 25cc trimmer/brushcutters are being built with a formed clutch drum & connector assembly A-00585-1 (see diagram below). Implemented along with the new drum & connector is the addition of flat washer 84065 under the clutch adapter 98930 (see diagram below). This washer is necessary to properly space the drum away from the engine housing.

The previous drum & connector A-00252 is no longer available and has been superseded by the new A-00585-1. When installing this drum & connector on unit made prior to S/N HJ3370950 it will be necessary to install the flat washer 84065 under the clutch adapter. If this washer is not installed, the drum will rub the engine housing.

When reinstalling the clutch adapter onto the crankshaft use a thread-locking agent (Homelite P/N 23488-C) on threads and torque adapter to 100-150 in. lbs. (11,3-16,9Nm). This prevents the adapter from coming loose when the clutches are removed.

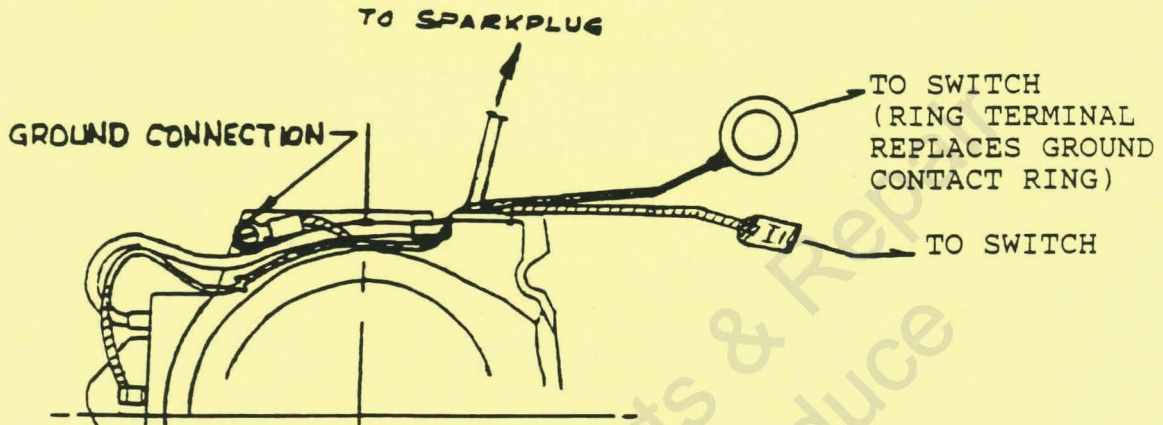
2. The braided ground lead previously used on the 540 has been replaced with a separate ground lead wire (still part of the stop switch lead assembly). The ground wire is retained by the top air guide scroll screw. Refer to the diagram below for proper routing of the new ground lead. The ground contact 98903 (located under the switch) is part of the switch lead and ground wire assembly. When using the new lead wire assembly the old ground contact ring should be removed and discarded.

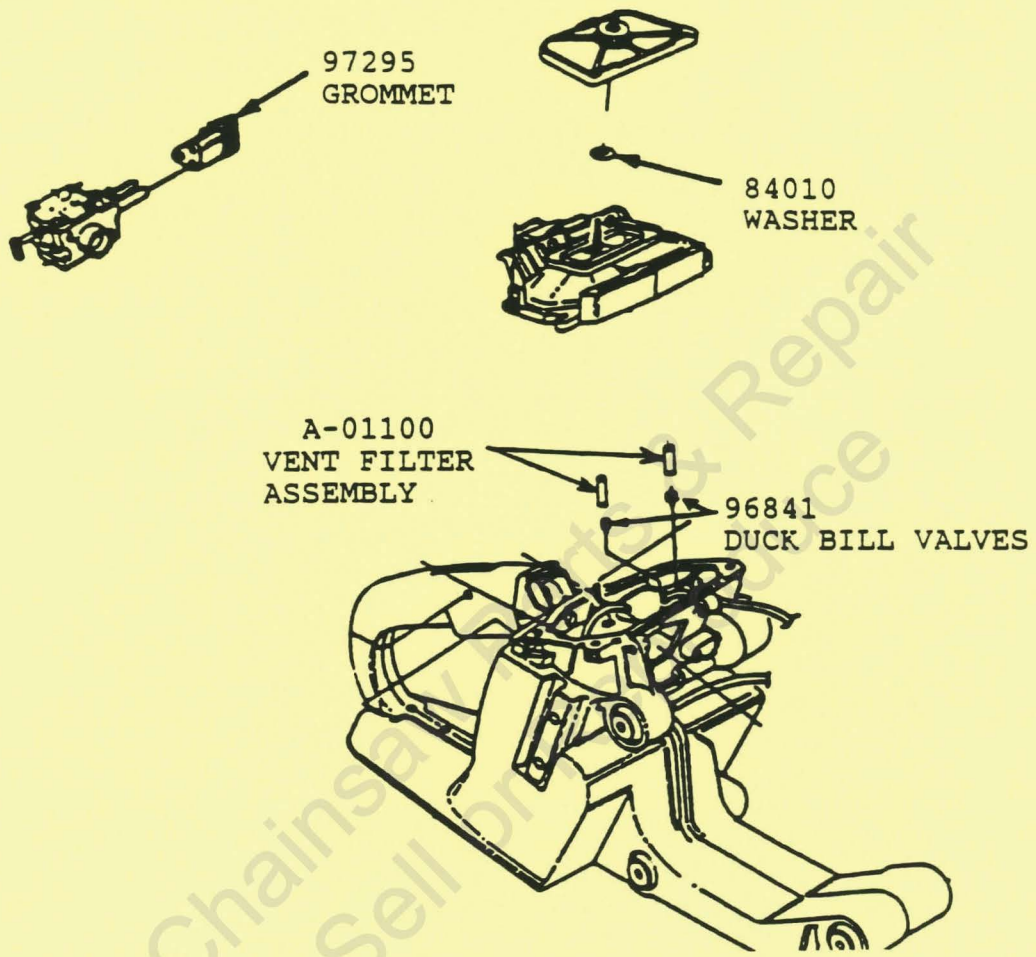
3. Effective with Lot # HJ074 new fuel and oil tank vent filters A-01100 have replaced the earlier sintered bronze filters 00788. The new filter assembly consists of a porous filter (white in color) pressed into an aluminum sleeve. The filter assemblies should be installed with the porous white filter facing up.
4. Along with the new vent filters mentioned in Item #3 the sealing of the carburetor chamber was improved by replacing the three (3) translucent yellow carburetor adjustment needle sleeves (00038 & 00039) with a molded rubber grommet 97295 and adding a flat washer 84010 under the air filter element to prevent it from bowing when the retaining nut is tightened.

During installation of the carburetor (with the grommet) make sure the grommet face seats and seals against the left side of the carburetor chamber. The flat washer should be installed and centered over the air filter mounting bracket stud, making sure it lays flat, use a cyanoacrylate adhesive (i.e. Super Glue) to hold it in place.

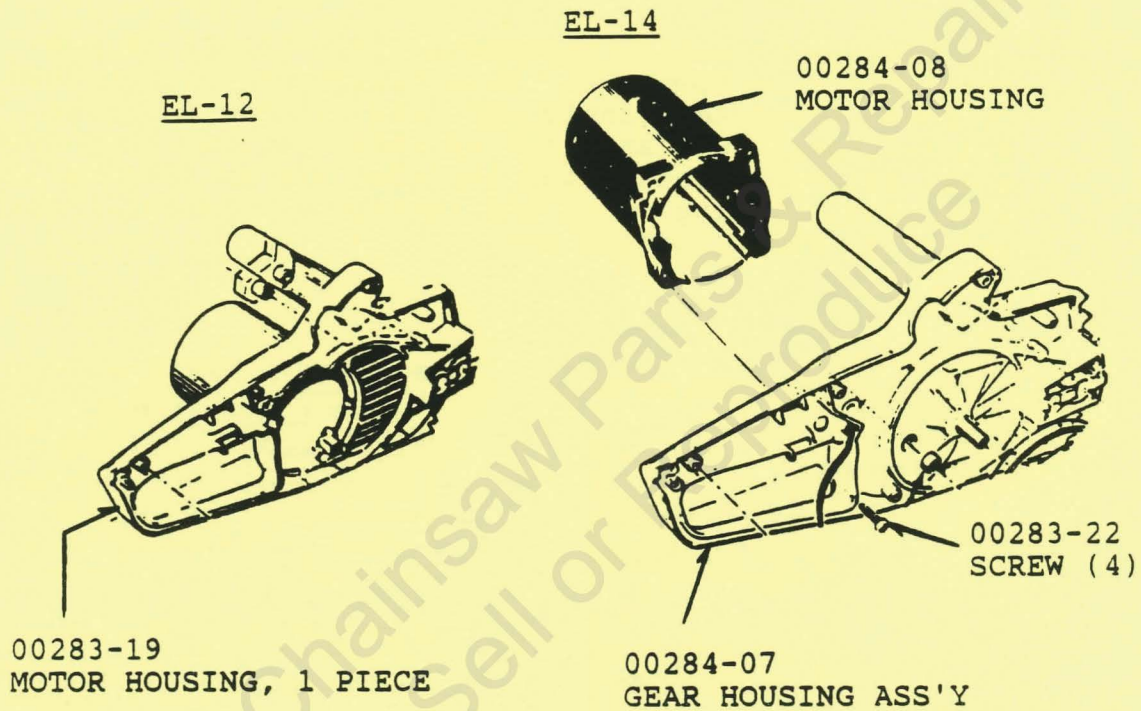
2. The EL-12 and 14 Parts List (18018) is somewhat unclear as to the part numbers of the motor housings and gear housing (EL-14 only). For clarification, please refer to the diagram below.
