HOMELITE® TECHNICAL SERVICE BULLETIN

NO. 194-001

SUBJECT: OEM "REPOWER" Short Blocks
"Smooth Operator" cylinders and muffler

AFFECTS: 25cc and 30cc (Except Pro-Series) String
Trimmers, Brushcutters, AP-125 and Blowers

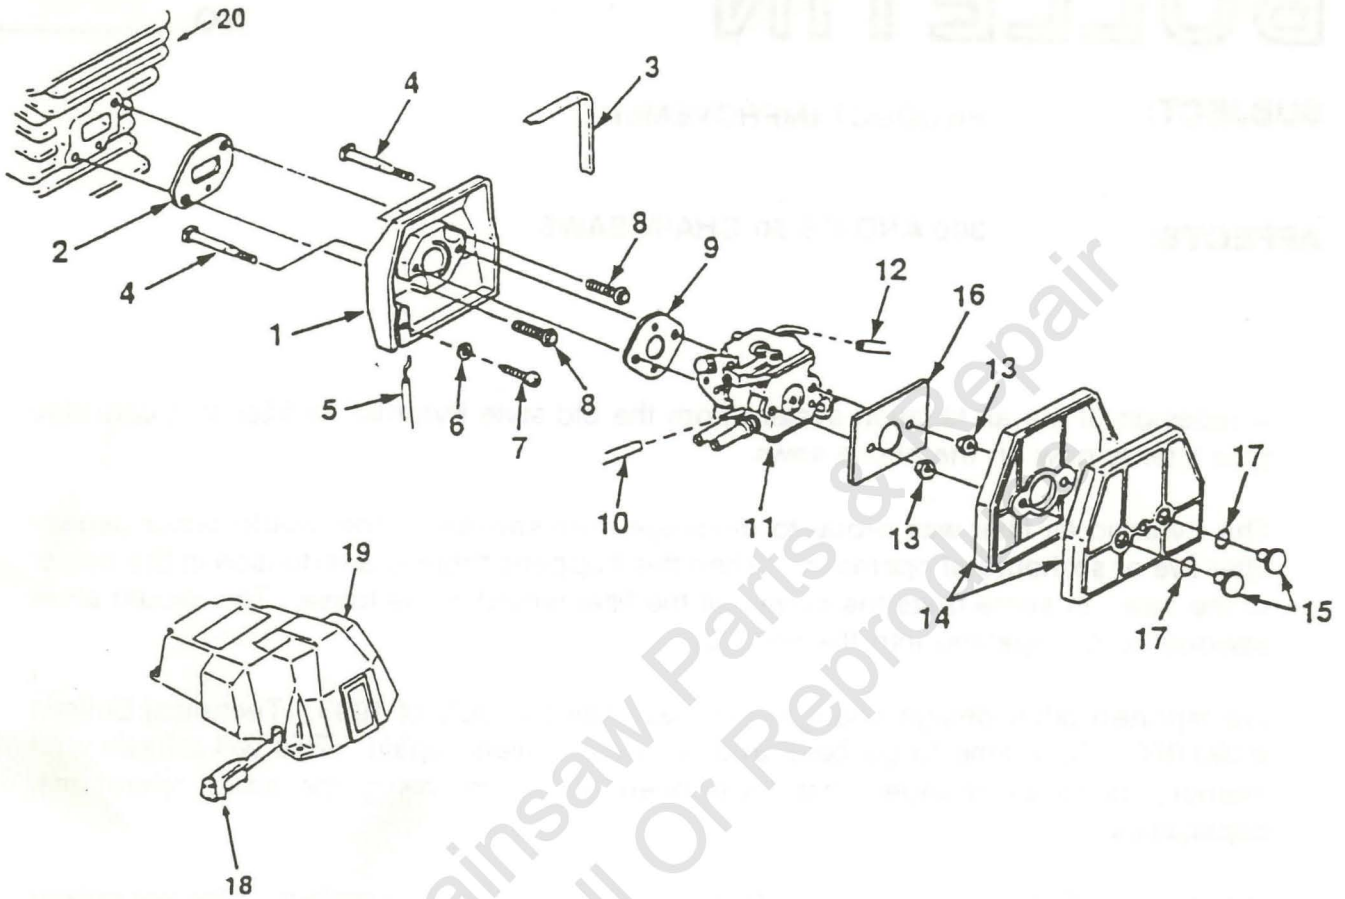
**NEW AIR FILTRATION SYSTEM: CS50 AND 300 CHAIN SAW
CONVERSION KIT A06611**

A redesign of the air filtration system from the old style Pyramid air filter to a cartridge type filter is now on the above saws.

The Pyramid air filter was prone to blockage from sawdust. This would occur usually after five or six hours of operation. When this happens there is a reduction in the power of the saw. In some units the corner of the filter would come loose. This would allow sawdust to be ingested into the engine.

If you need to change the piston and cylinder on one of the older units, a new kit, part number A06611 has been made available. A list of the parts included in this kit follows the illustration. ALL of these parts MUST be installed in order to make the proper conversion.

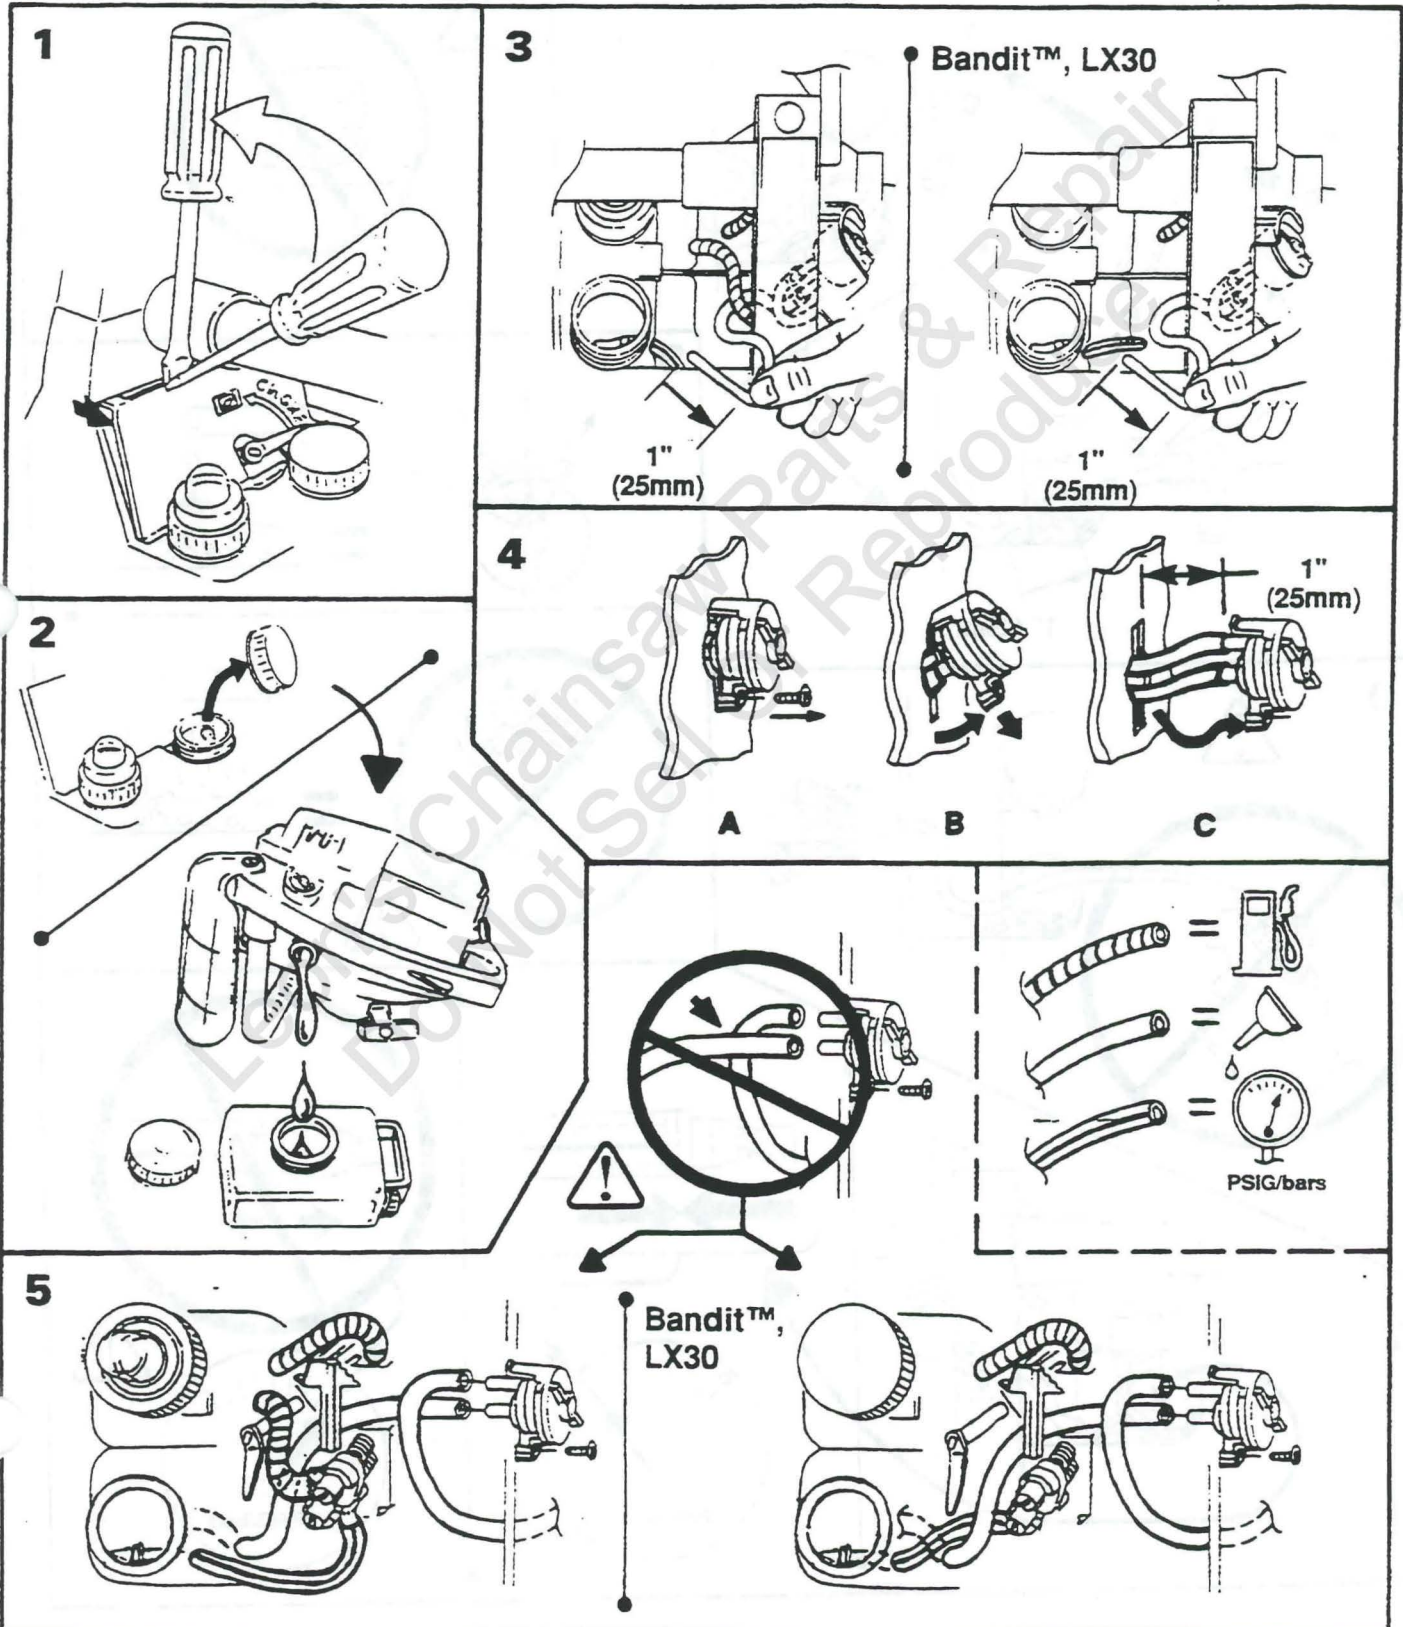
OIL VALVE KITS FOR XL, S2, 180, 192, 200 (A-06386) BANDIT™, LX30 (A-06387)

If you believe that the oiler may not be operating properly, the following quick physical inspection can help you find the problem. A visual work sheet has been included with this bulletin. By following the instructions below and referring to this sheet, you will find that checking the oil system or replacing the oil valve is quite simple.

1. The cross bar on the oil valve cap is tapered to a point. When looking directly at the valve make sure the pointer is on the right side of the 12 O'clock position. On the LX-30 saw the pointer should be to the right of the 10 O'clock position. Make sure the pointer is not set between the numbered positions. It must be set at one of the numbers to function properly.
2. Check the oil cap to see that it is on straight and not cross threaded. Make sure the gasket is in good shape. An air leak at this point will keep the oiler from functioning.
3. While the cap is removed check the duckbill valve located just inside the filler neck of the tank. Make sure the duckbill valve holds the lock washer tightly. (no gap). against the pressure line.
4. Remove the air filter cover and check that the oil lines as well as the pressure line have not been kinked.
5. Static Oiler Check:

Remove the pressure line from carburetor base and attach to pressure tester. Pressurize tank with 4-5 PSIG. In a short time, oil should flow freely at the guide bar pad. If not, recheck for kinked lines or air leak at oil cap. Check that oil flow decreases immediately when pressure is removed. If not lock washer is missing between duckbill valve and pressure line. Reconnect pressure line to carburetor. CAUTION: Testing pressure above 10 PSI may blow valve apart or damage oil tank.

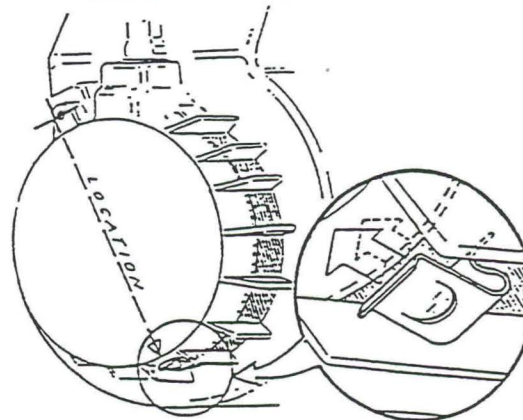
PUSH ON THIS SURFACE WITH
SCREW DRIVER BLADE

String trimmers and AP125:
From outside of housing, hold clip with needle nose pliers using screw driver as lever, push down.

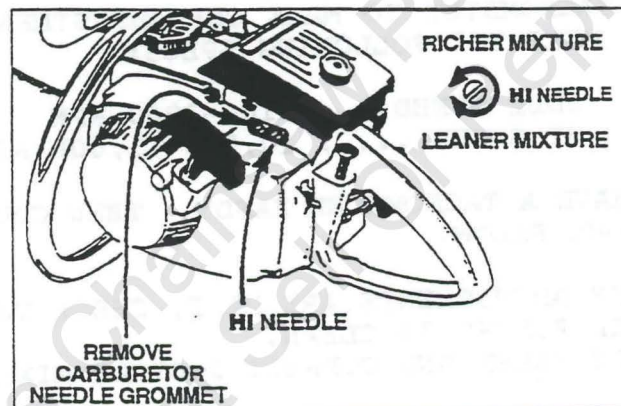
HIGH SPEED ADJUSTMENT

WHEN MAKING THE HI SPEED ADJUSTMENT REMOVE THE CARBURETOR NEEDLE GROMMET TO EXPOSE THE "HI" NEEDLE. AFTER COMPLETION OF ADJUSTMENT, MAKE SURE TO SECURELY RE-INSTALL THE GROMMET. IF NOT PROPERLY INSTALLED DIRT CAN ENTER THE CARBURETOR AND CAUSE CATASTROPHIC ENGINE FAILURE.

IF THE SAW HAS SPEED OUT OF THE CUT BUT LACKS POWER IN THE CUT, THEN TURN THE SCREW 1/16 OF TURN COUNTERCLOCKWISE. TEST IN CUT. REPEAT ABOVE STEPS ONLY UNTIL THE SAW HAS POWER AND RUNS SMOOTHLY IN THE CUT.

THE "HI" NEEDLE MUST BE SET A MINIMUM OF 3/4 OF A TURN COUNTERCLOCKWISE FROM THE CLOSED POSITION. A NEEDLE SETTING OF **LESS THAN** 3/4 OF A TURN WILL CAUSE CATASTROPHIC FAILURE. TO DETERMINE THE CLOSED POSITION, SLOWLY TURN THE NEEDLE CLOCKWISE ONLY UNTIL A SLIGHT RESISTANCE IS FELT.

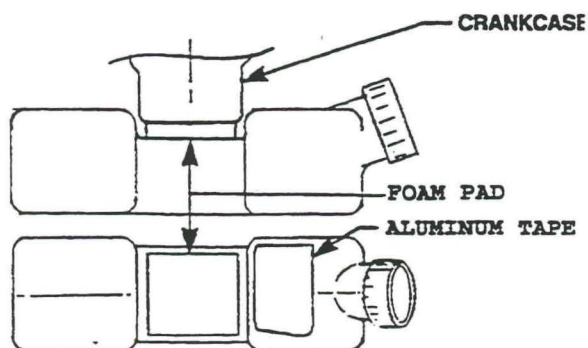
Figure 1

Under certain conditions of extremely high ambient temperatures (95 deg. F and higher), fuel may "boil" in the fuel tank causing gases to accumulate inside the tank. Because there is no vent in the tank that allows the gases to escape (the valve in the cap only allows air into the tank), pressure may eventually build high enough inside the tank to cause the tank to swell and contact the lower surface of the crankcase. If the tank contacts the crankcase for prolonged periods, it may melt at the contact point.

To prevent this from occurring a heat deflector kit, A07077 has been made available. The kit consists of two parts, foam pad, part number 07074, and aluminum tape, part number 95615. Install the parts as shown in figure 1. Before installing the aluminum tape make sure the surface of the fuel tank is clean and free of oil film. **NOTE:** When reinstalling the crankcase cover make sure the foam pad is not pinched between the crankcase and crankcase cover. When reinstalling the starter, rotate 90 degrees from its original position and install as shown in figure 2.

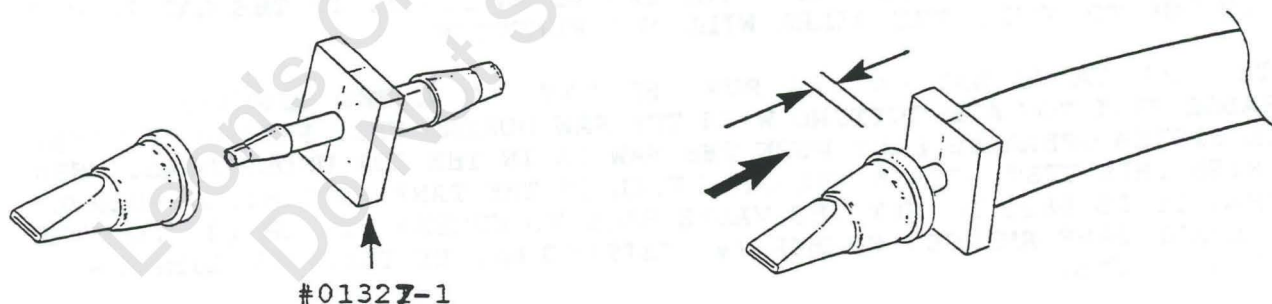
CURRENT PRODUCTION OF AFFECTED MODEL SAWS ARE NOW BUILT WITH A MODIFIED CHAIN OILER VALVE AND CONNECTOR. THESE WILL INCREASE THE FLOW CALIBRATION RATE TO THE GUIDE BAR AND CHAIN. IF A CUSTOMER IS COMPLAINING OF INSUFFICIENT OIL FLOW. YOU MAY SERVICE THE OLD STYLE OILER BY USING THESE COMPONENTS. IN MOST CASES YOU WILL FIND THAT BY CHANGING ONLY THE CONNECTOR AND USING THE EXISTING VALVE THE OIL FLOW WILL INCREASE SUBSTANTIALLY. IT IS NOT NECESSARY TO CHANGE BOTH ITEMS IN ORDER TO CORRECT AN INSUFFICIENT OILING COMPLAINT.

REMOVE THE CONNECTOR (69659B) AND WASHER (83024) FROM BETWEEN THE DUCKBILL VALVE AND CRANKCASE PRESSURE LINE AND INSTALL THE NEW CONNECTOR (01327-1) SHOWN BELOW TO CONNECT THE DUCKBILL AND THE PRESSURE LINE. WHEN INSTALLING THIS CONNECTOR MAKE SURE THE DUCKBILL IS PLACED ON THE SMALLER OF THE TWO BARBS (SEE ILLUSTRATION) AND IS PUSHED ON OVER THE BARB UNTIL IT SNAPS IN PLACE. **DO NO PUSH IT ALL THE WAY AGAINST THE SQUARE PART OF THE CONNECTOR.** IF IT IS PUSHED ALL THE WAY ON, THE BARB MAY REACH TOO FAR INTO THE DUCKBILL HOLDING IT OPEN, KEEPING IT FROM FUNCTIONING PROPERLY.

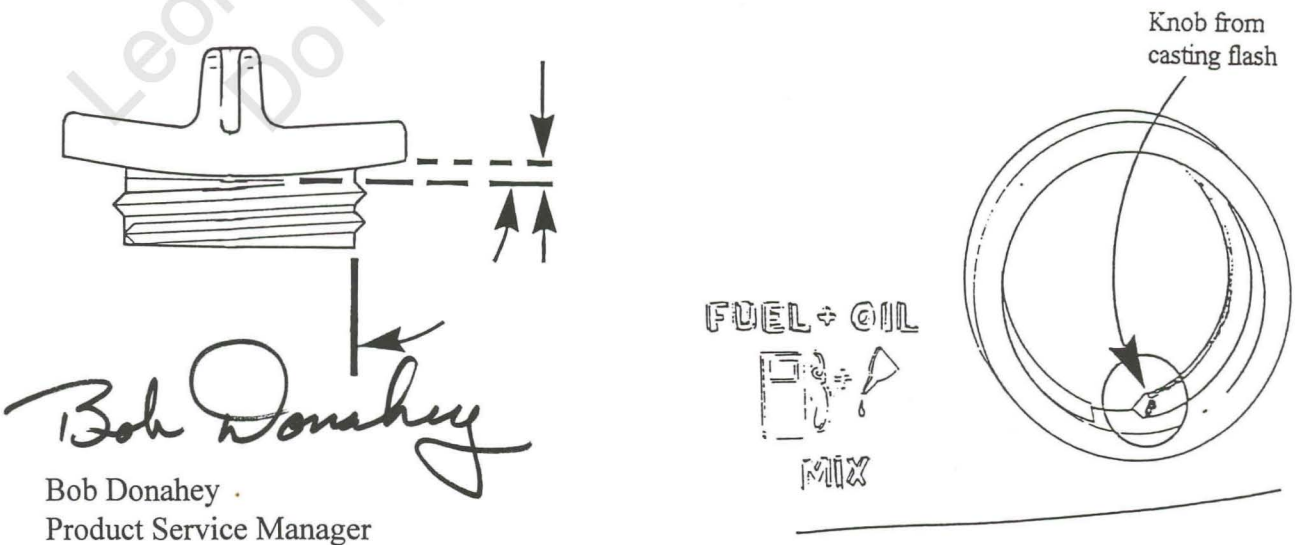
If you receive a complaint of a leaking fuel tank on one of the affected saws, you can be assured that it is probably leaking at the cap. There are two things that can cause fuel to leak around the cap on these units, both are easily corrected.

- 1) Remove the fuel cap, and check for flash on the threads of the tank. Refer to the illustration below for the exact location. You will notice at the bottom of the thread there may be a small knob (dark spot on illustration, see arrow). Using a small file or some other fine edged instrument remove the flash. **THIS AREA HAS BEEN PAINTED AND IT MAY NOT BE EASY TO SEE THE FLASH.**

- 2) The sealing surface of the cap may be warped (see illustration). We are presently machining the cap (A03131) to insure that we have a perfectly flat surface. Reworked caps are available in inventory, or you may request that caps be sent to you by calling a Dealer Service Representatives at (800) - 648 - 8951, then press 3.

When you repair a unit, use the number of this technical bulletin (194-009) as your authorization on the Warranty Claim. For the labor code use FF180, the time allowed will be .3 hr.
