Homelite®

BULLETIN

NO. H98A-007

SUBJECT: ELECTRIC START TRIMMER

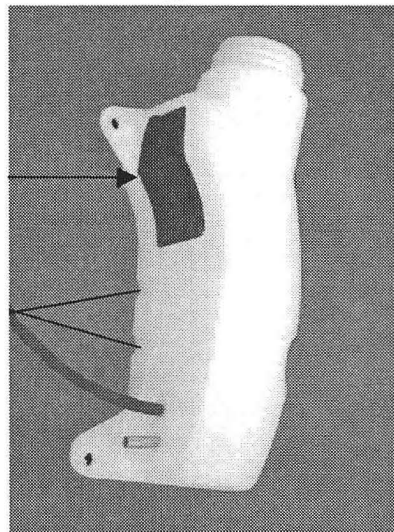
Figure 1

Under extreme operating conditions it is possible for the fuel tank to expand and contact the engine shroud. Continued operation with this condition could result in a fuel leak developing at the point of contact.

Foil Reflective Tape

Reinforcing Ribs

The fuel tank has been modified with two reinforcing ribs to prevent the expansion. A foil reflective tape has also been added to reduce the heat conductivity of the tank and lower the overall operating temperature. See Figure 1.

All affected units should be updated to the new tank configuration. All customers should be contacted for repair of affected blowers in their possession. The enclosed notices should be posted at your service counter to alert customers of the situation.

New Tank
Part Number UP00495
