Distribution:**TO:** ALL DISTRICTS, BRANCHES, SERVICE BRANCHES AND DEALERS**SUBJECT:** New carburetors for the Super 2, VI-Super 2 and VI-Super 2SL, Lot #8307 and above.**DATE:** 1-79

TECHNICAL SERVICE BULLETIN

NO. 179-002**AFFECTS:** ALL CHAIN SAWS**SUBJECT:** REPLACEMENT PARTS FOR CARBURETORS

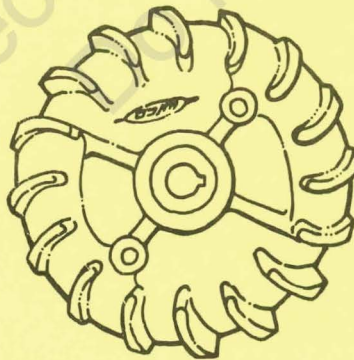
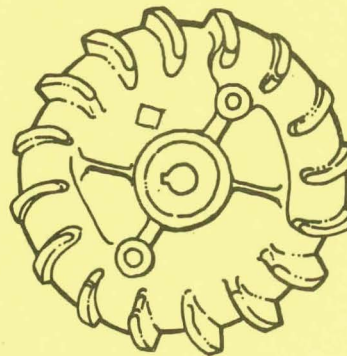
In order to meet production we have used a limited number of Phelon rotors on Wico solid state ignition systems. If you find a unit with this combination and the ignition system has failed, you should not suspect the failure is due to an incorrect rotor until the module is checked.

1. Place a Phelon rotor next to a Wico rotor and align the keyways to face each other. See below.
2. If the poles of the magnets attract each other, the Phelon rotor is to be used with a Phelon ignition system only.
3. If the poles of the magnets repel each other, the Phelon rotor must be used on a Wico ignition system only.

No Phelon rotors with "Reversed Polarity" were sent to Service Parts.

If you have a Wico solid state ignition with a Phelon rotor that requires replacement, order a Wico rotor as a replacement.

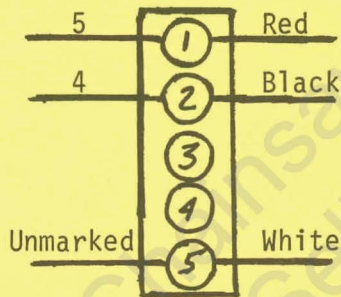
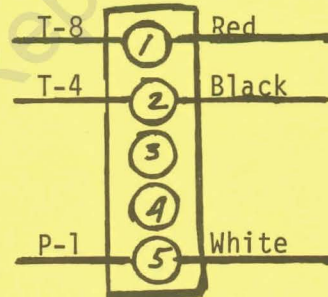
The SP300-1 pump wired for 240 volts should look like:

Adjust your parts lists and wiring diagrams for the SP300-1 accordingly. Do not change the wiring diagram for the SP300-1A.

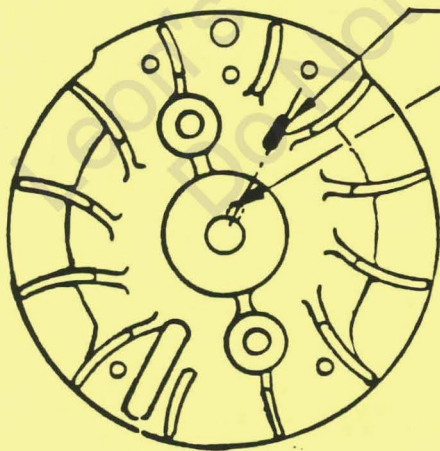
Solid state ignition rotor A-94717 has a blind keyway on the rotor face.

To insure proper alignment of the rotor to the magneto key on the crankshaft, an alignment mark is used on the rotor. This mark is in line with the keyway in the rotor as shown in the illustration below.

Alignment mark in line
with keyway.

Blind Keyway

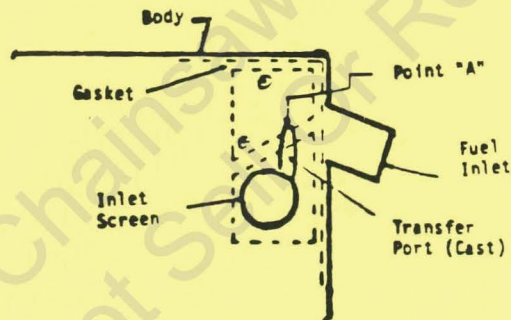
Some carburetors A-93866 (HDC-39) have been found that will flood when the unit is not running. These carburetors also cause erratic running and hard starting.

A leaking carburetor may have a transfer port that is too long. The pump gasket 67368 will not adequately cover and seal it at point "A".

NOTE:
BROKEN LINE IS
GASKET OUTLINE

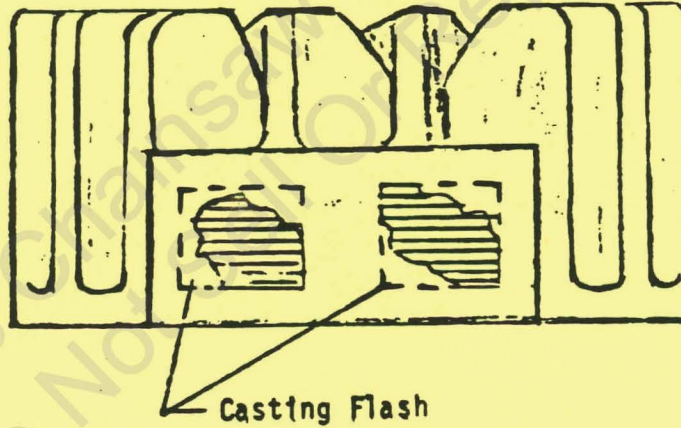
This flash will not affect the operation of the rotor. The air gap between the rotor magnets and the module core remains the same. It should be set using a Homelite magneto air gap shim #24306 (.012 black plastic).

The machined rotor A-69297-A will also be supplied as a service part for the breaker point ignition systems.
