HOMELITEA DIVISION OF
TEXTRON INC.

SUBJECT: Sprocket Keys and Clutch Spider Keys

SUBJECT: Gear Ratios in Homelite Gear Drive Saws

SUBJECT: Fuel Cap Valves, All Chain Saws

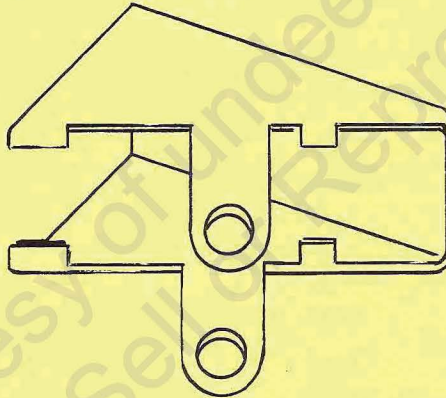
1. The four 6-32 tapped holes in the cylinder exhaust flange have been eliminated -- they are no longer needed. The cylinder part number changes to 56182-A.
2. A new exhaust cap Part No. 56396, made of steel, replaces Part No. 55507.

The new cap is held by the same two screws which fasten the heat damper.

3. To provide proper clearance the heat damper casting has been revised. Heat damper Part No. 55506-A must be used with the new exhaust cap.

The new parts can be installed on saws now in the field, provided these saws are equipped with a cylinder which contains the 10-32 threads for the two heat damper screws.

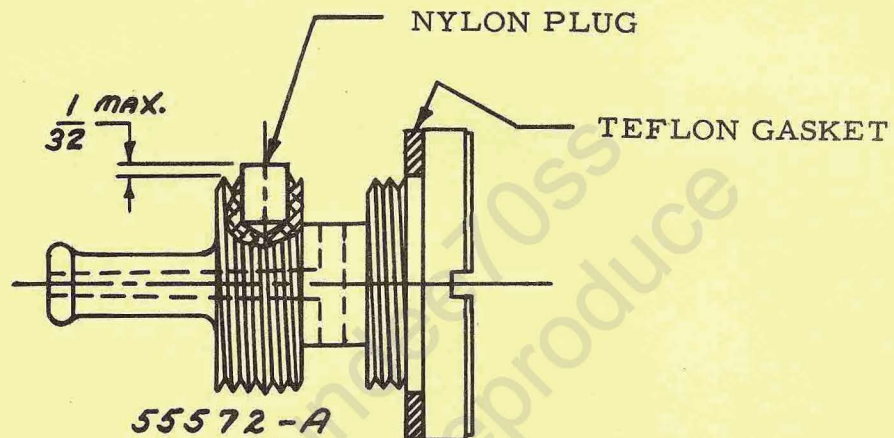
The sketch above shows the new Fuel Outlet Fitting #55572-A which supersedes 55572 in Homelite Direct Drive Chain Saws. The Nylon Plug is new and has been added to provide a seal on the inner thread.

When the saw is used in the "Right-Hand Felling" position the outlet fitting is not covered by fuel -- instead it is surrounded by the air in the fuel tank. If part of this air is drawn around the threads it enters the fuel supply line, leans out the mixture and may stall the engine. You may think that the carburetor has "gone out of adjustment".

The nylon plug prevents this difficulty. Use Outlet Fitting No. 55572-A for all replacements.

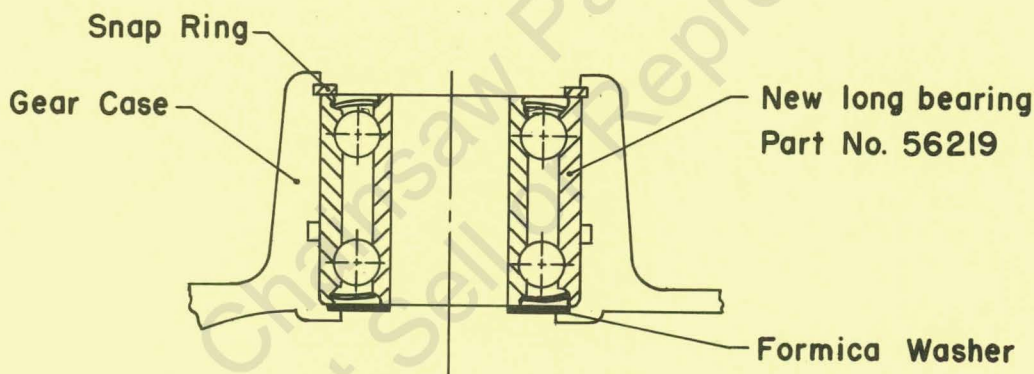
We have been able to procure a single, long Double Row Ball Bearing to replace the narrow ball bearing and roller bearing combination used formerly to support the sprocket shaft in 6-22 and 7-21 chain saws.

The new bearing carries part number 56219. It is permanently lubricated and sealed; for this reason it is no longer necessary to use Lubriplate in the groove of the Gear case.

After you use up your stock of 72040 ball bearing and 56073 roller bearings, use new bearing 56219 for all replacements.
