TO: Homelite Branches and Chain Saw Dealers

SUBJECT: Idler Gear Post

DATE: 1/5/66

Units Affected: XP-1100

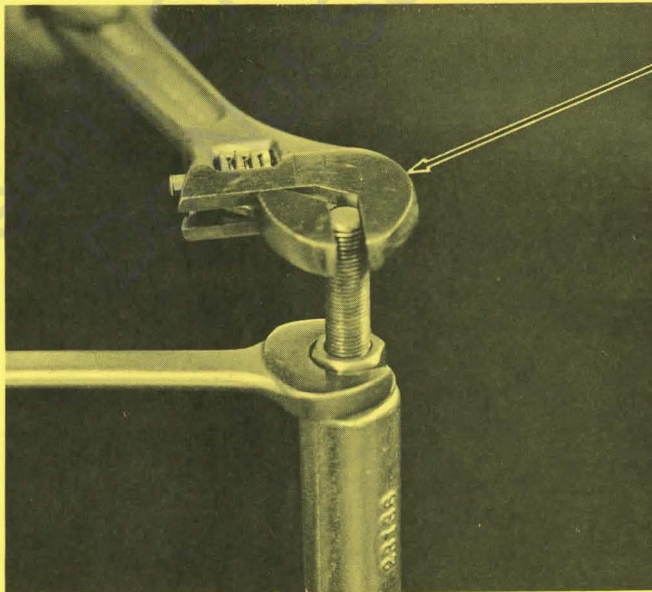
If the bearing is allowed to rotate under preload, the edges of the raceways may "dig" into the balls and may generate shallow grooves on the surface of the balls. These grooves or indentations will make the bearing rough turning and noisy.

Use this wrench to keep assembly from turning.

To prevent this damage, keep the jackscrew from turning while you turn the jack nut. If the jackscrew you use does not have flats or a hex head on the end, grind or file two flats so that a wrench can be used on the end of the jackscrew as shown in the picture below.

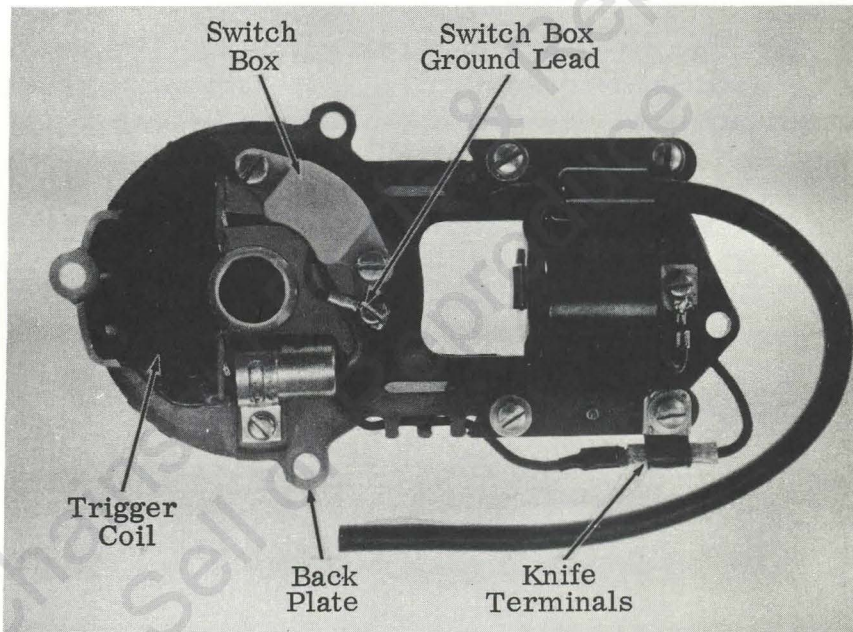
Figure 1

1. Connect the spark plug lead to a test spark plug and crank the engine to check for magneto output. If there is no output, remove the fan housing.
2. Visual Inspection
 - a. Inspect the rotor for physical damage.
 - b. Inspect the stator for broken or frayed wires.
 - c. Check for a short between the coil core and the knife terminals connecting the coil primary lead to the lead from the switch box. All leads should be dressed as shown in Figure 1. All soldered connections should be sound.

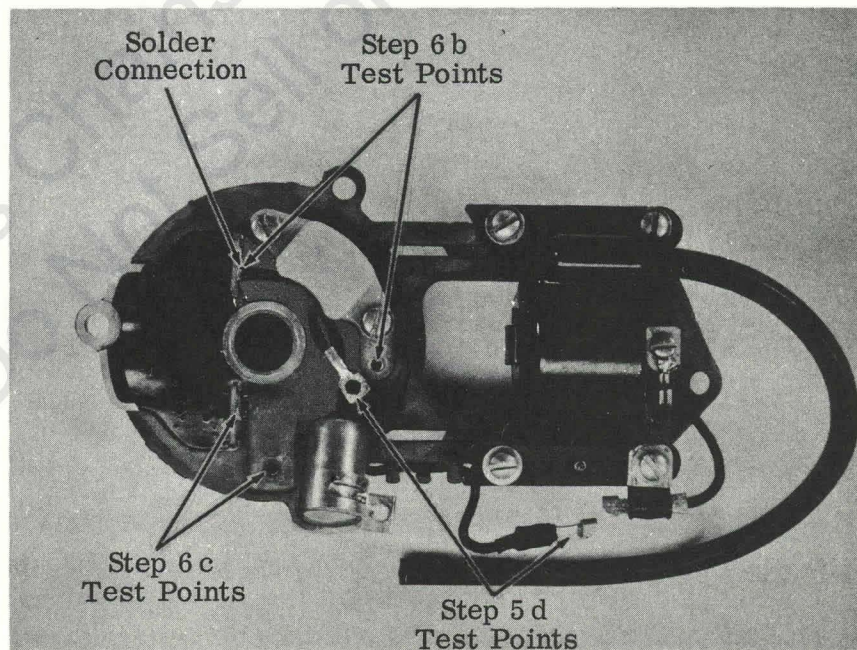
Figure 2

4. If the coil tests satisfactorily, remove the rotor.
5. Switch Box Testing (Figure 2)
 - a. The coil primary lead must remain disconnected from the switch box lead (Step 3) and must be above ground (not touching any part of the back plate) during all testing.
 - b. Remove the condenser mounting screw and hold the condenser above ground with a piece of insulating material.
 - c. Disconnect the switch box ground lead by removing the small screw in the center of the back plate, to the lower right of the switch box.
 - d. Perform the following tests with an ohmmeter by connecting:

6. Trigger Coil Testing (Figure 2)
 - a. Two different types of trigger coils are in use with the breakerless magneto, but both are tested by the same procedures. Magnetos with 700 turn trigger coils are

- e. Replace the switch box and condenser assembly if the switch box does not test within these limits. Use a hot small-tipped soldering iron to separate the switch lead from the trigger coil.
- f. When installing a new switch box, use "Loctite" on the two mounting screws. To connect the switch lead to the trigger coil, strip 3/32" inch of insulation from the end of the lead. Tin the lead with 60/40 rosin core solder, then solder into the connector grommet on the trigger coil.

- d. If the trigger coil is faulty, replace the back plate.

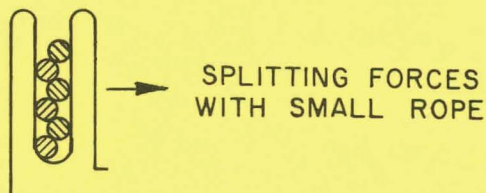
An XL spring can stand a total of about ten and one-half turns before it is fully wound. Homelite starting rope fills the pulley slot in about five turns. If you limit prewind to four turns you never overstress the anchor of the spring. "Black Market" rope, which is often thinner, changes this picture: more turns of thin rope fit onto the pulley, and there is also a greater danger that the rope lies in the pulley slot as shown here which increases the splitting forces on the pulley.

The answer, of course, is to use Homelite rope, properly knotted and with the knot secured by dipping it into cement.
