BRANCH SERVICE MEMO NO. 623CS

SUBJECT: Gaskets

DATE: 1/11/67

Units Affected: XL-700, 800 and 850

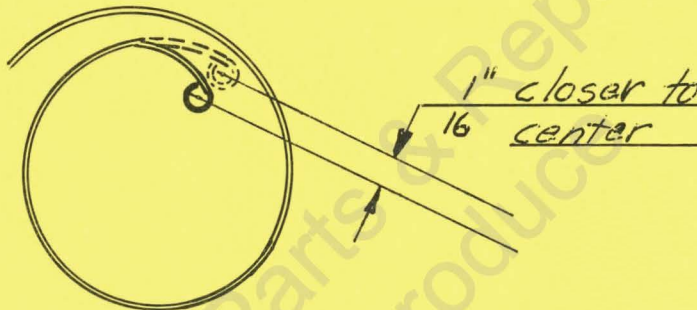
Here is a picture (slightly exaggerated to make it clearer) showing the last coil on an XL recoil spring.

By bending the innermost loop so that it approaches the center more steeply as shown, the spring stays engaged on the cam.

We have also determined that only a bare minimum of grease, if any at all, should be used on the spring itself, and then only on the side away from the starter pulley. But do continue to lubricate the starter pulley post.

All units being produced now, and all recoil springs in Spare Parts, have been reworked. Please bend any springs in your stock as shown (it's easiest by using two pairs of pliers next to each other) before installing them.

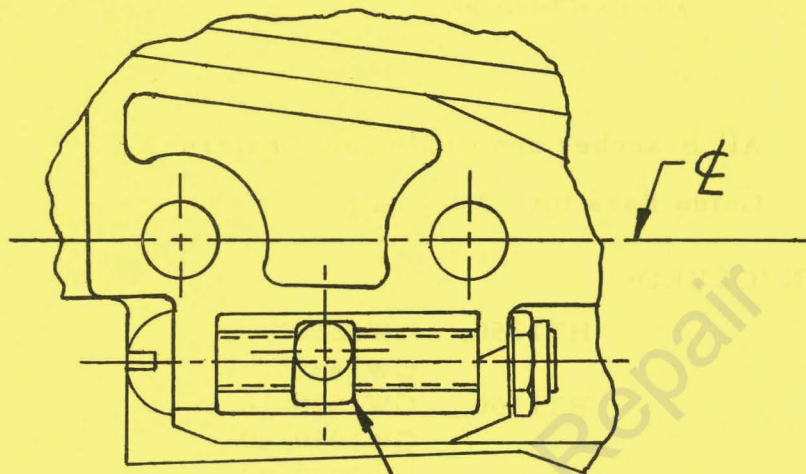
Adjusting Pin

Assemble with offset towards center line of bar.

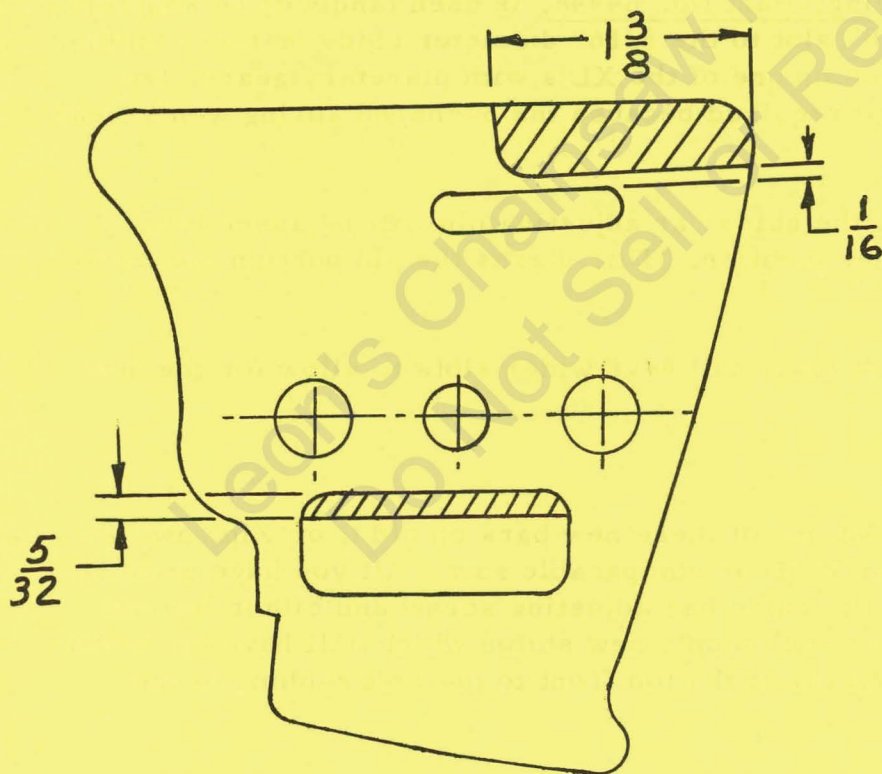
Guide Bar Shim

Shaded sections removed

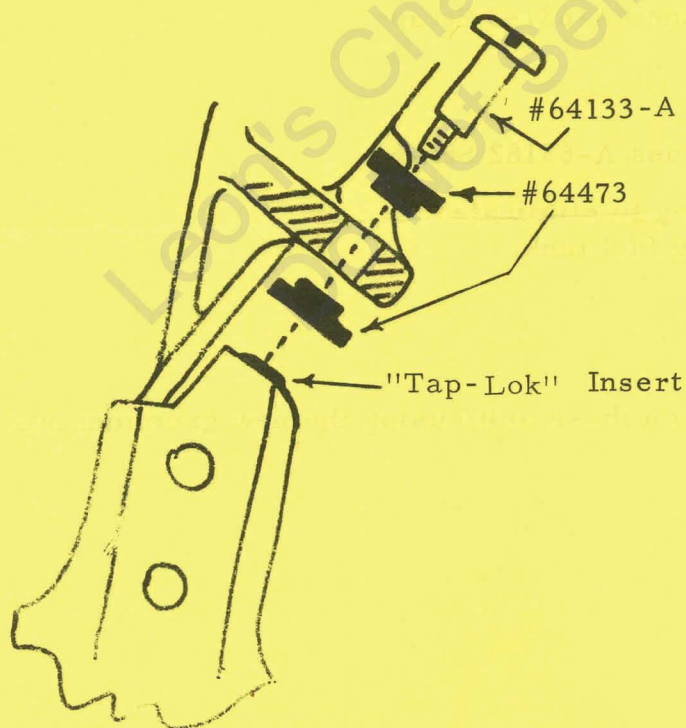
FIG. #1

- I A new crankcase A-64902 supersedes A-63177-A. The upper mounting boss for the fuel tank has been shortened 1/16" and instead of a 1/4" stud a #10-32 tap-lok insert is used.
- II With this new crankcase we use a new fuel tank A-65324 which supersedes A-59999-1. The mounting hole has been opened up to 3/8" diameter. We will supply two (2) grommets #64473 with each spare parts tank.

These changes were made so that the two (2) grommets (#64473) and a shoulder screw (#64133-A) could be used to give the assemblies more flexibility. See Figure #1.
