TO: All Districts, Branches and Chain Saw Dealers

SUBJECT: All Fuel Filters

DATE: March, 1970

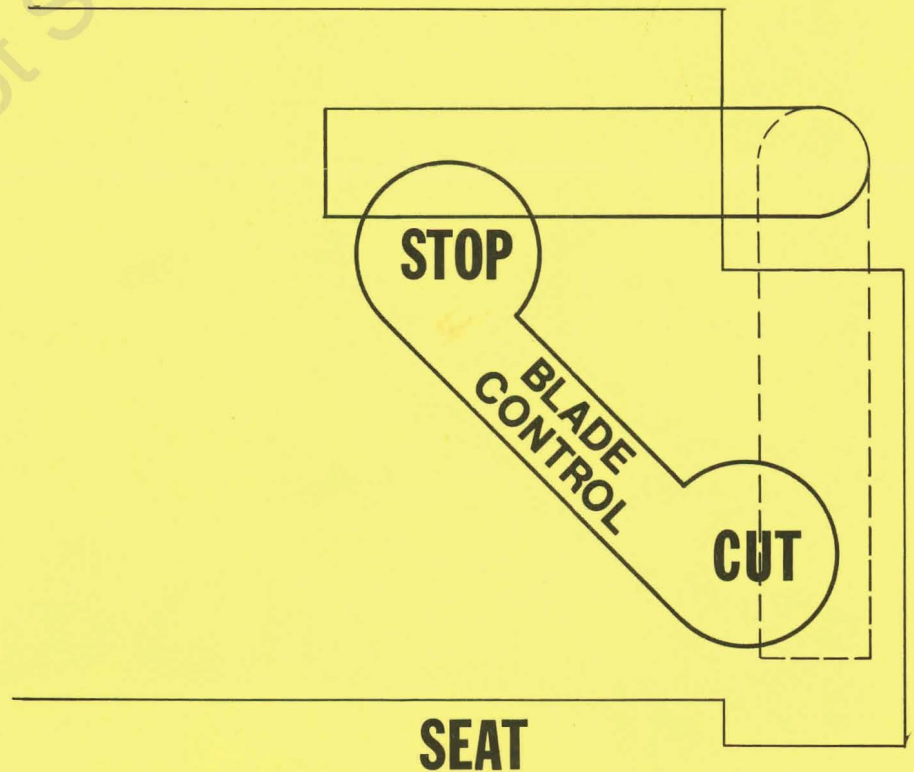
### CONTROL PANEL

Several dealers have found 1970 Yard Tracs with the yellow "Blade Control" decals applied upside down on the belt guard. This is hazardous because the cutting position for the blade control handle is then called out as the "stop" position on the decal.

To correct this situation peel off the upside down decal and relocate or replace on the blade guard so the word "stop" is Forward close to the control panel and the word "cut" is to the right and rear (see drawing).
