SUBJECT: Wiring 4-wire 230V180 cycle power tools

SUBJECT: Change Effective Immediately in the Field -- all
10HY35-1A and 119HY35-2 Units Equipped with or
being Converted to Automatic Idle Control

DATE: 3/71

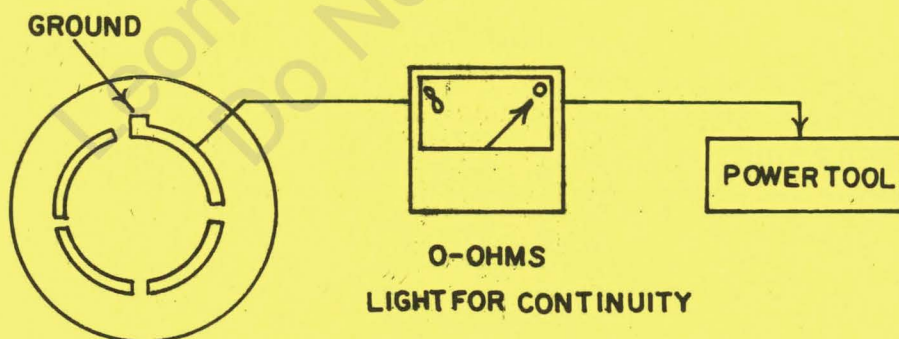
This can happen if the ground (green) wire at the generator is not grounded to the tool. If the ground wire should be attached to any one of three "hot" phases, the operator can be seriously shocked.

The ground prong of older receptacles is marked "GR," the live prongs are marked X, Y and Z. Newer receptacles may only have the live prongs marked X, Y and Z with no marking on the ground prong. In all cases, the ground terminal is the bent tab prong.

Before any high cycle tool is released from your shop regardless of what repair was made you must check the continuity of the green wire from the plug end to the body of the tool. Rentals must be checked each time they are sent out. The green wire must check out from the tool body to the ground prong of the cable end. The other three receptacle prongs should not be connected to the tool body.

This simple check can be made in a few seconds with an ohmmeter or battery operated continuity light and will save serious injury.

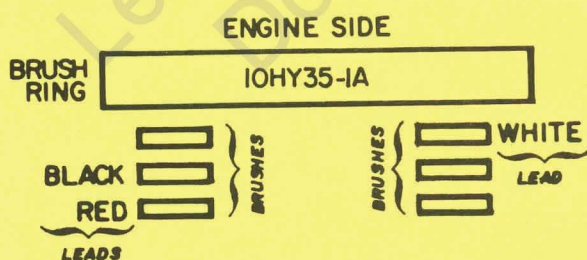
10HY35-1A

Units equipped with idle controls have a circuit that can produce a high voltage (500V) between an AC brush and DC brush. With carbon accumulation and arcing it is possible to burn a hole in the brush ring.

YOUR UNIT SHOULD LOOK LIKE
THIS WHEN LEAD CHANGES
HAVE BEEN COMPLETED.

To correct this condition and maintain phase rotation (sequence) it is necessary to switch the three wires on the AC brushes. The procedure is as follows:

- 1) Remove the end covers.
- 2) Take a white wire from the center brush holder on the right side and connect it to the innermost brush holder.
- 3) Take the black wire from the outermost brush holder on the left side and attach it to the center brush holder.
- 4) Take the red wire from the innermost brush holder and attach it to the outermost brush holder.
- 5) Replace the end covers.

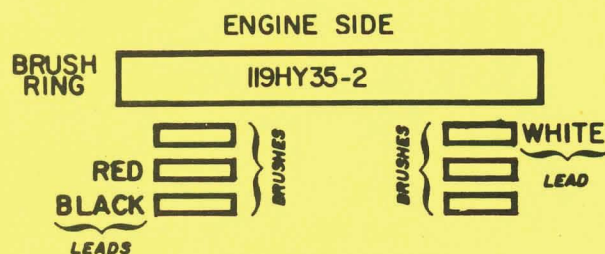
119HY35-2

YOUR UNIT SHOULD LOOK LIKE
THIS WHEN LEAD CHANGES
HAVE BEEN COMPLETED.

- 1) Remove the end covers.
- 2) Take the white wire from the center brush holder on the right side and connect it to the innermost brush holder.
- 3) Take the red wire from the outermost brush holder on the left side and attach it to the center brush holder.
- 4) Take the black wire from the innermost brush holder and attach it to the outermost brush holder.
- 5) Replace the end covers.

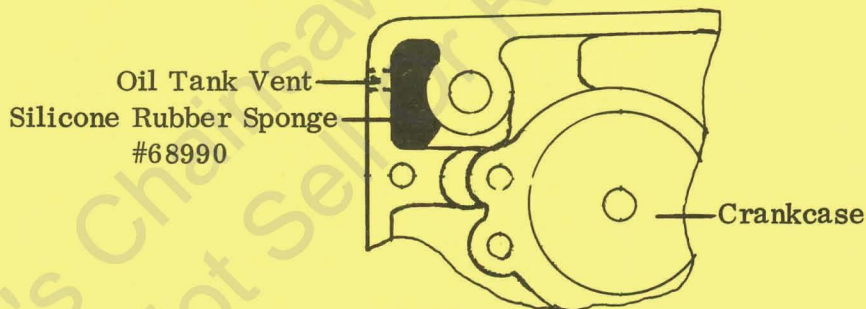
You may find that some Model 150 saws leak oil from the oil tank vent when the unit is stored, especially when some pressure exists in the tank.

In these cases, the felt vent filter (Part No. 68640) acts like a wick which allows the leakage. Replace vent filter Part No. 68640 with Part No. 68990 made from soft silicone rubber sponge. This filter will not "wick" but rather acts like a check valve when pressure exists in the oil tank.

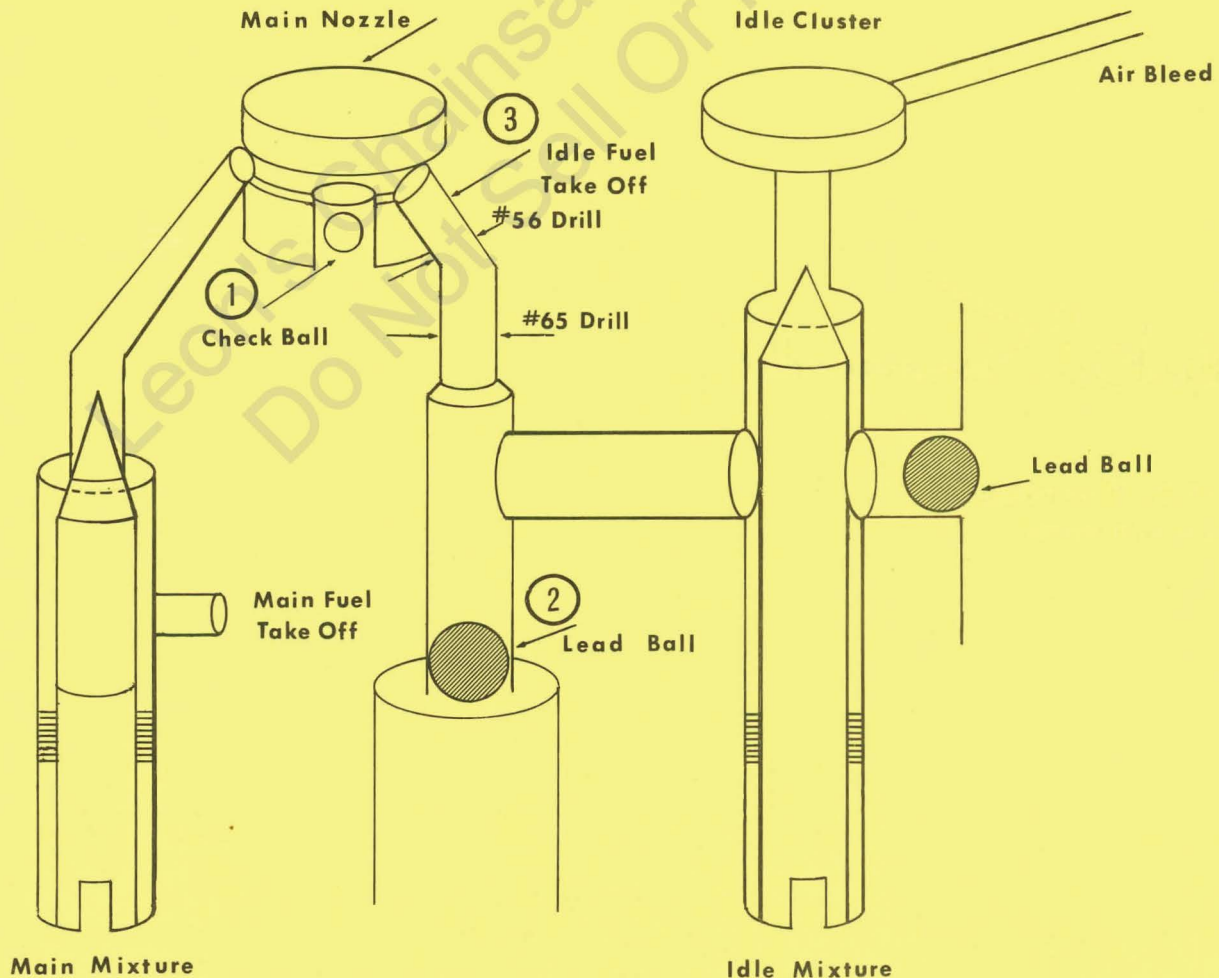
If you encounter hard starting check the following as possible causes on new units only:

- 1) Main nozzle check ball (Part No. 54444) may be stuck in closed position both in new units and new replacement carburetors.
- 2) Lead shot between HI and LO needles left out.
- 3) The idle fuel take off hole not drilled or not drilled completely from main nozzle check valve bore.

We have just received from Tillotson a new disc type main nozzle check valve Part No. 68284. This assembly is less susceptible to sticking. Check Valve Part No. 68284 can be used interchangeably with Part No. 54444 in all applications.

Sticking main nozzle check valves can in most cases be freed by using a bent paper clip to move the ball.

The main nozzle check ball can also be unseated by air or hydraulic pressure applied through the high speed adjusting needle opening, but the main diaphragm must be removed first. In most cases, just the force required to knock the valve out of the body is enough to jar the ball loose.

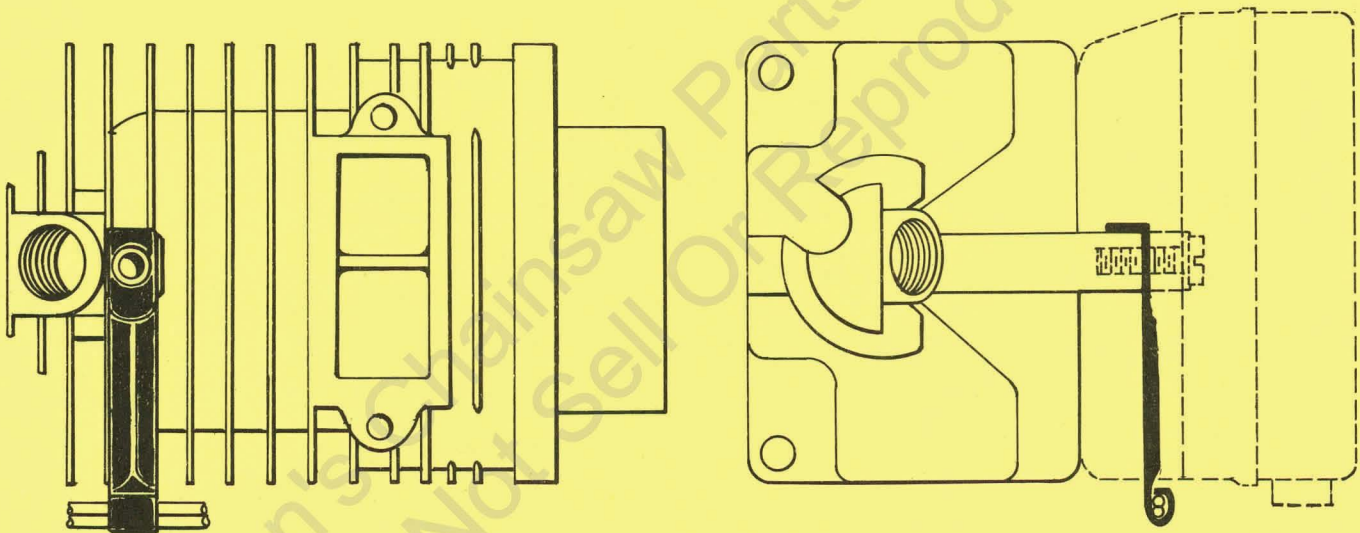
Oil housing castings are being changed to provide an area where the oil lines can be clamped to restrict movement due to vibration.

Clamp, (Part No. 68965) is available as a field fix for existing units if you encounter this problem. It is installed as shown below.

1. Remove approximately .030 (0,8 mm) from top muffler mounting boss and form clamp to fit boss.
2. Place oil lines in clamp, and squeeze clamps tight with pliers.

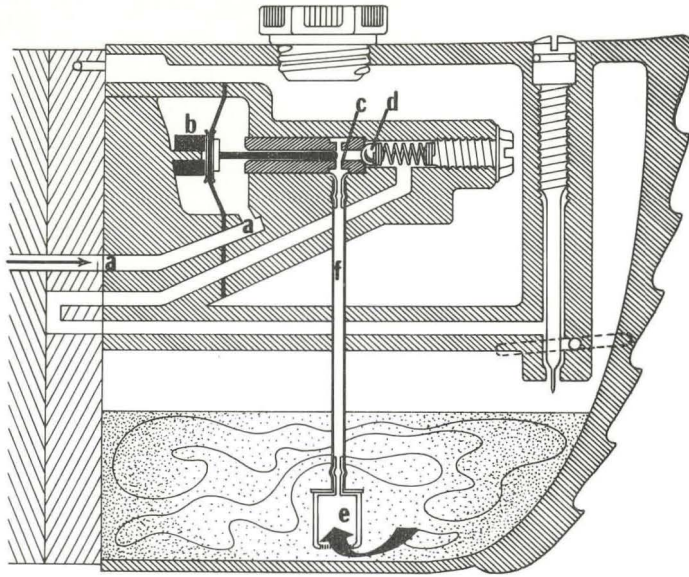
FIGURE 1

On the engine downstroke, positive pulse pressure applied to the plunger diaphragm through pulse channel a) moves the diaphragm in direction of the bumper b) creating low pressure in pump cavity c). Check ball d) remains seated, preserving a low pressure condition inside cavity c). Oil drawn in through the pick-up screen e) flows through pick-up tube f) into pump inlet chamber c).

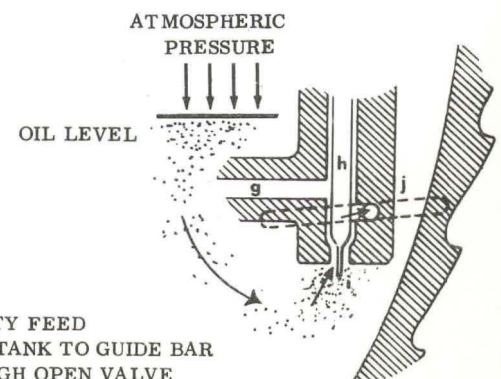
FIGURE 3

1. REMOVE THE BAR AND CHAIN: See that there is oil in the tank, then idle the engine for at least 5 minutes with the oil feed rate needle valve (h) closed tightly clockwise (to the right).
2. If pump has good output, drain most of the oil and repeat step 1, as a check against a leak in the inlet line. If oiler does not pump, check inlet line and fitting for leaks.
3. If the output is greater with needle valve open than with the valve closed, the pump is not working. With the valve open, there will be a gravity flow through the valve and out the discharge hole as shown in Fig. 3.

GRAVITY FEED
FROM TANK TO GUIDE BAR
THROUGH OPEN VALVE
