TO: All Districts, Branches & Chain Saw Dealers

SUBJECT: Muffler Caps with Shield

DATE: 1/72

Units Affected: XL-123 starting with Serial No. 11601140

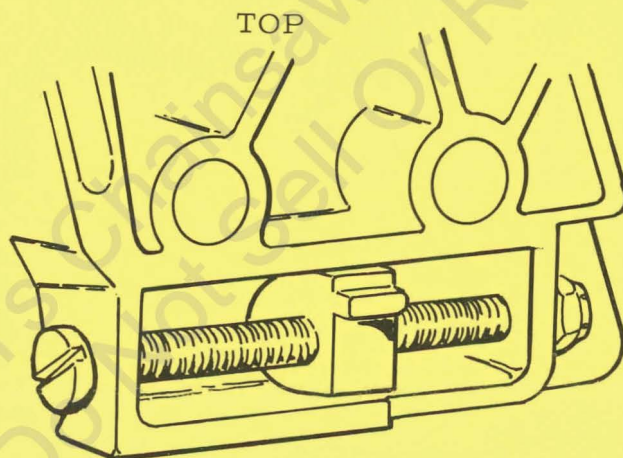
There is a possibility that the guide bar adjusting pin in the drivecase cover may be assembled up-side down. The diagram below shows an inside view of the drivecase cover showing the adjusting pin in the correct position.

Note that the adjusting pin is assembled with the engaging pin above the center line of the adjusting screw.

Guide bar adjusting pin
in the correct position

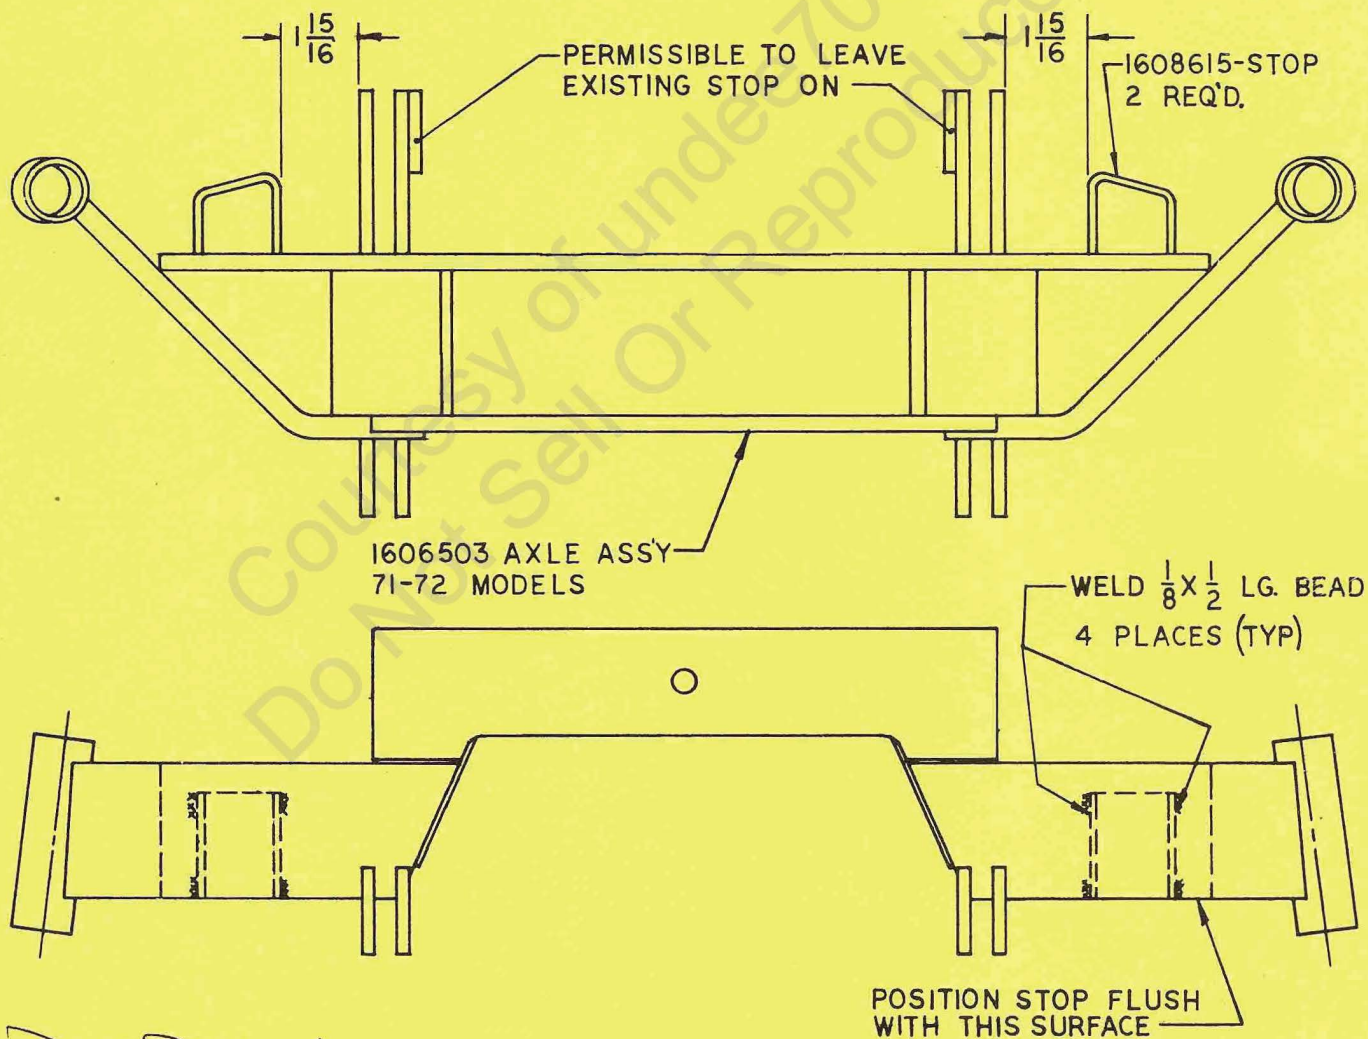
Occasionally we have tractors in the field where oversteering will cause the front spindle to ride past its stop. This possibility has been eliminated in the 1973 models by the addition of new stops. These two new stops #LM-16086-15 are available for the 1972 tractors with this steering condition. The illustration shows the welding location on front axle assembly #LM-16065-03.

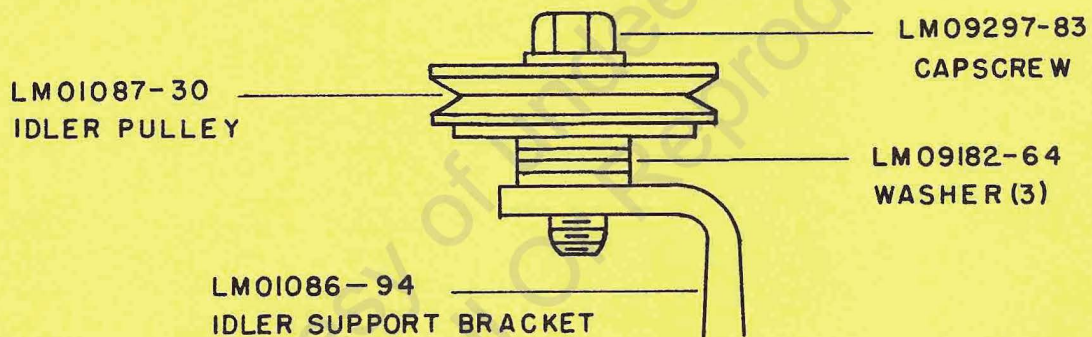
The belt on M-21S mower can jump off the idler pulley LM-01087-30 if engine "back fires" in starting or stopping. When the idler pulley is raised $3/16$ " , the exit angle of the belt is reduced enough to hold the belt if engine happens to "back fire". To raise the idler pulley $3/16$ " use one cap screw LM-09297-83 and three washers LM-09182-64.

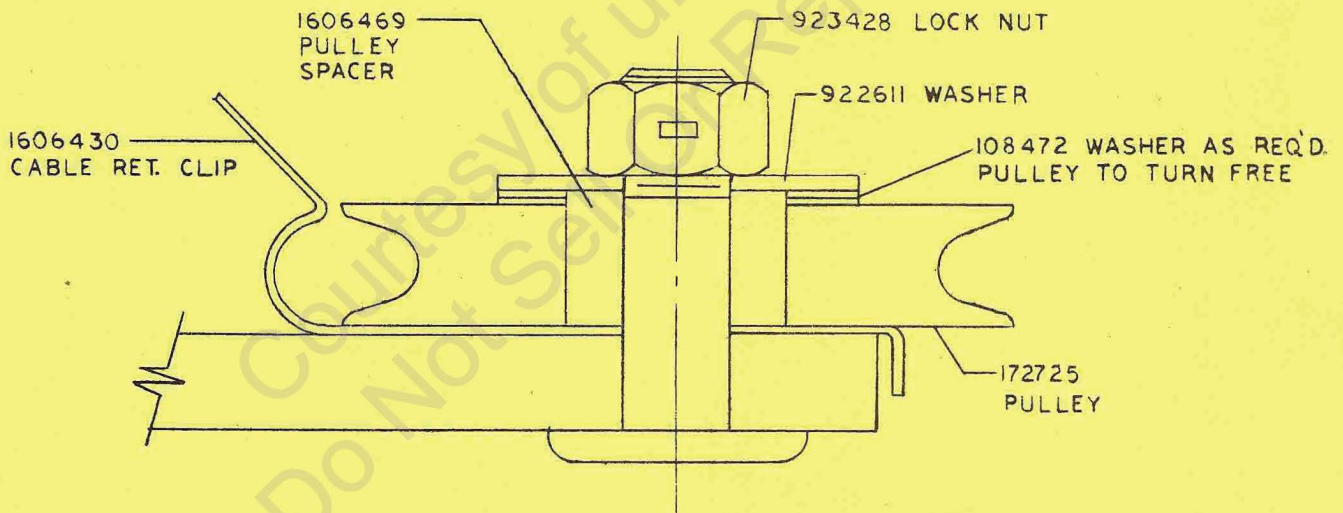
We occasionally have cable (LM-16064-73) breakage when the cable slips between the retaining clip LM-16064-30 and the support bracket. By eliminating one washer LM-09226-11 between the clip and support bracket the cable can't become jammed between the two.

The assembly must be shimmed with washer or washers LM-01084-72 as shown to prevent pulley from binding.
