SUBJECT: Connecting Rod, Crankshafts, Crankcases

Units Affected: All XL Engines (except XL-700 and XL-800)

SUBJECT: Ignition Coil Adjustment

SUBJECT: Ball Bearing Installation

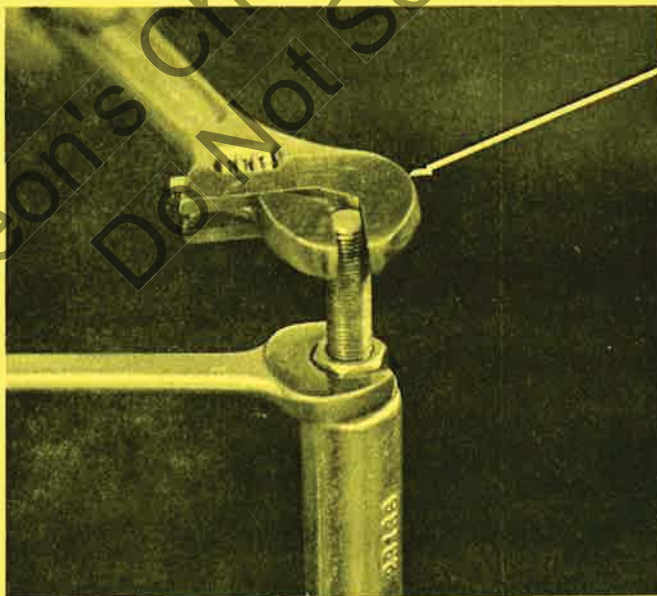
If the bearing is allowed to rotate under preload, the edges of the raceways may "dig" into the balls and may generate shallow grooves on the surface of the balls. These grooves or indentations will make the bearing rough turning and noisy.

Use this wrench to keep assembly from turning.

To prevent this damage, keep the jackscrew from turning while you turn the jack nut. If the jackscrew you use does not have flats or a hex head on the end, grind or file two flats so that a wrench can be used on the end of the jackscrew as shown in the picture below.

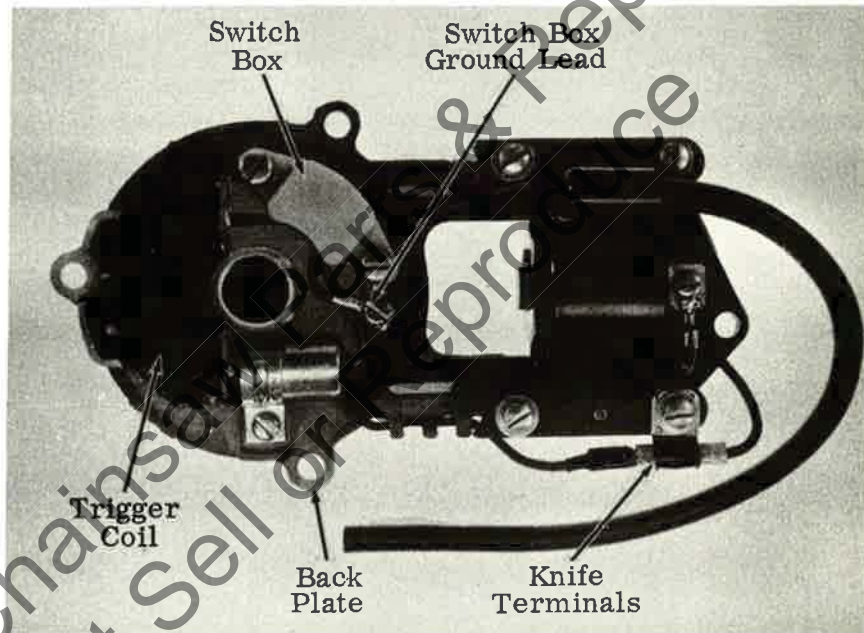
Figure 1

1. Connect the spark plug lead to a test spark plug and crank the engine to check for magneto output. If there is no output, remove the fan housing.
2. Visual Inspection
 - a. Inspect the rotor for physical damage.
 - b. Inspect the stator for broken or frayed wires.
 - c. Check for a short between the coil core and the knife terminals connecting the coil primary lead to the lead from the switch box. All leads should be dressed as shown in Figure 1. All soldered connections should be sound.

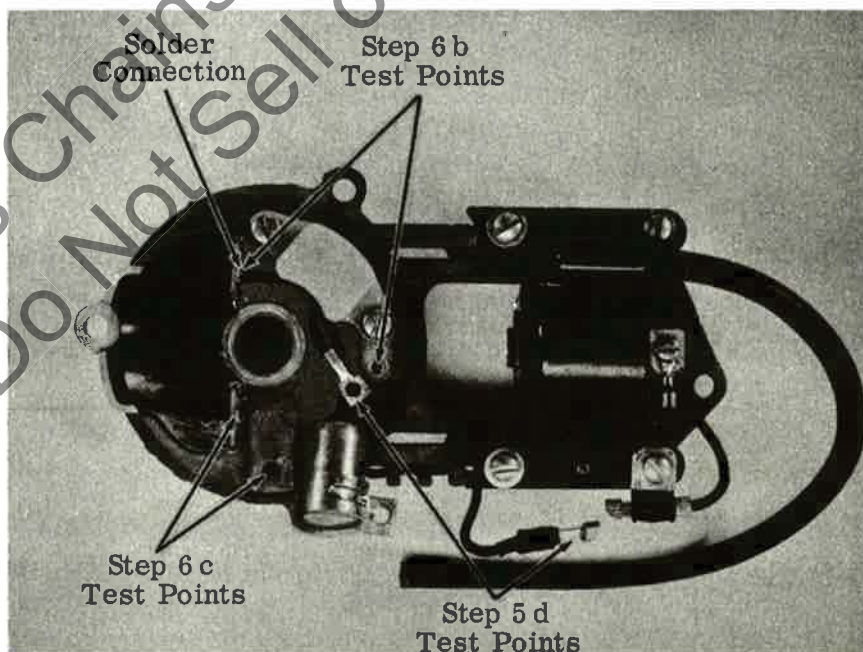
Figure 2

4. If the coil tests satisfactorily, remove the rotor.
5. Switch Box Testing (Figure 2)
 - a. The coil primary lead must remain disconnected from the switch box lead (Step 3) and must be above ground (not touching any part of the back plate) during all testing.
 - b. Remove the condenser mounting screw and hold the condenser above ground with a piece of insulating material.
 - c. Disconnect the switch box ground lead by removing the small screw in the center of the back plate, to the lower right of the switch box.
 - d. Perform the following tests with an ohmmeter by connecting:

6. Trigger Coil Testing (Figure 2)
 - a. Two different types of trigger coils are in use with the breakerless magneto, but both are tested by the same procedures. Magnetos with 700 turn trigger coils are

- e. Replace the switch box and condenser assembly if the switch box does not test within these limits. Use a hot small-tipped soldering iron to separate the switch lead from the trigger coil.
- f. When installing a new switch box, use "Loctite" on the two mounting screws. To connect the switch lead to the trigger coil, strip 3/32" inch of insulation from the end of the lead. Tin the lead with 60/40 rosin core solder, then solder into the connector grommet on the trigger coil.
