TECHNICAL SERVICE BULLETIN

NO. 182-001**SUBJECT:** GUIDE BAR INSERT KIT #A-96612**AFFECTS:** 360 CHAIN SAW

INSTALLATION OF GUIDE BAR INSERT FOR 360 CHAIN SAWS

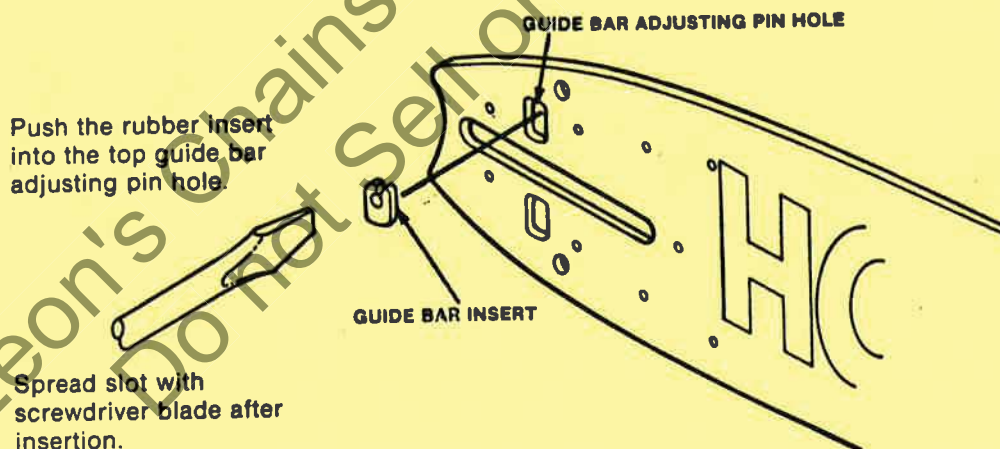
We have had reports from the field that when guide bars longer than 16 inches are used on 360's a minimal amount of oil is getting to the chain. In order to improve the oil flow to the chain a rubber insert for the chain adjusting pin hole of the guide bar has been designed. (See illustration). This insert will route the oil from the oil slot in the guide bar pad directly to the groove of the guide bar.

This insert will be in the new 360 owners kit. If extra inserts are needed order part number A-96612. This kit will contain 5 inserts and 1 instruction sheet.

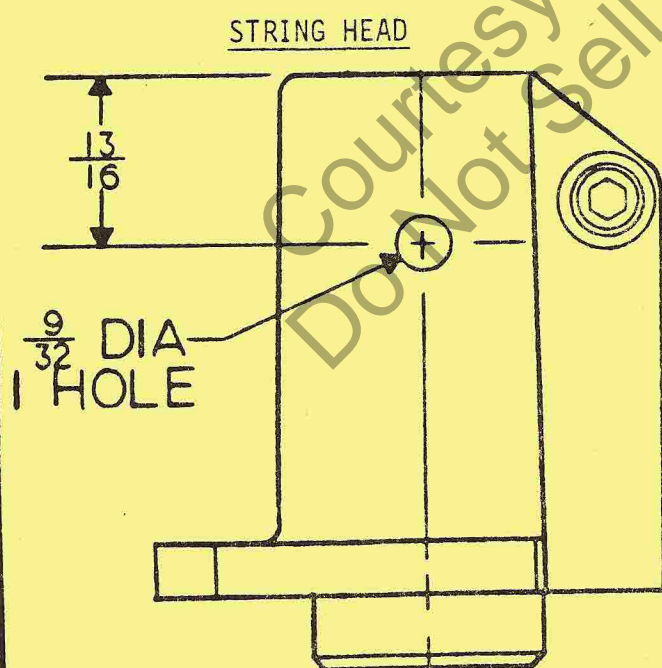
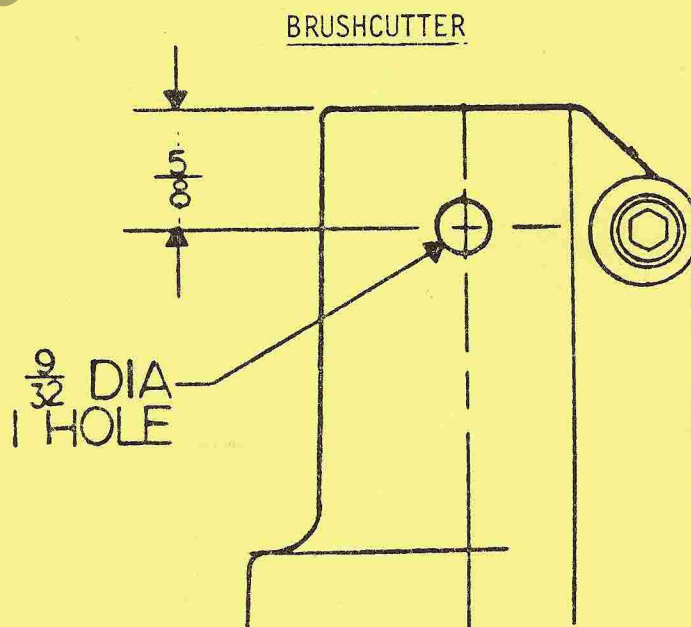
Before the 1982 season all ST-200's were built with the locating hole for the brushcutter or string head in front of the tube. Some tubes of this type broke just above the brushcutter or string head. In order to correct this in the 1982 season, the locating hole was moved from the front to the side and raised closer to the top of the brushcutter or string head housing.

All units built in 1982 have the hole on the side of the tube. A problem arises when a new 1982 ST-200 (hole in side of tube) is matched with an old brushcutter (hole in front of housing). In order to solve this problem use the templates below to drill a new locating hole in the side. Use a $\frac{9}{32}$ " (.2812) drill bit.

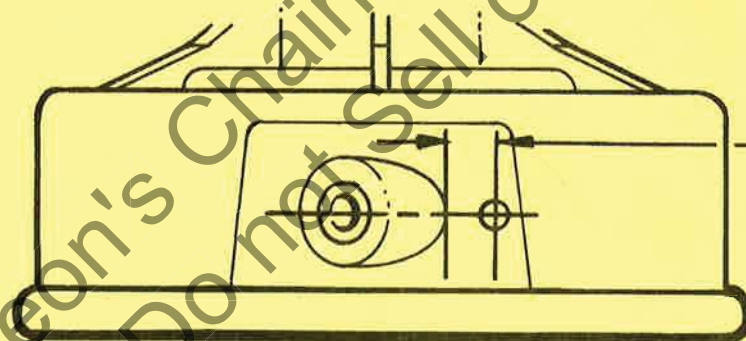
1. As stated in a previous bulletin, the Weldnot tubes are now retained to the stringhead with a cotter pin. A hole is drilled through the stringhead near the string eyelet. The pin is then inserted into the hole and spread apart. This keeps the Weldnot tube from "pounding" the eyelet.

Old stringheads can be updated to accept the new Weldnot tubes. A hole must be drilled near the eyelet for the cotter pin. Refer to the drawing below for the location of this hole. The hole diameter is $\frac{1}{8}$ " (.125). The distance from the eyelet to the center of the hole is $\frac{1}{4}$ " to $\frac{3}{8}$ ".

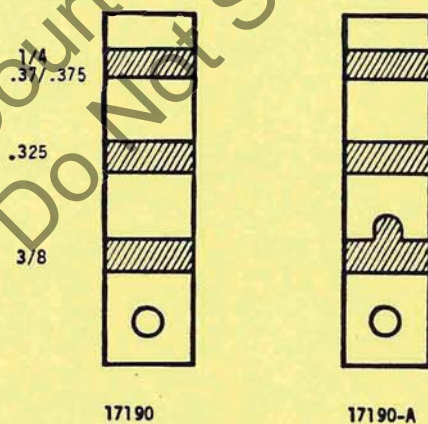
Illustration #2

Also, in order to "break" this chain for repair, it will be necessary to use the new 17190-A anvil. (See illustration #2.)

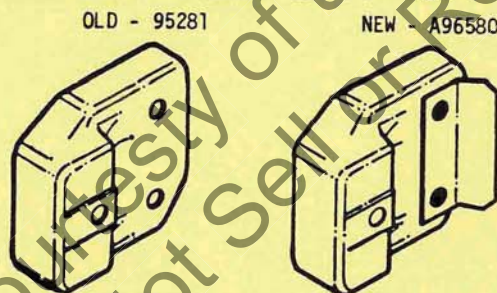
The muffler cap on the West Coast muffler directs the exhaust toward the drivecase cover. As a result the saw will run hotter because the excess heat from the cover transfers through the unit. You may also see discolored air filters and carburetors due to the direction of the exhaust. Heat from these sources contributes to vapor lock.

A deflector has been added to the existing muffler cap to guide the exhaust away from the drivecase cover. See illustration below.

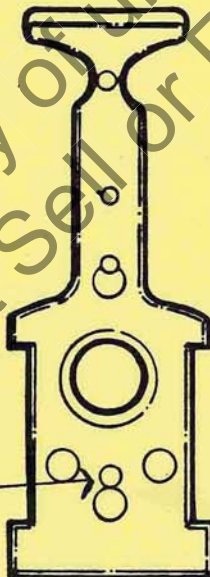
Drill Through
#43 Drill Bit

Your customer may complain that the trimmer floods too easily and that he cannot hear the engine "fire" the first time. This can be remedied by drilling a small hole in the choke. See the illustration below for size and location.

The hole will allow more air to enter the carburetor venturi creating less vacuum and therefore drawing less fuel into the engine.

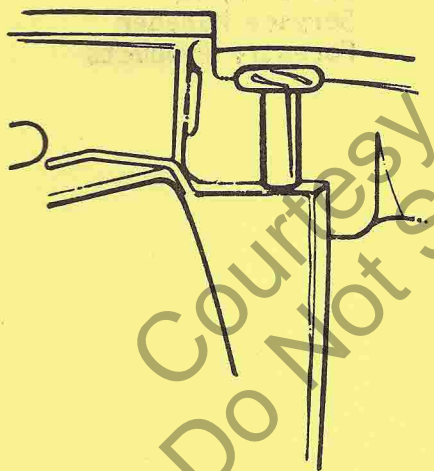
OLD DESIGN

1. The throttle handle has been redesigned to lengthen the bore for the manual oil pump plunger (see illustration). This was done to minimize the "side to side" movement experienced by the plunger when the user depresses the button. The part number did not change. The current number is A93926. This change is effective with the serial number OD2250000 and above.

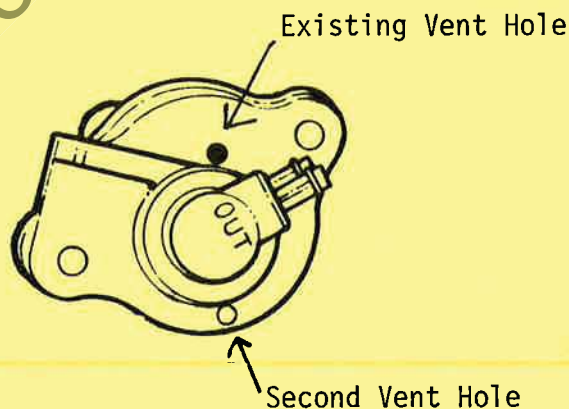
Any excess oil will be discharged through the existing vent hole (see illustration below) soon after the saw is put into operation. This situation is normal and should stop after a short while. However, in very cold weather, the oil under the diaphragm may stiffen and reduce the efficiency of the pump. If this happens, disassemble the oil pump, clean it, and lubricate only the plunger before reassembly.

There have also been a few reports that oil is again discharged through the vent hole, even after the cleaning of the pump. Such a situation would be indicative of an internal leak, in which case the oil pump should be replaced. If a new pump is not immediately available, a second vent hole, drilled with a 3/32 inch (2,5 mm) drill 180 degrees from the existing vent hole will prevent excessive oil build-up in the diaphragm chamber.

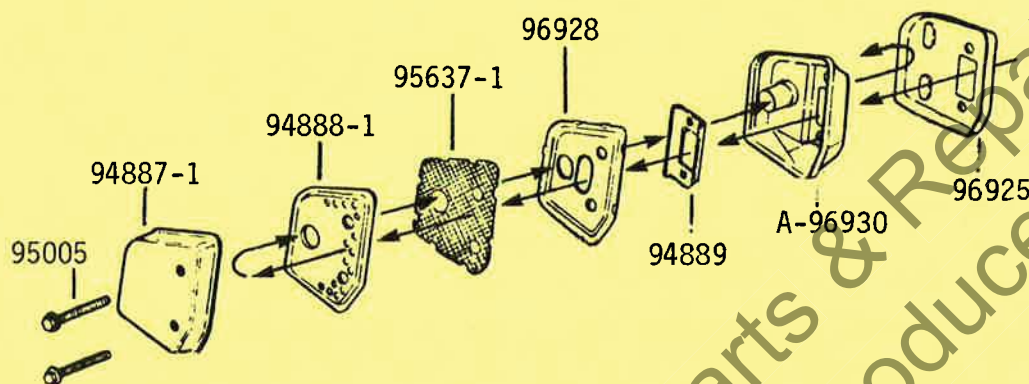
Arrows indicate direction of exhaust flow.

2. A new muffler is used on all 240 chain saws above serial number XD200XXXX. The exhaust is now directed to the rear of the muffler and exits near the cylinder.

NOTE: The muffler cap does not have holes for the exhaust to escape through.

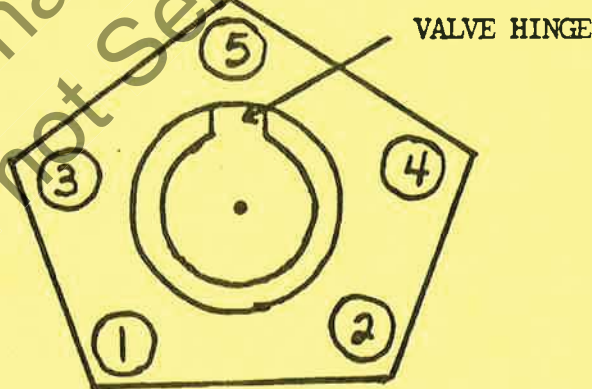
FIGURE "A"

Proper field assembly of the discharge fitting and check valve on the FP-250 has been a problem. Improper assembly may result in an air leak which will prevent the pump from priming properly.

1. Coat both the faces of the pump body and the discharge fitting with a lubricant. Dow Corning number 4 compound, Homelite number 22636-B is used in the factory, and has been found to be the most effective.
2. Snug up the bolts in sequence shown in figure "A" but do not torque at this point.

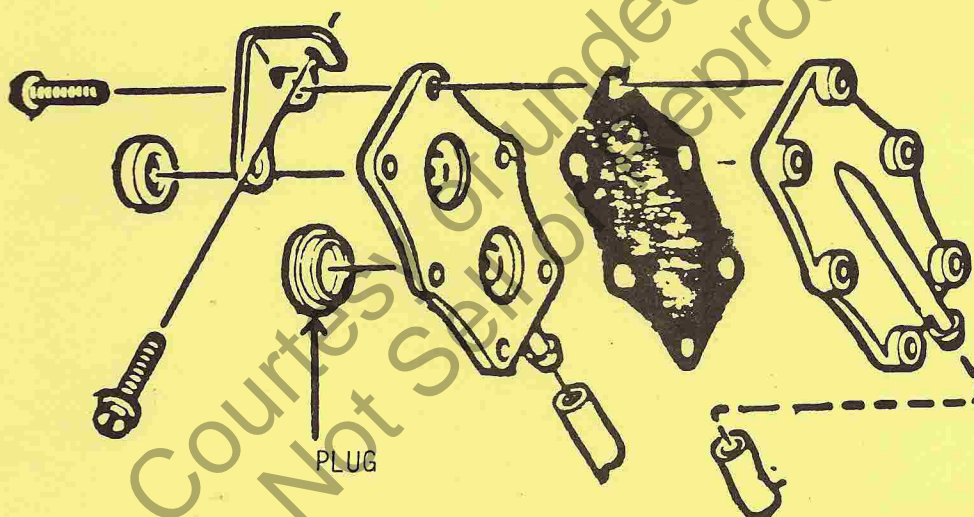
The plug (part number 95789) on the air pump (HB-680) can pop out after a few hours of operation. If this happens there will be a loss of pressure in the fluid tank and the sprayer will not work. The plug must be installed back in place making sure that an adhesive is applied evenly around the outer diameter of the plug (we recommend Zip Grip adhesive, part #70627).

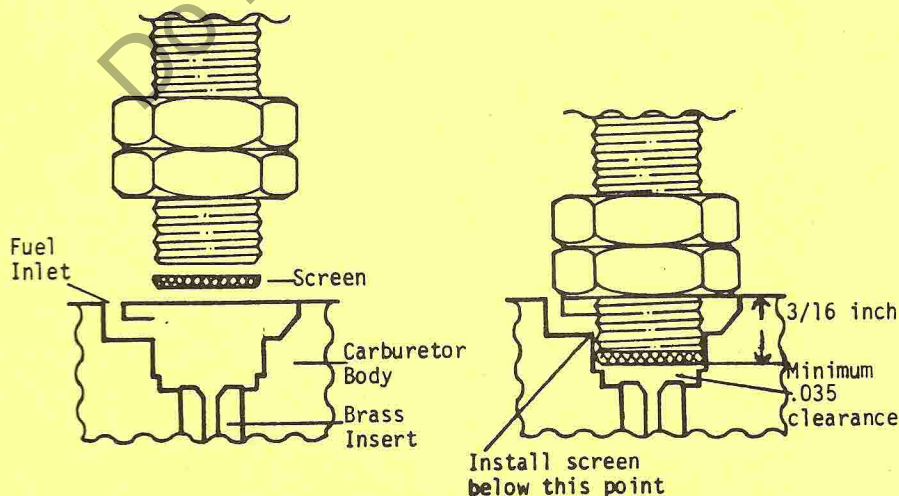
We have had a few reports of lean running or no start conditions due to fuel starvation. First check the inlet screen in the carburetor. The very fine screen was installed to ensure complete filtration of the finest particles that may slip by the filter in the gas tank. The dirty screen must be replaced with a new screen #97098 as it is so fine it can't be easily cleaned.

Use the two nuts to maintain the 3/16 inch depth. This allows the screen to be set in place without blocking the fuel inlet hole, or touching the brass insert pressed into the carburetor body.
