SUBJECT: CORRECTION TO TECHNICAL SERVICE BULLETIN 184-014**AFFECTS:** ST-160, ST-180 STRING TRIMMERS

On Technical Service Bulletin 184-014, the illustration of assembly shows the wrong sequence. Please follow the revised illustration below when assembling the shield (94409) and second flat washer (84099).

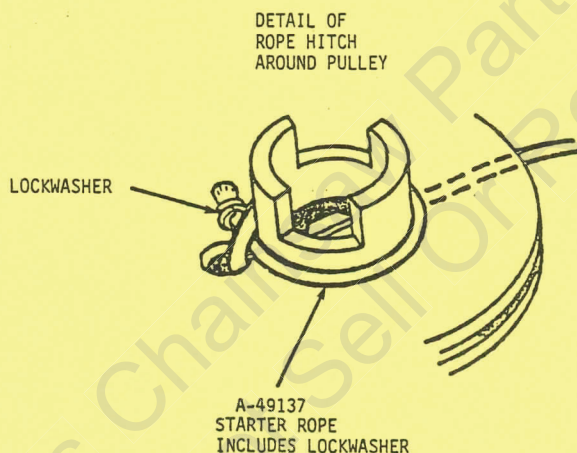
- 1) Starter rope p/n 97500 used in the Model 410 chain saw has been superseded to p/n A-49137 which is also used on the Model DM-40 multi-purpose saw. This starter rope (A-49137) incorporates a lockwasher (83060) crimped onto the pulley end to keep the THROAT SEIZING HITCH from slipping. Refer to the diagram below when installing starter rope on the subject model saws, noting the location of the lockwasher.

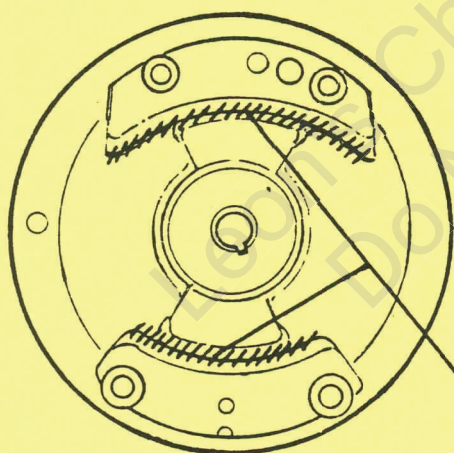
When using this Phelon rotor (95218-AS) on the Wico breaker point ignition system, it may be necessary to file off any excess flashing on the underside of the rotor (see diagram) to prevent possible interference with the point box cover. The breaker box and cover should be inspected for warpage and replaced as needed.

If necessary,
file off excess
flashing in these
two areas

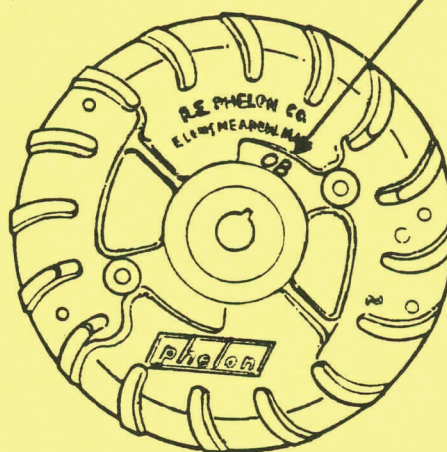
- 1) Wico (Prestolite) ignition rotor p/n 68701 has been superseded by a Phelon (Repco) ignition rotor p/n 95218-AS. The magnetic polarity of this Phelon rotor (denoted by the letter "B" on the top side) allows it to be used with either the Wico solid state ignition module A-94111-S or the older Wico breaker point ignition systems.

Letter "B"
location

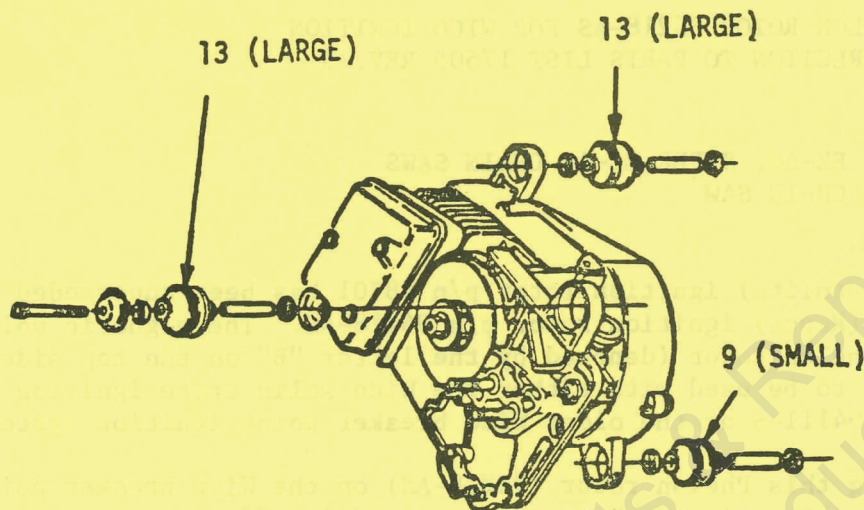
- 2) The isolator item numbers shown in the model 330 parts list (Figure 2) are incorrect. Adjust your parts list according to the illustration below.

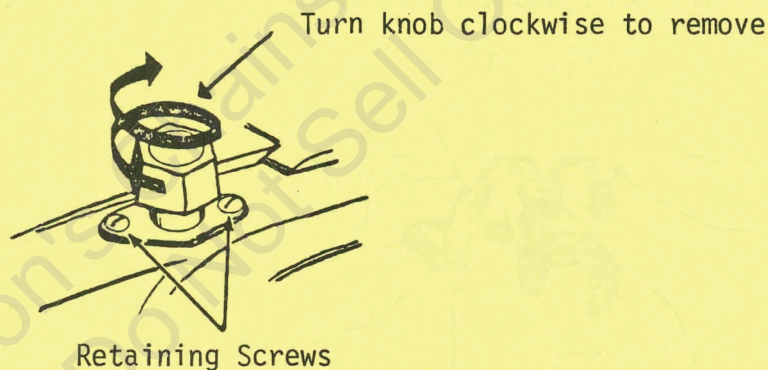
(Figure 1)

- a. Turn knob clockwise until it comes off.
- b. Remove two retaining screws and sharpener assembly.

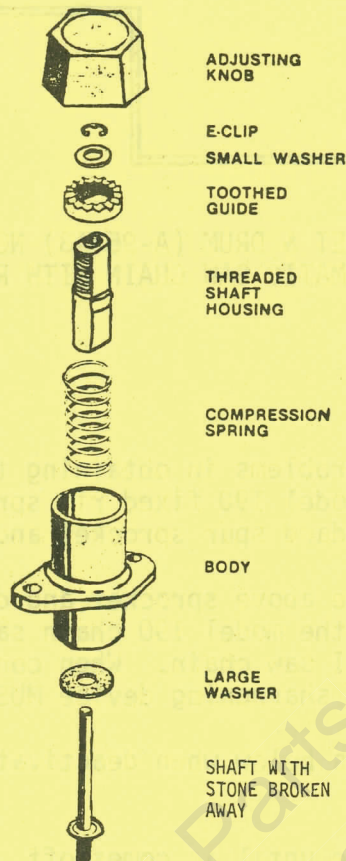
(Figure 2)

- c. Remove the E-clip retainer
- d. Slide the stone and shaft assembly out of the sharpener body.
- e. Using a hammer, break the stone away from the shaft.
- f. Reassemble the now deactivated sharpener according to the order of assembly shown (Figure 2).

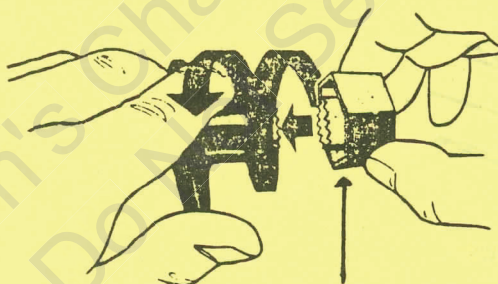
Figure 3

- g. To reassemble knob, press teeth of knob against toothed guide while turning knob counterclockwise.

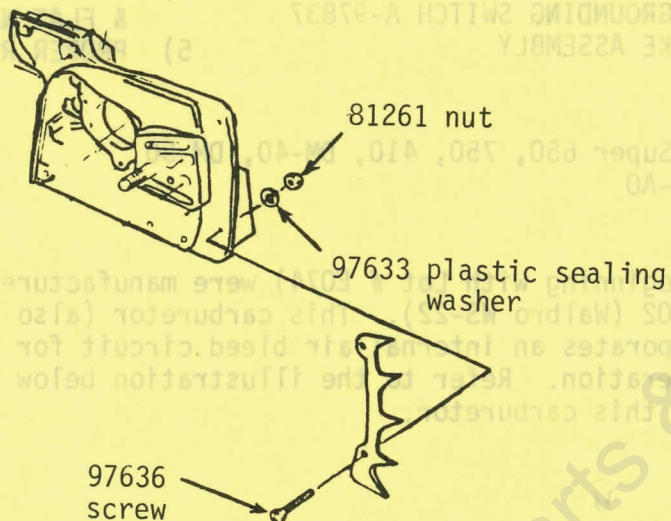
- 3) When assembling the bumper spike to the Model 410 chain saw, the plastic sealing washer should be installed onto the screw between the crankcase and the nut. When the nut is tightened, the plastic washer collapses and fills the pocket in the crankcase for improved spike retention. See diagram.

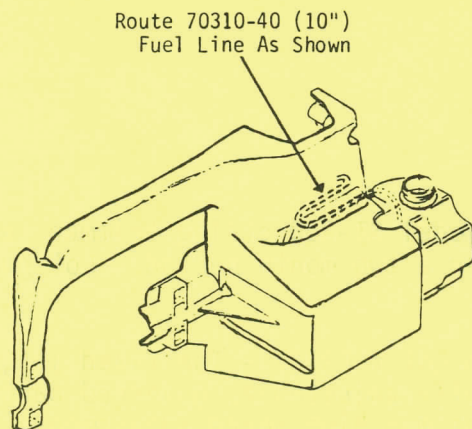
- 3) Fuel tank and fuel line (starting with Lot # F339) - To allow for complete drainage of the fuel tank during operation, the fuel line has been lengthened to 10 inches (25cm) and rerouted. This fuel line 70310-40 now exits the tank near the fuel filler hole resulting in the fuel filter being located at the front of the tank rather than the rear of the tank. Route fuel line as shown in diagram below.

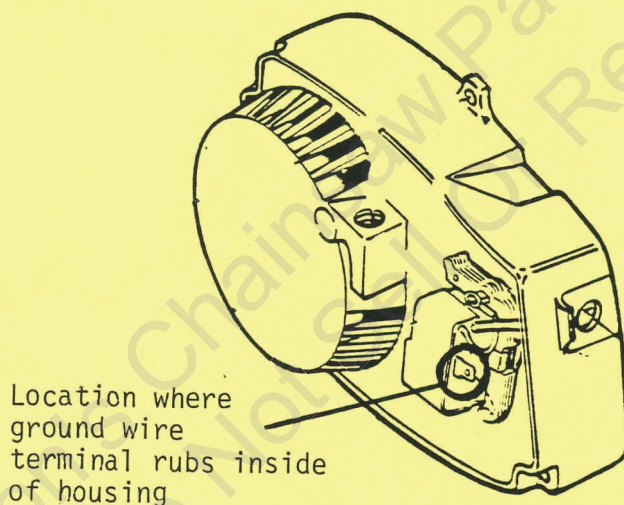
FIGURE 1

Remove the starter housing and inspect the inside surface for a small area where the paint is rubbed off (see Figure 1). This indicates the ground tab (for the stop switch wire) coming out of the module is angled improperly and is allowing the switch lead wire to rub and ground out against the starter housing.

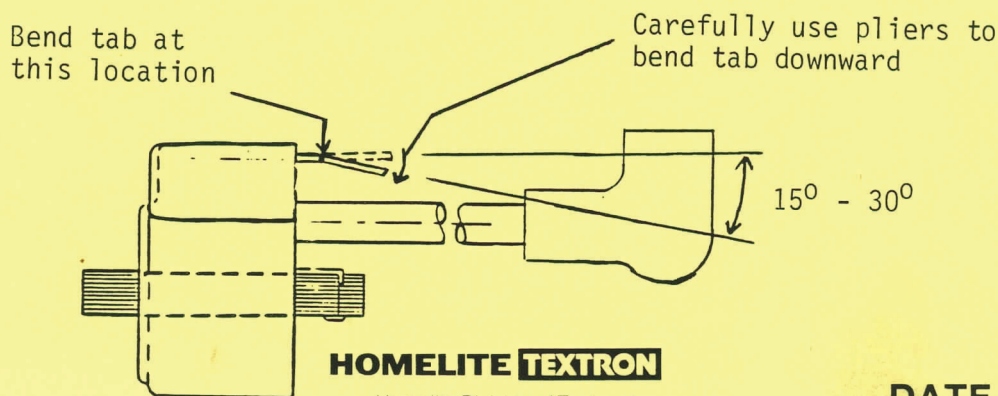
FIGURE 2

The ground tab can be bent slightly downward by carefully using a pair of pliers (see Figure 2). The tab should be angled between 15° and 30° to prevent the switch lead wire from contacting the starter housing.

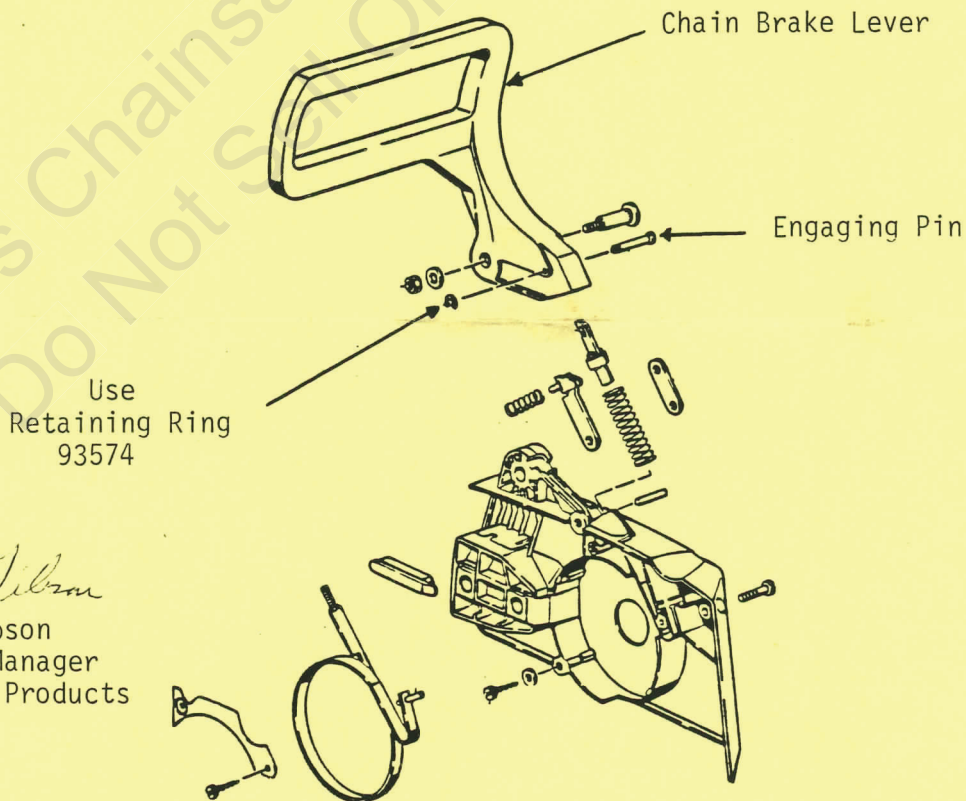
Units which have already been sold should be inspected for a possible loose or missing retaining ring. Should the retaining ring come off and the engaging pin vibrate out of the chain brake lever, the chain brake assembly would be rendered inoperative.

The retaining ring which holds the engaging pin in the chain brake lever should be replaced with P/N 93574 retaining ring (see illustration below) on ALL subject units.

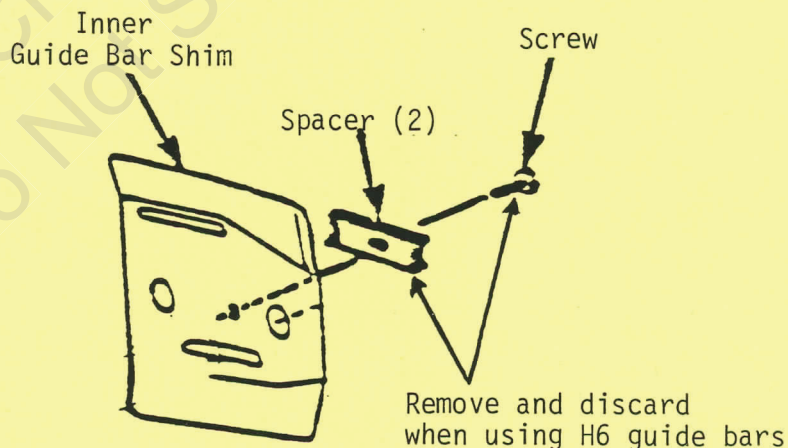
When replacing the G5 series guide bar with an H6 series guide bar, the two spacer plates and retaining screw (80513) MUST be removed and discarded (see diagram below).

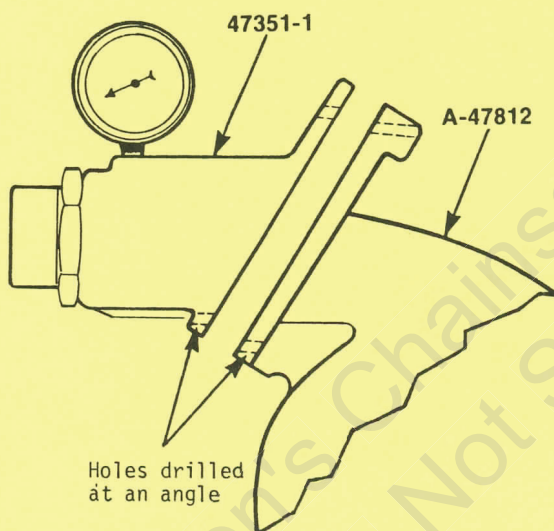
OLD

Part numbers are in parts list # 17398 and are used prior to Lot # F152

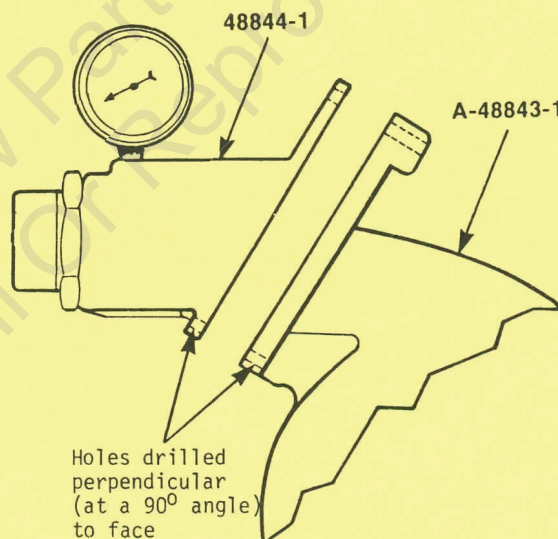
NEW

A new pump and valve body are now being used on the FP250. The bolt holes in the new design are drilled perpendicular (at a 90° angle) to the face where the flapper valve seats. This aids in assembly and prevents the flapper valve from moving when the valve body is assembled and torqued. Both old and new style parts are available.

Part numbers are in parts list # 17398 Rev. 1 and are used after Lot # F152
