BULLETIN 186-001 286-001 NO. 386-001

SUBJECT: TECHNICAL SERVICE BULLETIN LISTING

1985 TECHNICAL SERVICE BULLETINS

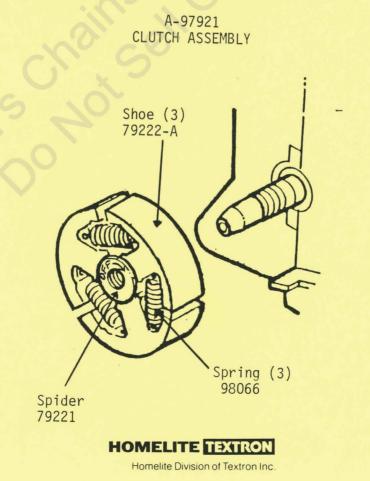
The one-piece "S" Clutch used on the subject model chain saws has been replaced by a three-shoe unlined clutch assembly A-97921. This three-shoe clutch should be used whenever replacing the "S" Clutch on the XL, XL-2, Super 2, and VI Super 2 chain saws.

Install the clutch assembly (left hand thread) with the counter bore in the spider facing towards the crankshaft (Refer to Technical Service Bulletin 184-009, 9/84). Torque clutch to 125 in.lbs. (14.1 Nm).

Refer to the diagram below when ordering parts.

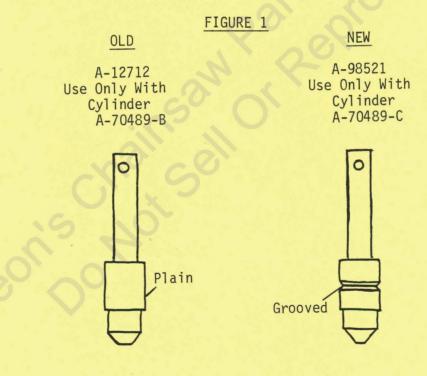
The cylinder assembly on the Model 750 Chain Saw has been revised in the area of the compression release valve. The revision was made to eliminate the valve pounding the seat resulting in cylinder bore and piston damage. Due to the compression release hole in the bore of the cylinder being made smaller, the new cylinder assembly (A-70489-C) requires and includes a revised compression release valve assembly (A-98521).

In order to insure proper seating, the new compression release valve (A-98521) must be used with the new cylinder (A-70489-C). The new valve can be identified by a "V" groove as shown in Figure 1 below.

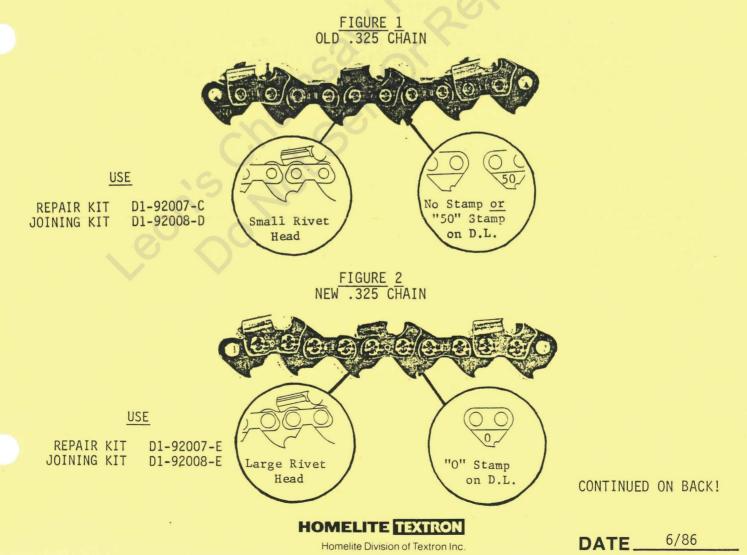
The 32ME Series (.325) saw chain has been made stronger by increasing the diameter and length of the rivet. This improvement required larger holes in the drive links, tie straps, and cutters, therefore the repair and joining kits SHOULD NOT BE interchanged.

The new, stronger chain can be identified by larger rivet heads and "O" stamped on the drive link. Refer to FIGURE 1 (OLD CHAIN) and FIGURE 2 (NEW CHAIN) below when identifying saw chain and ordering service kits.

Using the older service kits in the new chain will adversly affect the strength of the chain which could result in injury.

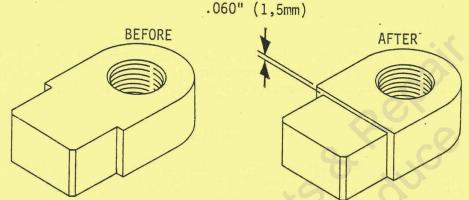
If this modification is not made, the adjusting pin may not drop into the slot in the bar when installing a new, out of the box, chain.

2) When installing the new, stronger 32ME50-67 (67 drive link) chain with the PT-16321-G4 guide bar on the Model 245 (or 240 with .325) it may be necessary to file .060" (1,5mm) off that section of the adjusting pin which fits into the guide bar. Refer to Figure 3 below. Reinstall the adjusting pin into the drivecase cover with the step (the side which was filed) facing TOWARD THE FRONT of the saw.*

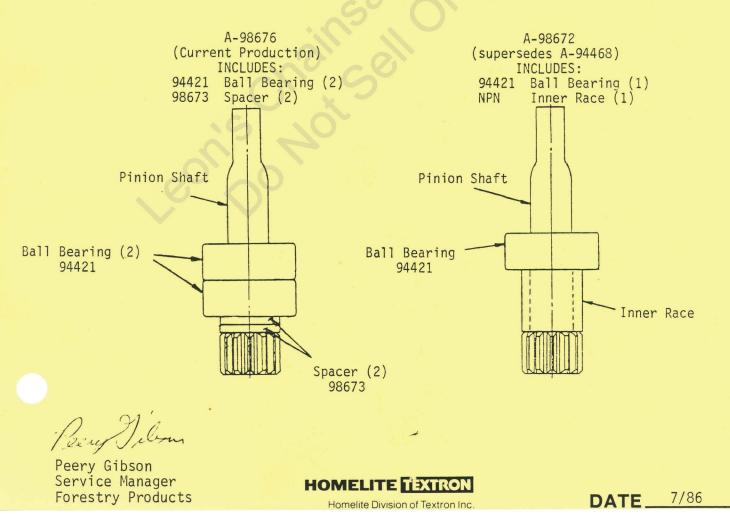
A one-piece pinion shaft and cut gear has replaced the two-piece pinion shaft assembly in the ST-200 brushcutter attachment.

Service will supply two pinion shaft assemblies (see FIGURE 1 below) to service both the NEW and OLD brushcutter kits.

A-98676 Pinion shaft with two ball bearings to service brushcutter kits built AFTER the LOT dates shown above.

A-98672 (supersedes A-94468) pinion shaft with <u>one</u> ball bearing and inner race to service older brushcutter kits.

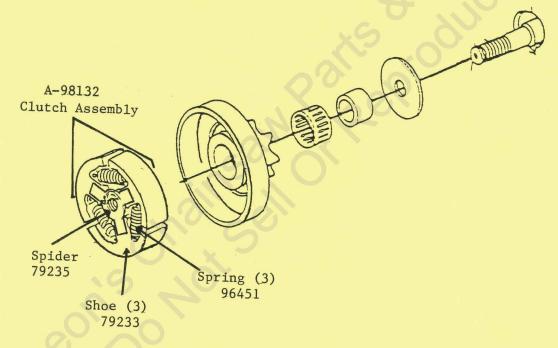
A three-shoe unlined clutch assembly A-98132 has superseded the one-piece S-clutch 68362-7 used on the subject model chain saws. Refer to the diagram below when ordering parts for this new clutch assembly.

Install clutch assembly A-98132 with the "OFF \rightarrow " facing out. Torque clutch assembly to 250 - 300 in.1bs. (28.2 - 33.9 Nm).

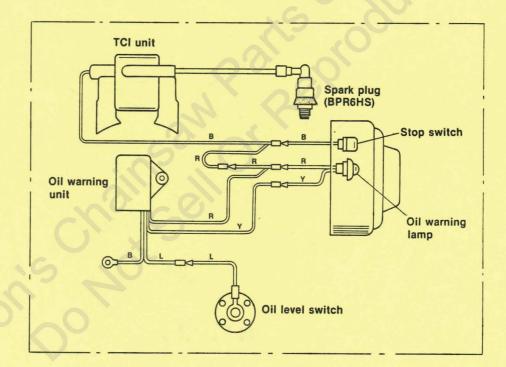
The HG1400's are now equipped with solid state ignition systems starting with Serial Number 7H6405450 and above. Below is a list of parts and part numbers for the components that make up this system and the wiring diagram.

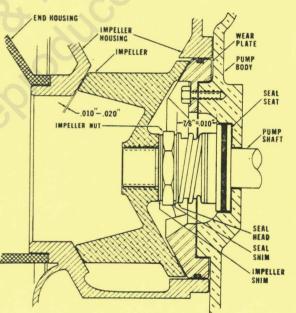
It is very important to shim the spring pressure of the seal properly when installing new seals. If the seal is not properly shimmed, it will leak and the priming ability of the pump will be very poor. Some seals have an additional shim packed with them which is normally needed for proper spring pressure.

If scraping noises are heard, additional shims will have to be removed to obtain proper impeller housing to impeller clearance. Remove one .015" impeller shim, reassemble and check that there is no scraping noise.

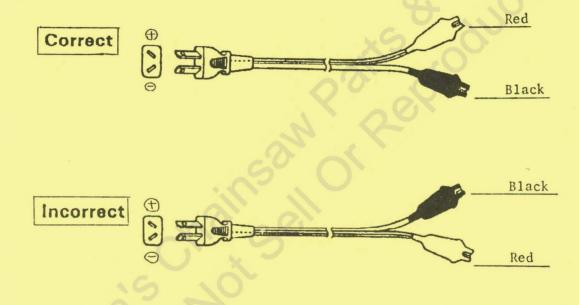
The battery charging cord (#49024-35) in units with serial numbers 7FF-000701 to 7FF-001100 may be reversed in polarity. If the charging cord you have is reversed, it will be necessary to remove and reinstall the red and black vinyl clip covers to the proper lead wire. This labor time can be covered by Warranty for 0.2 hr. per unit.

If the leads are used in reverse, the DC Circuit Breaker will trip and the DC Rectifier and Stator Coil could be damaged.
