BULLETIN

NO. H97D-001

SUBJECT: BP 250 BLOWER RETURN LINE SLEEVE

AFFECTS: BP 250 BACKPACK BLOWERS
UT08017F, G
SERIAL NUMBER HP2000001 THROUGH HR2109999

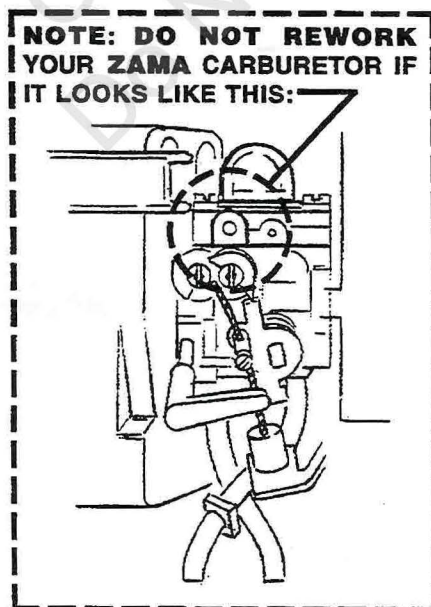
Carburetor: Zama 3mm: no fitting on
choke lever side, no rework required

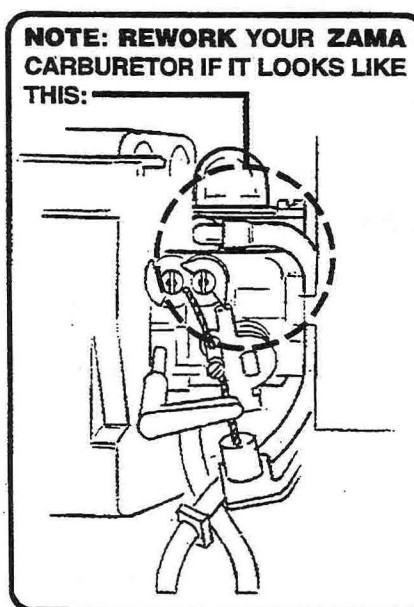
Carburetor: Zama 4mm: fitting on
choke lever side, add sleeve kit
to return line

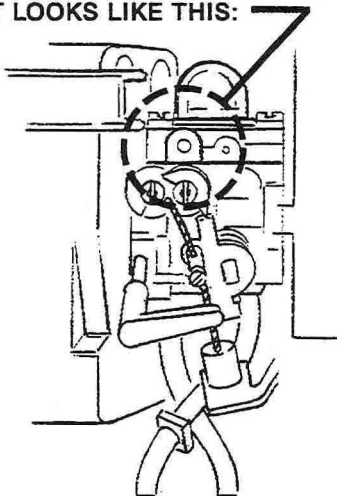
NOTE: DO NOT REWORK YOUR ZAMA CARBURETOR IF IT LOOKS LIKE THIS:

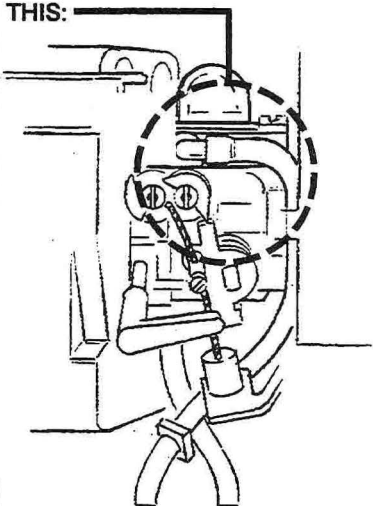
NOTE: REWORK YOUR ZAMA CARBURETOR IF IT LOOKS LIKE THIS:

1. Remove the return line from the carburetor and fuel tank.
2. Using a fuel line puller, install **new** return line in fuel tank.
3. Trim **sleeve** as per illustration.
4. Slide sleeve over return line.
5. Trim return line to fit.
6. *Make sure that the sleeved line does not contact cylinder or crankcase.*
7. Connect return line to carburetor.

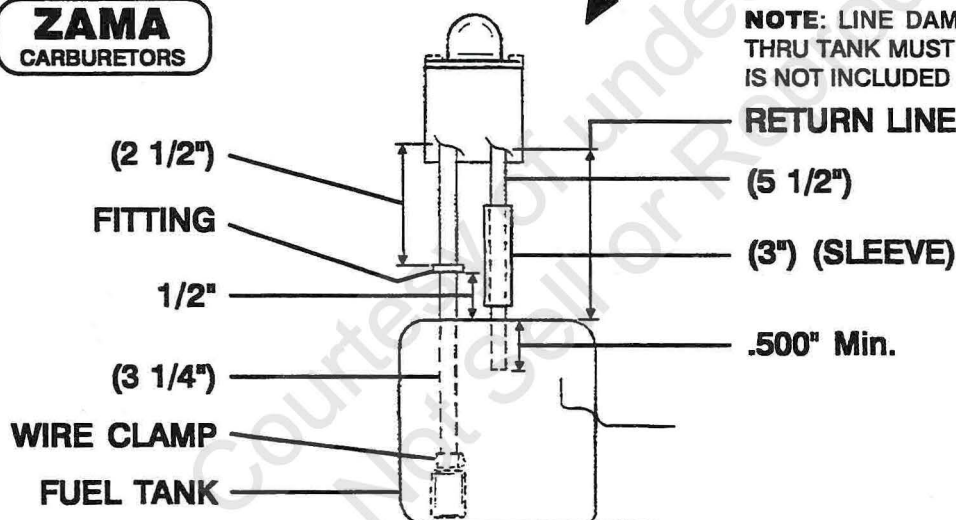
ZAMA CARBURETORS

NOTE: LINE DAMAGED WHEN PULLED THRU TANK MUST BE CLIPPED OFF. THIS IS NOT INCLUDED IN SPECIFIED LENGTH.

RETURN LINE 4" OUT OF TANK

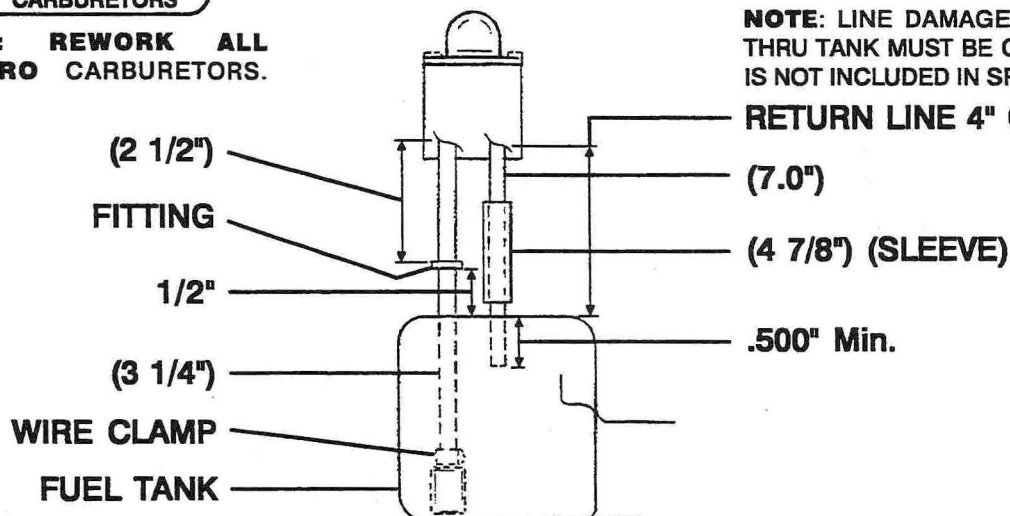
WALBRO CARBURETORS

NOTE: REWORK ALL WALBRO CARBURETORS.

NOTE: LINE DAMAGED WHEN PULLED THRU TANK MUST BE CLIPPED OFF. THIS IS NOT INCLUDED IN SPECIFIED LENGTH.

RETURN LINE 4" OUT OF TANK
