BRANCH SERVICE MEMO NO. 916CS

DEALER SERVICE MEMO NO. 604

SUBJECT: Connecting Rod #A-63477-B and A-67745-B
supersede A-63477-A and A-67745-A

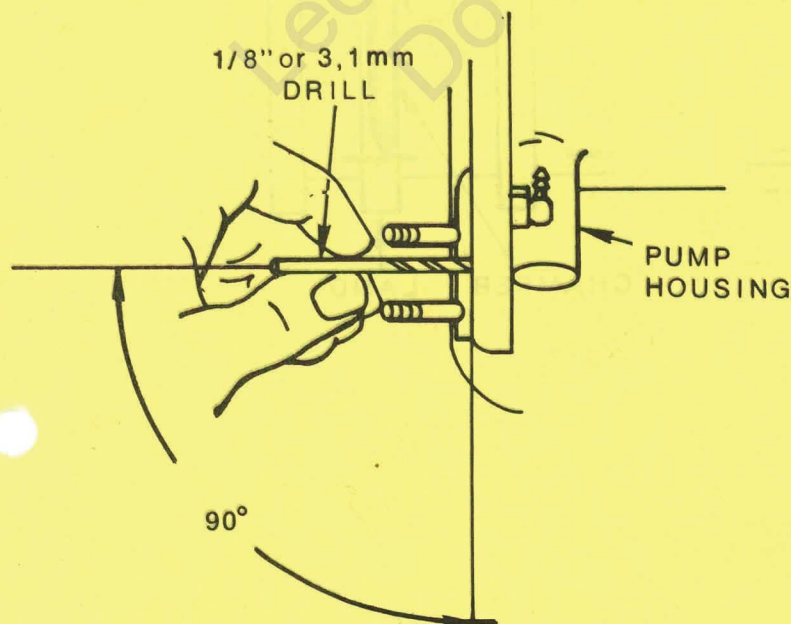
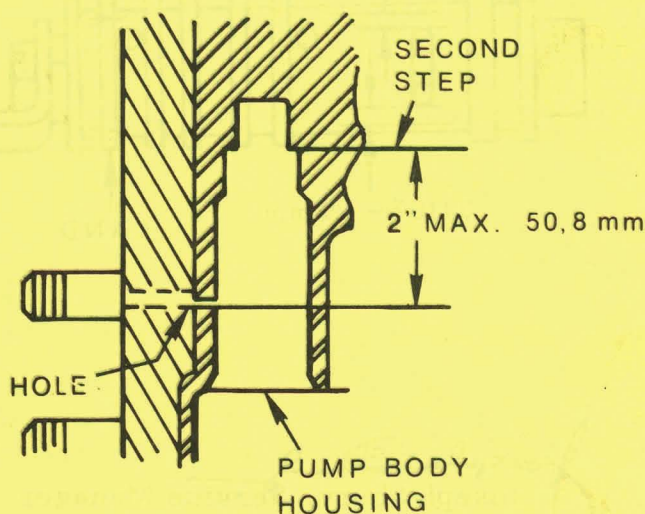
HOLE LOCATION CHECKS

We have determined that some failures of 350 automatic oil pumping are the result of improper location of the oil discharge hole in the pump housing wall, especially true in cold weather. The pump discharges properly when the hole is open to the front chamber between the two front O-rings. But when the hole is over the front O-ring land, discharge is impeded. This memo tells you how to check for proper hole location, and what to do to restore pumping if the hole is wrongly located.

1. Push a 1/8" or 3,1 mm drill into the oil discharge hole in the guide bar pad to check that it is drilled correctly.
 - a) The hole can be drilled upward at an angle of up to 13 degrees. (13 degrees is the print specification).
 - b) The hole must be drilled perpendicular to the mounting face of the guide bar pad so that it will break through into the pump compartment within the 2" (5,0 cm) Dim. specified below.
2. With a steel rule, measure from the edge of the second rise or step of the housing bore to the outside edge of the discharge hole.
 - a) The measurement can be less than but not more than 2" (5,0 cm). If measurement is more than 2" (5,0 cm) the hole is too far forward. Take remedial action.

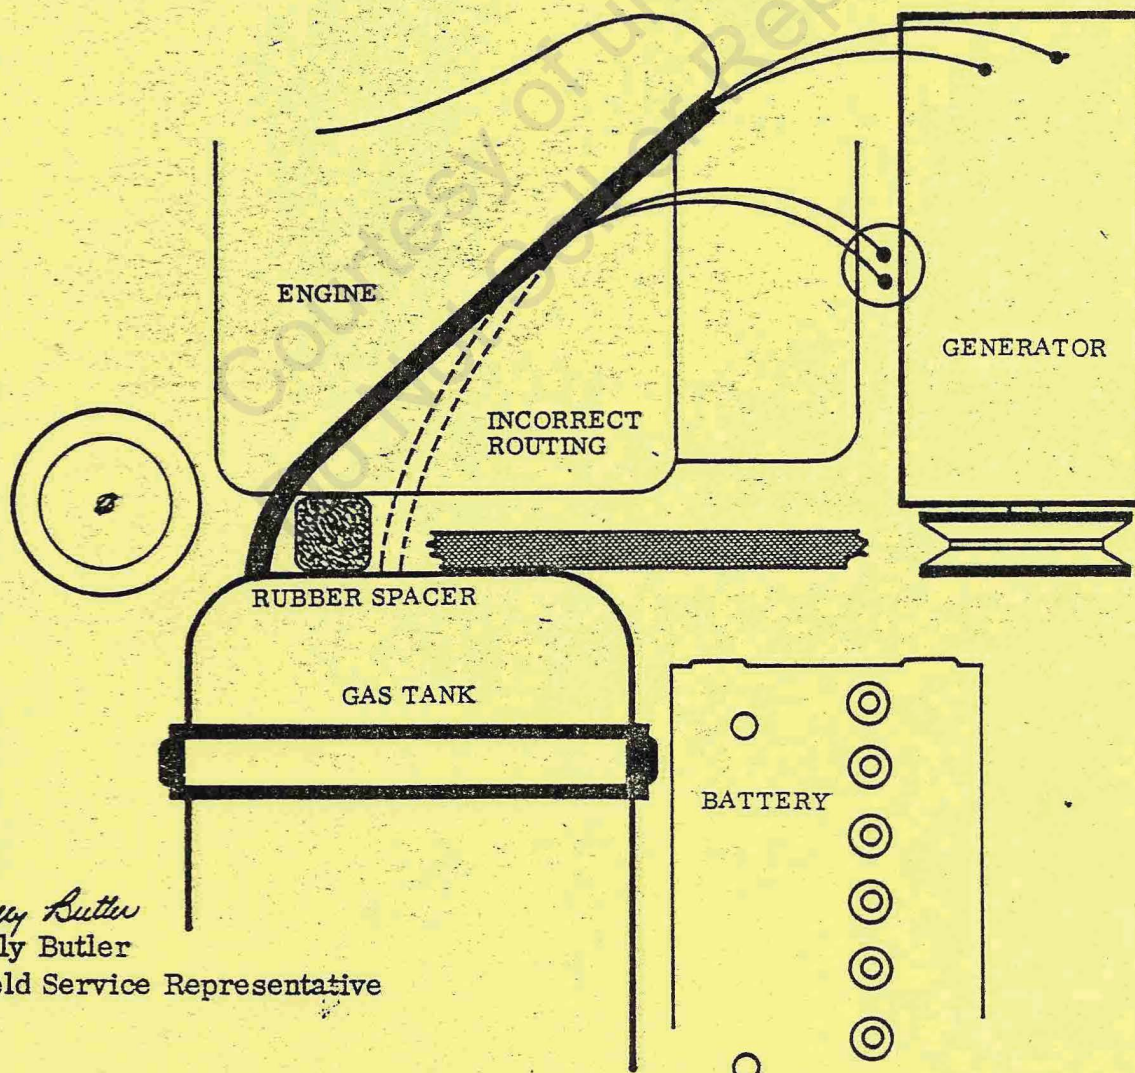
The units correctly wired should have the harness routed to the left side (viewed from the operator's position) of the rubber spacer block between the gas tank and the engine shroud (see illustration below).

Units incorrectly wired have the harness routed to the right of the rubber spacer block (see illustration below). The harness should be re-routed to prevent possible damage to wiring harness by coming into contact with "V" belt drive and shorting out the electrical system. A warranty claim may be submitted for the re-routing --.4 of an hour will be allowed for the repair.
