TECHNICAL SERVICE BULLETIN

NO. 181-001

AFFECTS: XL-12, SXL-A0

SUBJECT: ZAMA CARBURETOR PART NUMBER A-94953

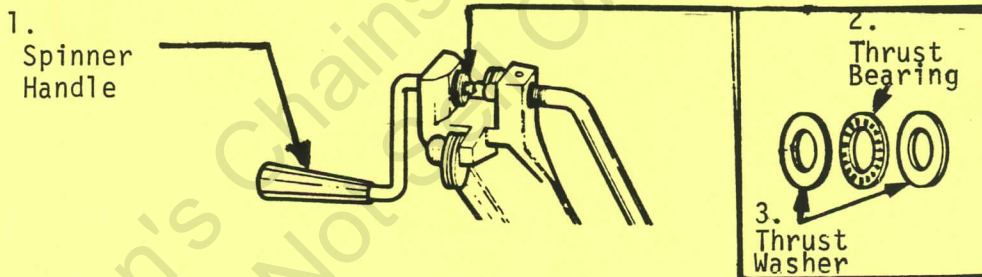
The following parts are now available for servicing the A-17163 rivet spinner.

ITEM #	NAME	PART #	QTY.
1	Spinner Handle	17605	1
2	Thrust Bearing	96733	1
3	Thrust Washer	96732	2

Please order these parts according to your requirements.

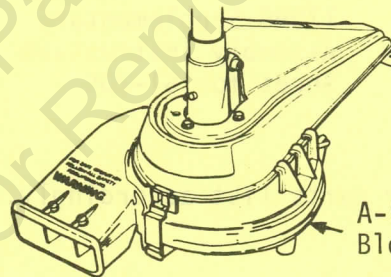
FIGURE #2

A-93597
Blower

To retro-fit an ST-200 produced before the above mentioned serial number, it is necessary to replace the present A-94473 string head cover with the new A-94473-A cover (notched as shown above) before the blower attachment can be assembled. (See figure 2).

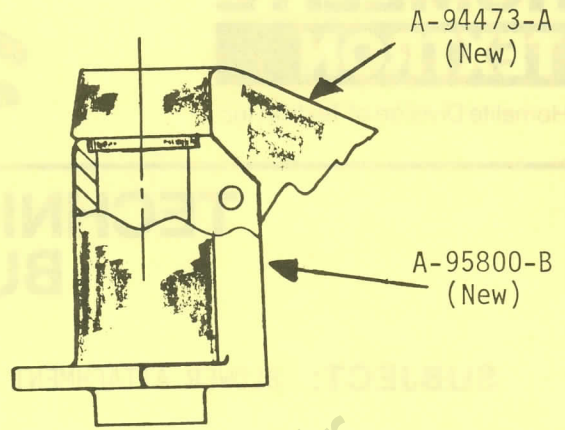
FIGURE #4

When retro-fitting the new string head cover to the old lower head assembly A-95800-A it will be necessary to remove (by filing, sawing, etc.) the locking collar as shown in figure 3. This collar on the new string head cover is used with the new lower head assembly A-95800-B which has a mating locking recess as shown in figure 4. The new head assembly can also be identified by the full length clamp.

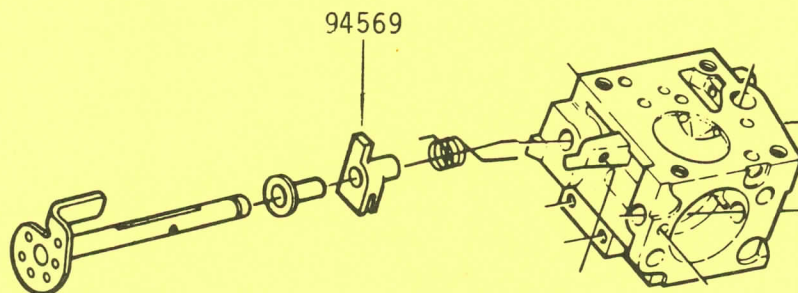
- 2) We have had some requests from the field asking that we supply the throttle shaft bushing as a separate item. The part number is 94569. Refer to the illustration below.

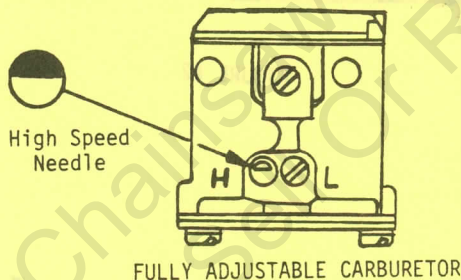
Figure #1

A new carburetor with an adjustable high speed jet is now available for the XL family of chain saws.

This carburetor can be identified by a short high speed needle that has a "D" shaped key instead of a screwdriver slot. (See Figure #1). To adjust this carburetor, remove the air filter cover, then use a needle nose pliers to turn the "D" shaped needle. The initial settings are 1¼ turns open for both the high and low speed needles.
