TECHNICAL SERVICE BULLETIN

NO. 182-001

SUBJECT: GUIDE BAR INSERT KIT #A-96612

AFFECTS: 360 CHAIN SAW

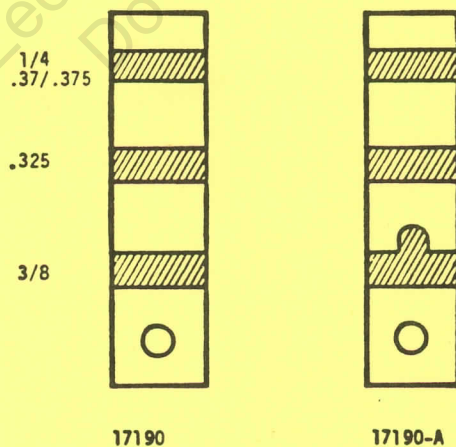
Illustration #2

Also, in order to "break" this chain for repair, it will be necessary to use the new 17190-A anvil. (See illustration #2.)

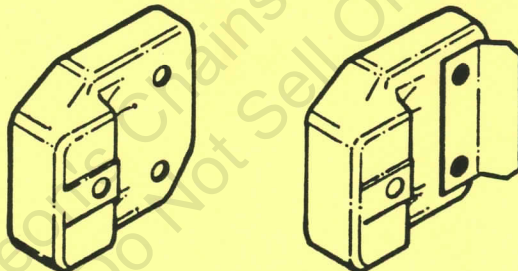
OLD - 95281

NEW - A96580

All SEZ-A0's with serial number #D1380000 and above will have the new deflector.

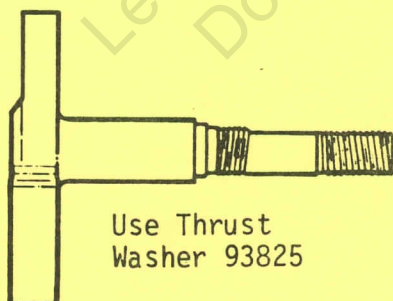
A96418A

1. To improve unit performance and durability a new piston design A95882-A is available for all 330 chain saws. This new piston incorporates narrow piston rings number 96510. When "thick ring" pistons A95882 are no longer available the part number will be superseded by A95882-A. Note that the "thick" piston rings 93823 are still available.
2. Also, the crankshaft was redesigned in the thrust washer area to increase crankshaft durability. This change required a redesign of the thrust washers. The new washers are part number 94860. Old thrust washers 93825 are still available for servicing crankshafts made before this change. All new crankshafts A96418-B will include thrust washers. See picture below.

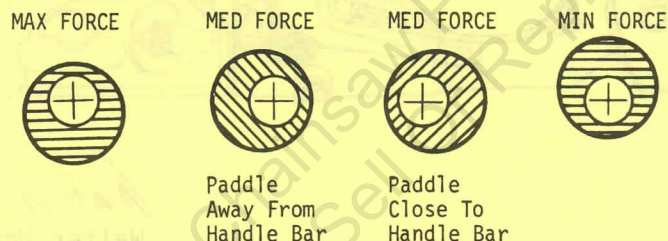
The actuating force and the distance between the handle bar and the chain brake paddle on the model 240 SL are adjustable. Adjustments are made by rotating the brake lever cam, PN 96170, illustrated as item 12 on page 6 of the illustrated parts list number 17601.

The sketches below show the cam in four positions. Dimensions are somewhat exaggerated and the hexagon head is omitted to show the cam positions clearly.

At MAX FORCE and at MIN FORCE adjustments, the paddle to handle distance is identical and intermediate.

As shown by the two center sketches, intermediate actuating forces may be selected with the paddle moving away from, or toward the handle bar.

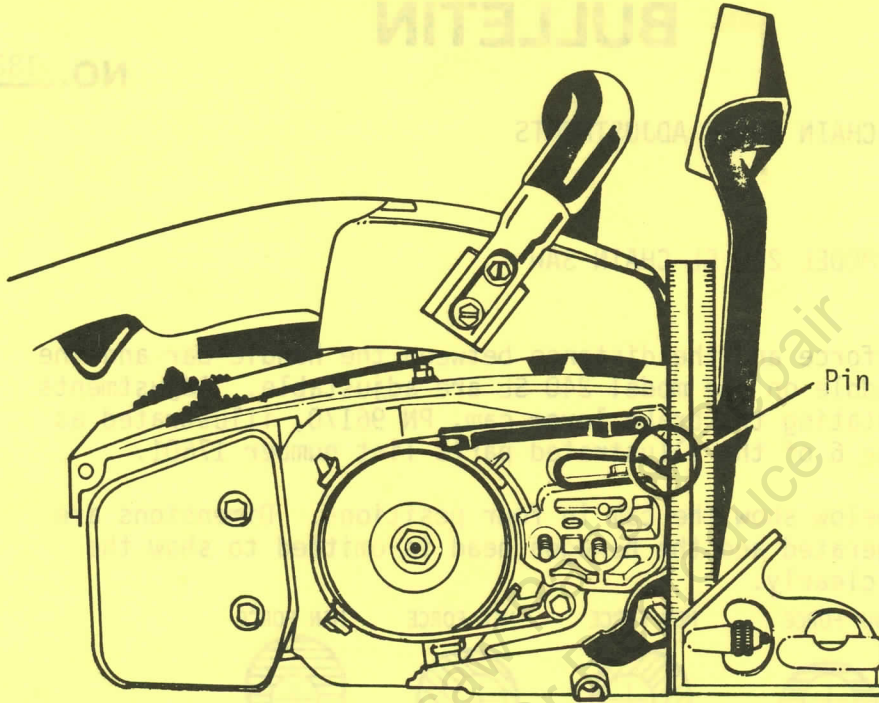
Normal factory adjustment locates the lock pin of the brake lever arm on a vertical line, tangent to the front of the guide bar pad as shown below.

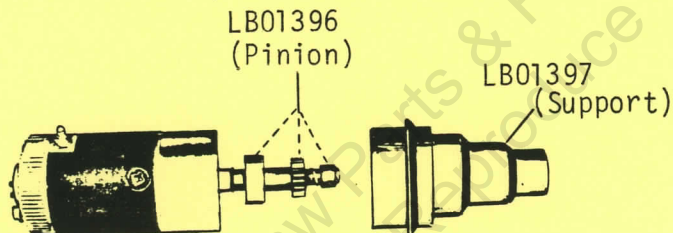
The support (LB-01397) and pinion (LB-01396) for the Prestolite starting motors are now available through service parts. This starter was used on the DTP3-1 prior to serial number 1794629.

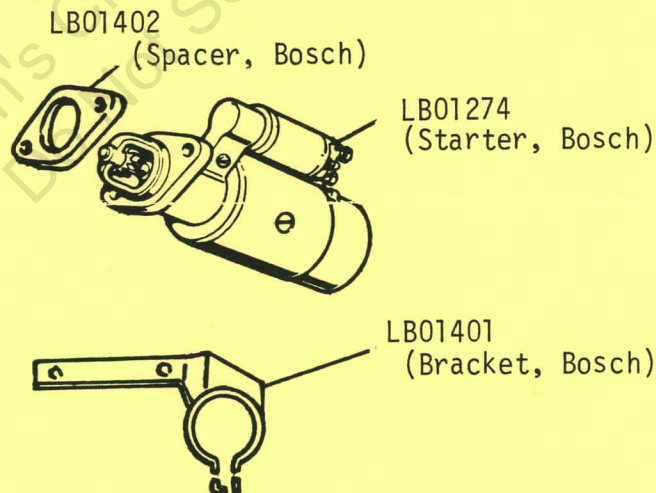
The Bosch starters have a spacer (LB-01402) and a different bracket (LB-01401) that are used on all 177D38-1. These parts are also used on all DTP3-1 pumps after serial number 1794629.
