# TECHNICAL BULLETIN INDEX

## TECHNICAL SERVICE BULLETIN

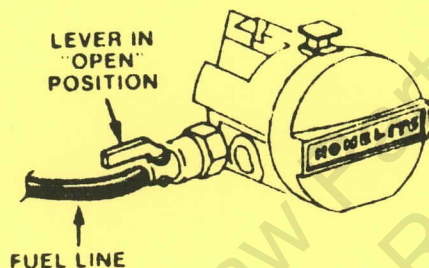
A new fuel shut off valve A-97117 (pictured below) is being incorporated into the above mentioned string trimmers.

In order to use this valve the fuel lines have been shortened. Fuel line 93157-24 (6", 152mm) is replaced by fuel line 94772-22 (5½", 140mm) on the ST-80 and ST-100. Fuel line 93157-27 (6 ¾", 171mm) is replaced by fuel line 94772-25 (6¼", 158mm) on the ST-120.

The ST-120 fuel line insulating sleeve 95098 (4¼", 114mm) can be shortened to 3 ¾" (95mm) for use with the new fuel valve. A new fuel line insulating sleeve 97173 (3 ¾", 95mm) is available for use on the ST-80, ST-100 and ST-120.

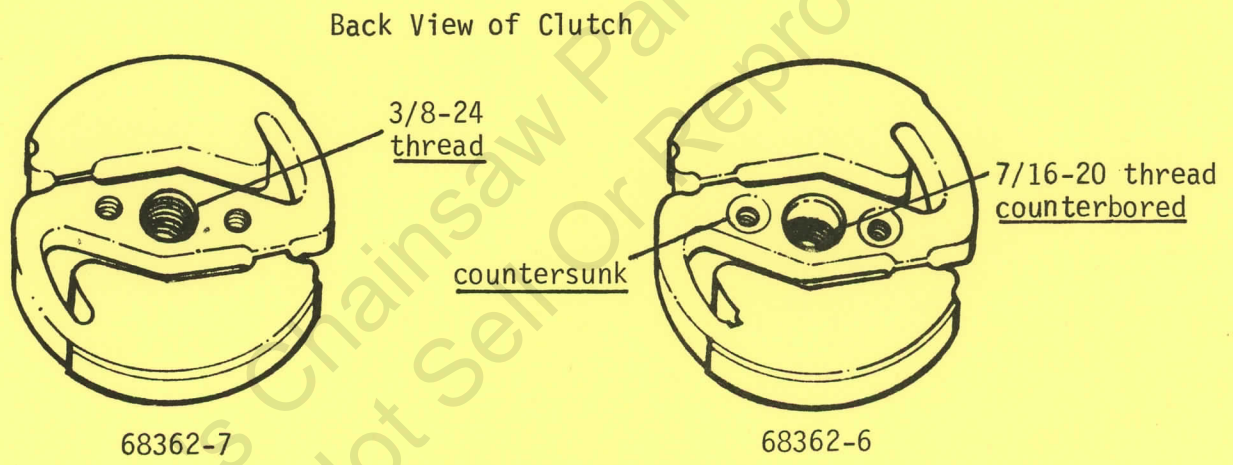
Identify the clutches in your stock and correct part numbers on the packages accordingly.

Use the illustrations and descriptions below to identify each clutch.

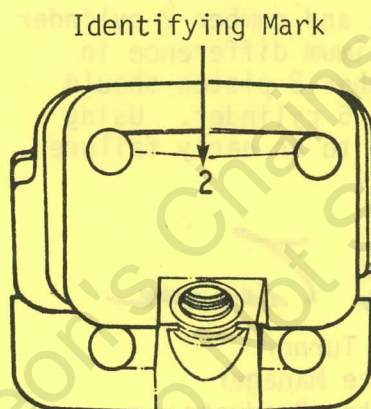
Cylinder  
Ill. #1

The bore size is measured on each cylinder. The cylinders are then sorted by size into five different categories. Each cylinder is marked according to its category (see illustration #1), number 1 being the smallest and number 5 being the largest.

As stated in a previous bulletin, the cylinder and piston for the 410 are now being matched for maximum performance. In order to service the piston only on saws with matched components, we now have available three different size pistons.

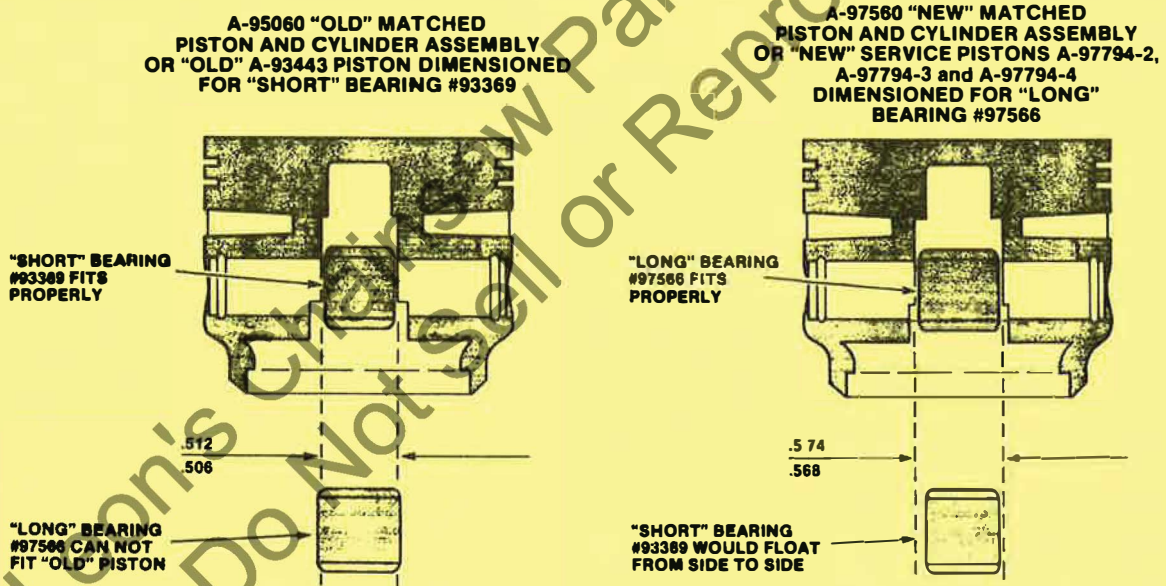
1. New Piston Pin Bearing - A new longer piston pin bearing is being used to increase bearing life. See below for details and part numbers.

The new crankshaft assembly A-97567 will have the longer bearing 97566 pressed into the connecting rod. A short bearing 93369 will be packed with the assembly. When servicing an older saw, remove the long bearing and install the short one using the service tool provided.

IMPORTANT: Read the instructions, provided with each assembly, carefully. Use the tools provided. Proper matching of parts is necessary to avoid engine damage.

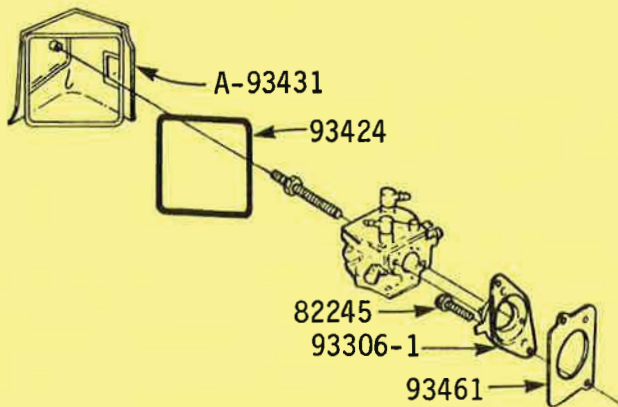
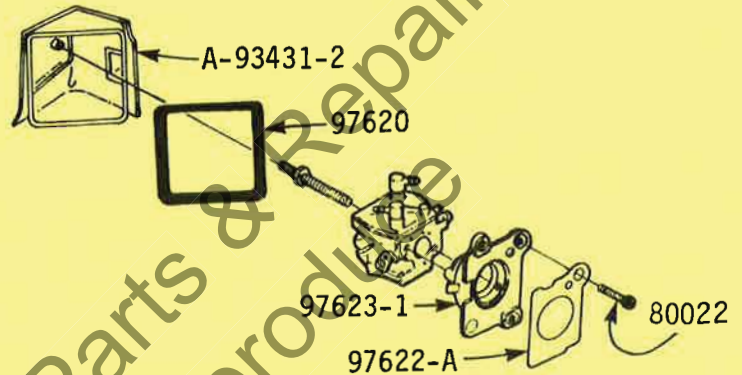
2. Improved Sealing of Carburetor Chamber - In order to substantially reduce the amount of sawdust entering the carburetor chamber, two major changes were made. The cover sealing gasket was enlarged and an extra fastener and a gasket were added to the carburetor adapter. See illustrations for details and part numbers.

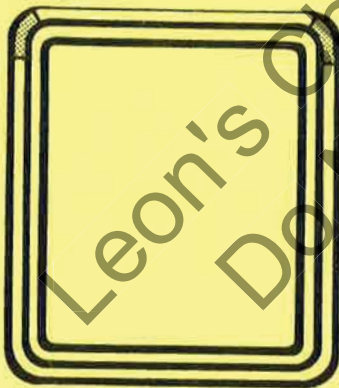
Shaded areas indicate "cut-out" corners.

When assembling the new gasket 97620 to the carburetor cover note that the two "cut-out" corners are to be placed at the top of the cover. See Illustration.

A bead of cement 22788 should be used to retain the gasket to the cover.
