NO. 184-001

SUBJECT: WORN CARBURETOR INLET NEEDLE LEVERS

AFFECTS: 240 CHAIN SAWS

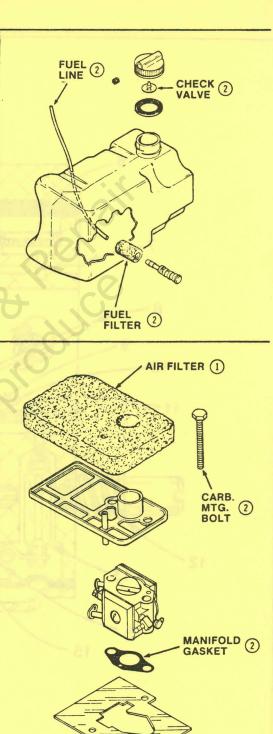
- POSSIBLE SOURCE OF
 FLOODING OR RICH RUNNING
- 2 POSSIBLE SOURCE OF LEAN RUNNING

- FUEL INLET FITTING
 Pressure test for air leaks press
 fit should be tight.
- SURGE CHAMBER Should be clean, check for debris or metal chips.
- INLET CHECK VALVE Should lie flat on carburetor body look for tears or wrinkles.

- 4. FUEL PUMP DIAPHRAGM
 Should be flexible not stiff or stretched. Replace if diaphragm is porous.
- 5. OUTLET CHECK VALVE
 Should lie flat on carburetor body look for tears or wrinkles.

- 8. THROTTLE VALVE
 Check for proper alignment in venturi.
 Check throttle shaft for wear-source
 of air leaks.
- 9,10,11. IDLE PORT HOLES
 Check for dirt & debris, clean with compressed air only.

- 12. HI-SPEED NEEDLE
 Remove & inspect needle & seat for damage.
 - 13. INLET NEEDLE VALVE
 Inspect rubber tip for wear. If
 needle seat is damaged replace
 carburetor.

- 14. METERING LEVER
 Check for wear at metering diaphragm
 contact point. It must turn freely on
 fulcrum pin. Check for proper adjustment.

- 15. METERING LEVER SPRING
 Check proper position. Check for
 distortion or stretching.
- 16. ATMOSPHERIC VENT
 Must be clean & clear of any debris.
 Diaphragm will not work properly if vent is not open.
- 17. METERING DIAPHRAGM
 Should be flexible not stiff or stretched. Check for porosity. Metal plate should be tight on diaphragm.
- 18. METERING CHAMBER/CIRCUIT PLATE
 Check circuit plate fuel take-off holes.
 Make sure the circuit plate & gasket is
 the correct type for this carburetor.
 - 19. LO SPEED NEEDLE
 Remove & inspect needle & seat for damage. Replace spring if needle will not stay adjusted.
 - 20. IDLE TAKE-OFF Check for dirt or debris.
 - 21. NOZZLE WELL Check for dirt or debris.
 - 22. NOZZLE CHECK VALVE

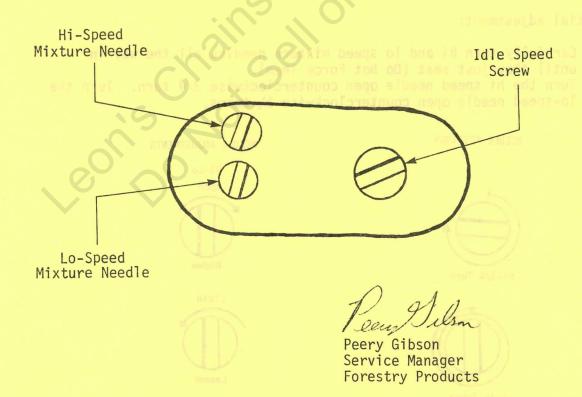
LOCATION OF CARBURETOR ADJUSTMENT NEEDLES

- 2. With throttle wide open and $6\frac{1}{2}$ " (17" cutting circle) of string protruding from head, slowly turn the hi-speed needle clockwise (lean) until the engine fluctuates between 4-cycling and 2-cycling.
- 3. NOTE: Anytime the lo-speed mixture needle is adjusted, always check the hi-speed performance and reset the hi-speed needle if necessary.
- 4. Recheck acceleration and idle response.
