SUBJECT: PRIMER REPAIR PARTS FOR 25cc ENGINES

AFFECTS: 25cc STRING TRIMMERS & BLOWERS

TECHNICAL SERVICE BULLETIN

NO. 189-002

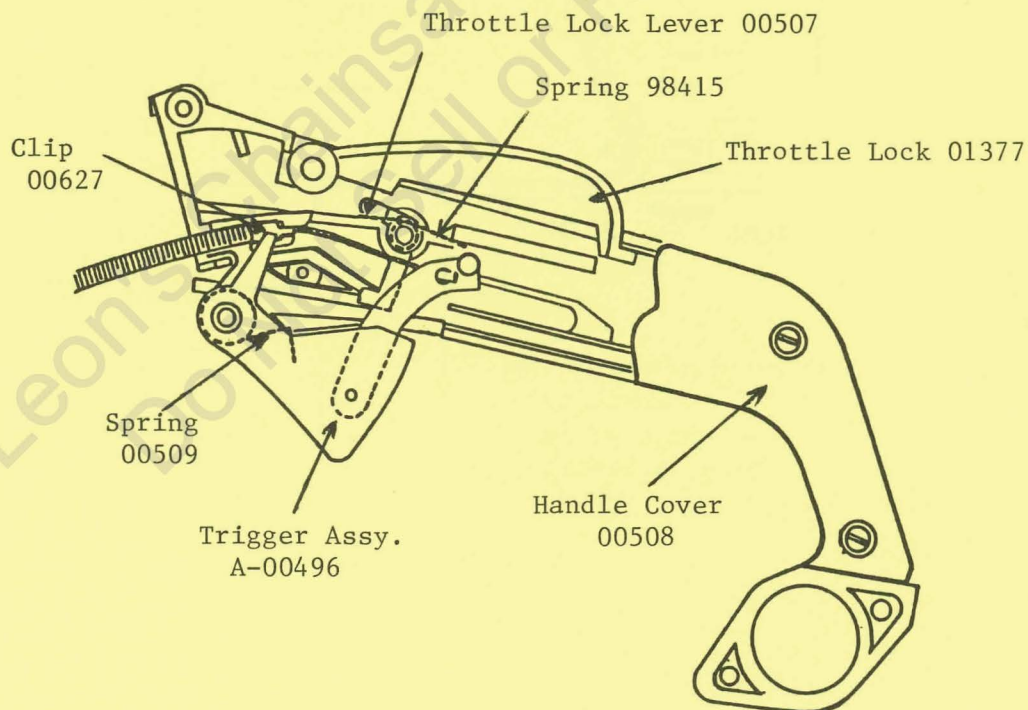
None of the parts associated with the new cable system are compatible with the earlier throttle rod design.

Refer to the two diagrams below when ordering parts for units built with the throttle cable.

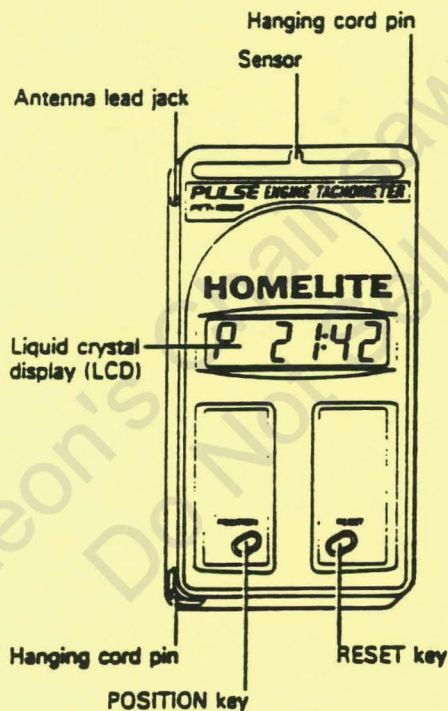
1. An electronic engine tachometer (P/N 18416) is now available from Homelite. This tachometer can be used to check 2-stroke, single and twin-cylinder engines and 4-stroke, twin and four cylinder engines (see spec sheet below). Accessories included are an antenna lead with clip, hanging cord, and instruction manual. Current price is \$85.00 dealer net.

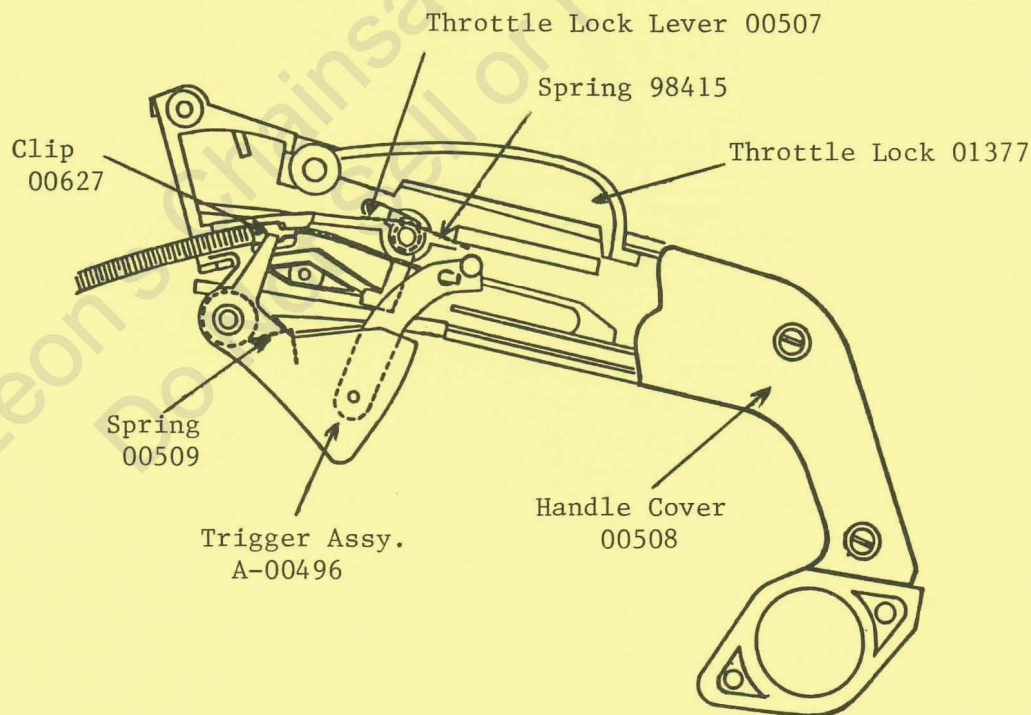
None of the parts associated with the new cable system are compatible with the earlier throttle rod design.

Refer to the two diagrams below when ordering parts for units built with the throttle cable.
