Distribution:**TO:** ALL DISTRICTS, BRANCHES, SERVICE BRANCHES AND DEALERS**SUBJECT:** New carburetors for the Super 2, VI-Super 2 and VI-Super 2SL, Lot #8307 and above.**DATE:** 1-79

TECHNICAL SERVICE BULLETIN

NO. 179-002**AFFECTS:** ALL CHAIN SAWS**SUBJECT:** REPLACEMENT PARTS FOR CARBURETORS

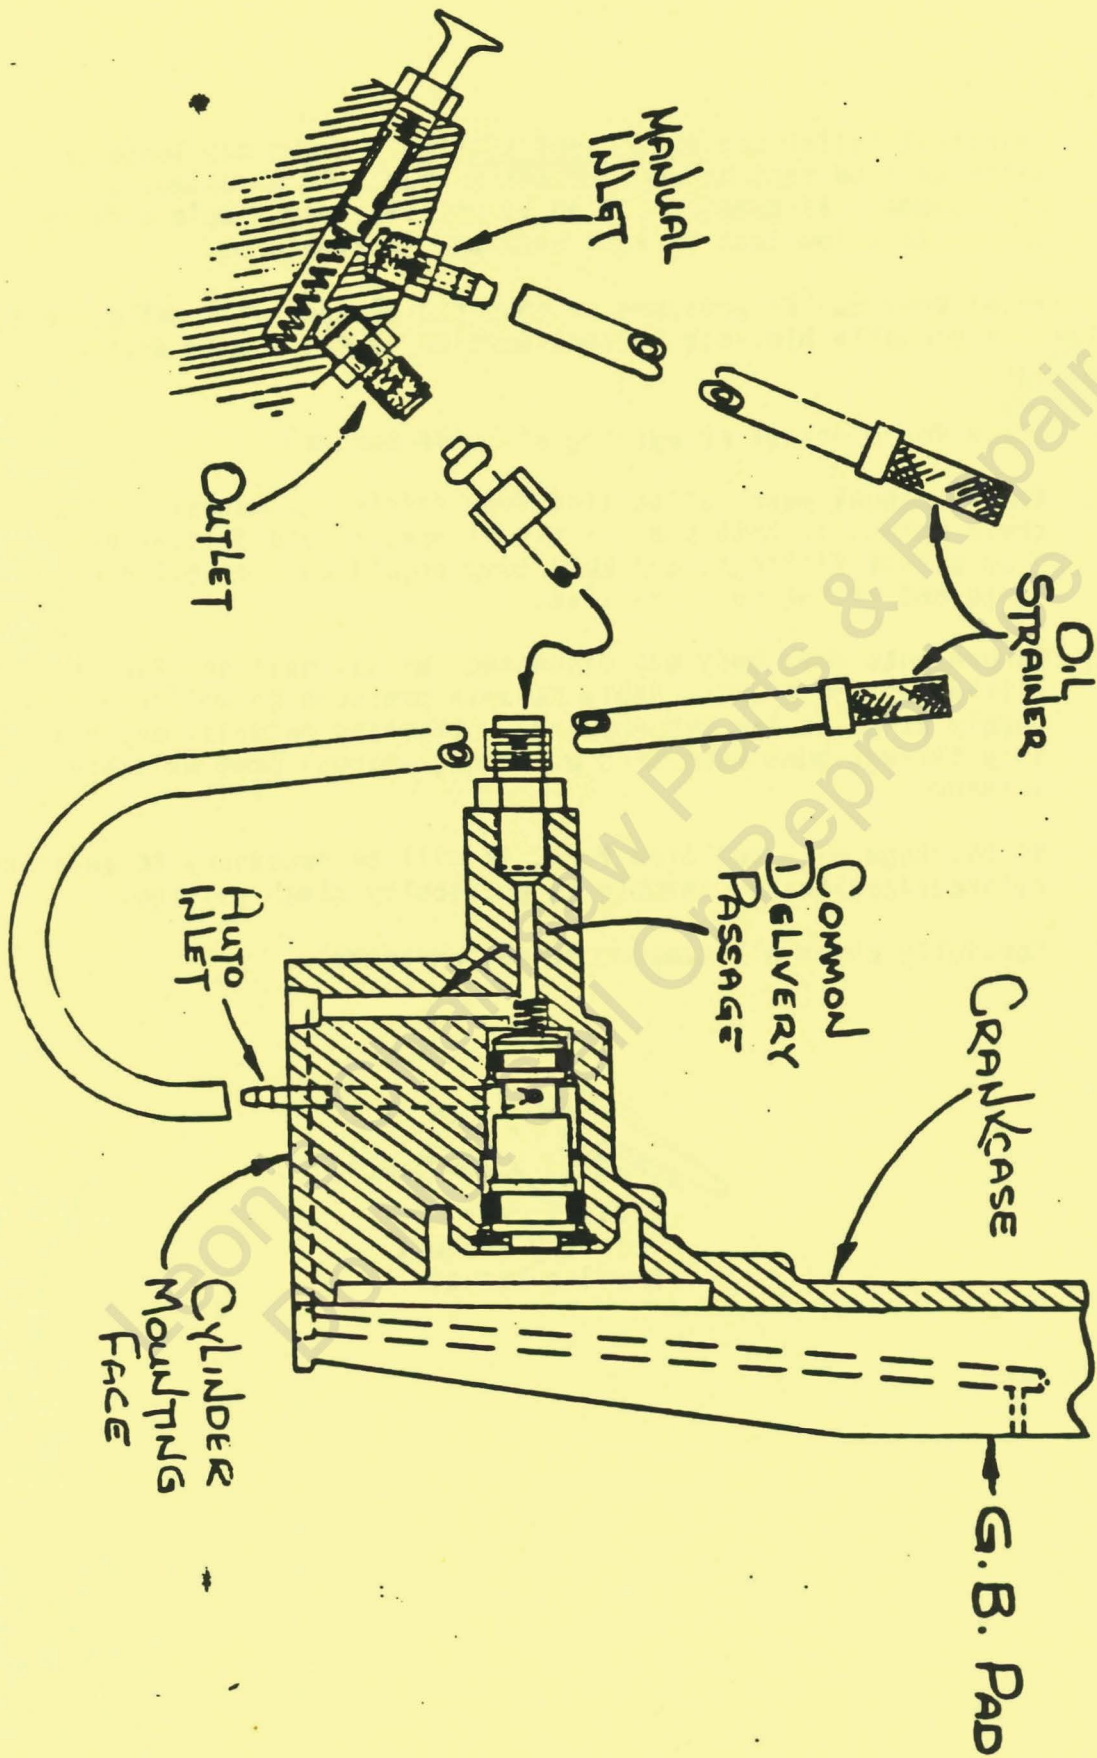
I. AUTO OILER FAILS TO DELIVER OIL - MANUAL OILER PERFORMS SATISFACTORILY

2. Remove pump cover and diaphragm and plunger.
 - A. Check cover for lead shot plug in outside wall near corner (will be found in older covers only). If ball is not sealing, or if cover wall is cracked, replace with latest cover #69224-2C.
