HOMELITEA DIVISION OF
TEXTRON INC.

SUBJECT: Sprocket Keys and Clutch Spider Keys

SUBJECT: Gear Ratios in Homelite Gear Drive Saws

SUBJECT: Fuel Cap Valves, All Chain Saws

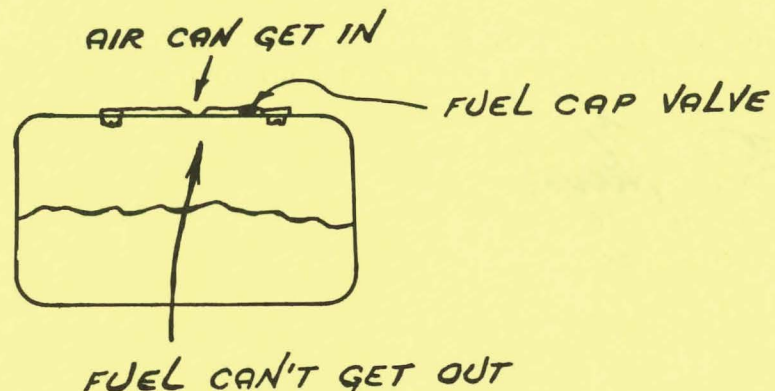
Now it's an interesting fact that we can't get fuel out of the tank, unless we let air in. It works just like your picnic cooler -- you have to loosen the cap before it pours well. In our fuel tanks we have the added problem that we don't want to spill any fuel when the engine is turned upside down. We accomplish this "venting" as it is called through our fuel cap valve.

Remember this valve -- later we'll mention it again in the trouble shooting section.

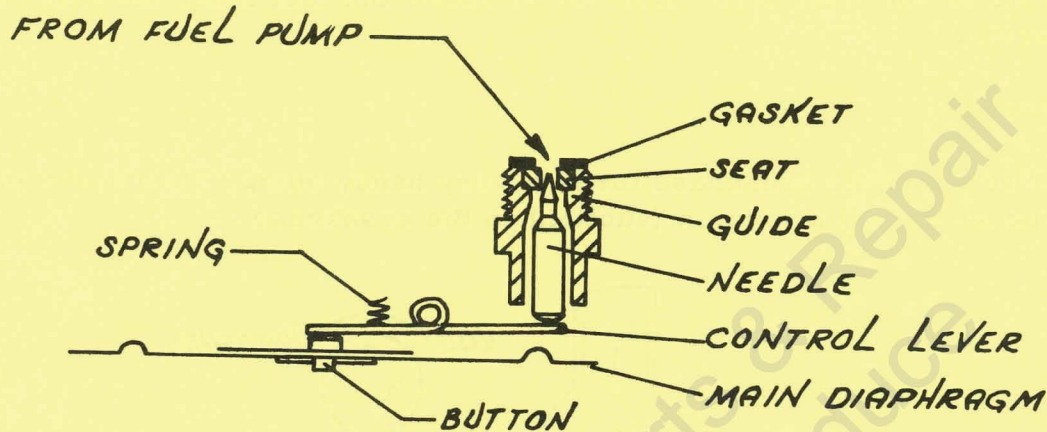
- 3) the Inlet Needle and Seat.

Normally the inlet needle shuts off the fuel and allows no flow into the main carburetor chamber unless:

- 1) The needle stays open from dirt, or because the lever binds on the fulcrum pin or because the control lever is adjusted wrong, or the main diaphragm gasket is on the wrong side
- or 2) because fuel leaks around a spot which should be sealed -- for instance a "shrunk" seat, or a leaky gasket, or bad threads in the body or simply because the guide isn't tightened down well enough during installation.
- or 3) With everything else all right even a tiny piece of dirt may keep the needle from sealing properly on the seat.

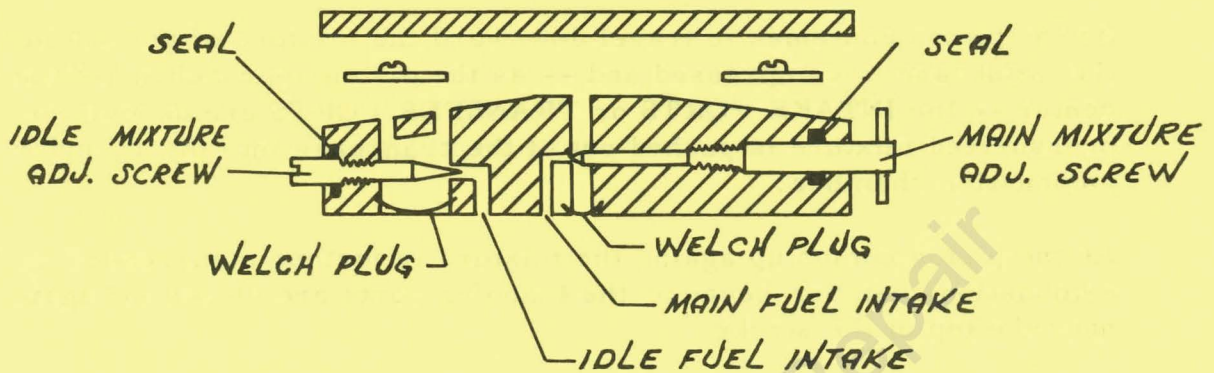
The main mixture adjustment screw controls the amount of fuel mixed for open throttle operation.

The idle mixture adjustment screw controls the amount of fuel mixed for no load and idle operation.

The further in you turn each adjustment screw, the less fuel is mixed with the air and the "leaner" the engine runs.

The two Welch plugs are also important. They seal the extension of the holes which have to be drilled to produce the idle and main passages -- but note that a leaky Welch plug would permit unwanted fuel to reach the barrel. The engine would run rich, even with the adjustment screw fully turned in.
