TO: Homelite Branches and Chain Saw Dealers

SUBJECT: Idler Gear Post

DATE: 1/5/66

Units Affected: XP-1100

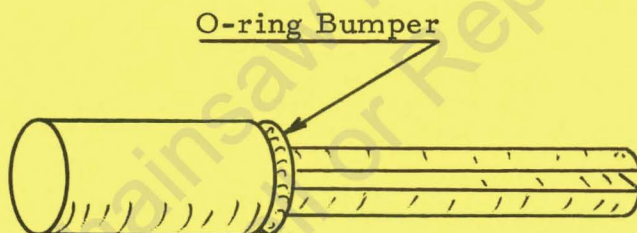
A permanently installed Spirol Pin takes the place of the Snap ring on the exhaust side only. One snap ring (for the side opposite the exhaust) will still be supplied as part of each Piston and Pin Assembly.

New piston pin removers have been designed:

These tools are slotted to "straddle" the Spirol Pin.

For 3/8" diameter pins order #A-23949
