BRANCH SERVICE MEMO NO. 623CS

SUBJECT: Gaskets

DATE: 1/11/67

Units Affected: XL-700, 800 and 850

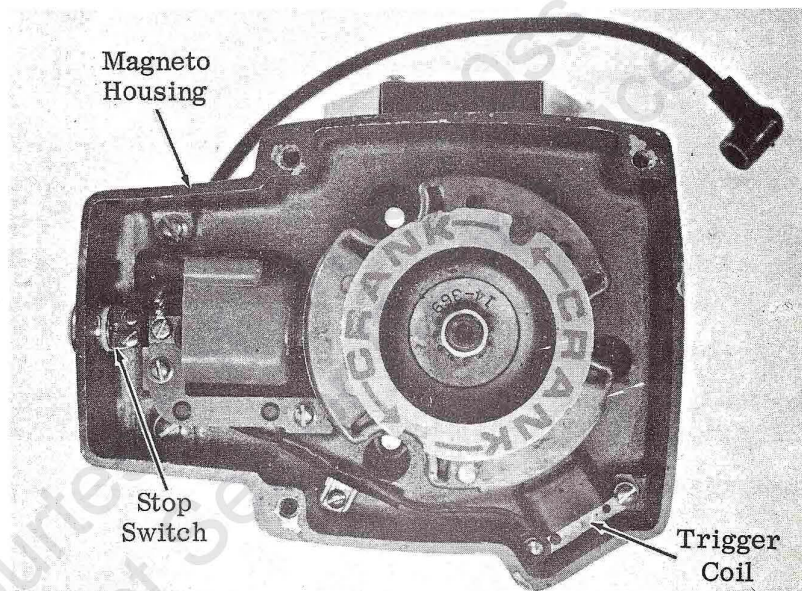
Figure 1

1. Connect the spark plug lead to a test spark plug and crank the engine to check for magneto output. If there is no output, remove the starter cover.
2. Visual Inspection
  - a. Inspect the rotor for physical damage.
  - b. Inspect the magneto for broken or frayed wires.
  - c. Check for a short between the coil core and the stop switch lead, or a grounded stop switch.
  - d. Check for a short between the knife terminals connecting the trigger coil lead to the lead from the switch box. All leads should be dressed as shown in Figure 1.

- c. Be sure that the "D" washer holding the plastic lead clamp to the magneto housing is positioned so that it will not cut the clamp.
- d. All leads should be dressed as shown in Figure 1. The switch box-trigger coil knife terminals should be fully covered with insulating sleeving.

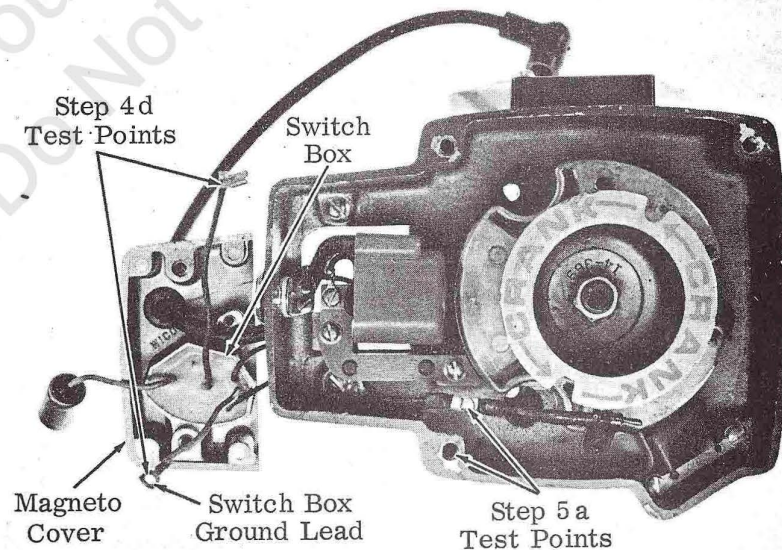
Figure 2

- a. The switch box lead must remain disconnected from the coil primary terminal and must be above ground (not touching any metal parts) during all testing.
- b. Remove the magneto cover from the magneto housing, and position as shown in Figure 2.
- c. Disconnect the switch box ground lead by removing the condenser mounting screw, then hold the condenser above ground with a piece of insulating material.
- d. Perform the following tests with an ohmmeter by connecting:

<u>Positive Meter Lead to</u>	<u>Negative Meter Lead to</u>	<u>Meter Reading</u>
Switch box-trigger coil lead knife terminals	Ground (back plate)	22 - 24 ohms
Ground (back plate)	Switch box-trigger coil lead knife terminals	22 - 24 ohms

- e. Replace the magneto cover assembly if the switch box does not test within these limits.
- f. When installing a new magneto cover, use "Loctite" on the two mounting screws. Be sure to connect the switch box lead to the lead from the trigger coil.

b. If the trigger coil is faulty, replace it.
