TO: All Districts, Branches and Chain Saw Dealers

SUBJECT: All Fuel Filters

DATE: March, 1970

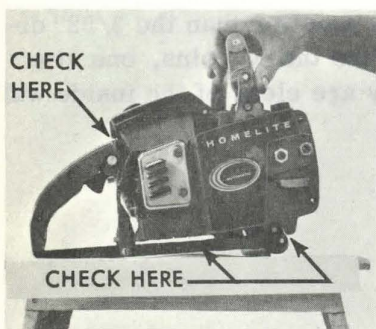
PHOTO 6

- 7 Refer to the triple exposure photo (#5). Place the saw on a flat surface and rotate the bracket front to rear to find the best condition of clearances. The best condition of clearances is when the engine does not bottom against the vibration mount base (photo #6) or the carburetor chamber does not rest against the vibration mount handle.
- 8 Secure bracket in best clearance condition.
- 9 Using the existing holes in the handle bar as a guide, drill into and through the new bracket on both sides with a 3/32" drill (2.3mm) (photo #7).  
NOTE: New holes can be drilled if desirable.
- 10 Place a spirol pin in the newly drilled hole and gently tap the pin into the hole until it is flush with the handle bar (photo #8). Repeat on other side.
