SUBJECT: Wiring 4-wire 230V180 cycle power tools

SUBJECT: Change Effective Immediately in the Field -- all
10HY35-1A and 119HY35-2 Units Equipped with or
being Converted to Automatic Idle Control

DATE: 3/71

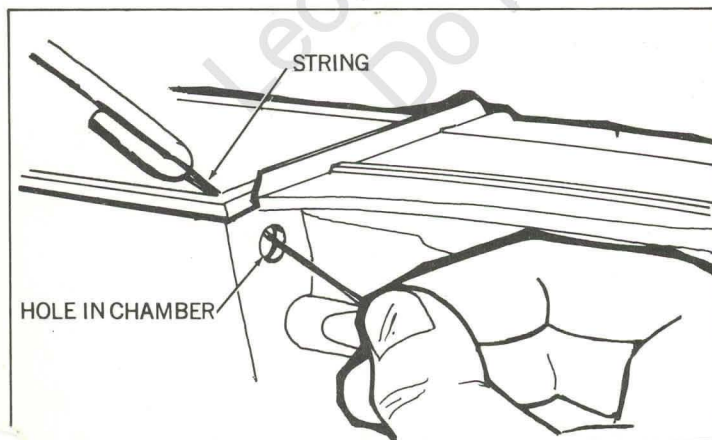
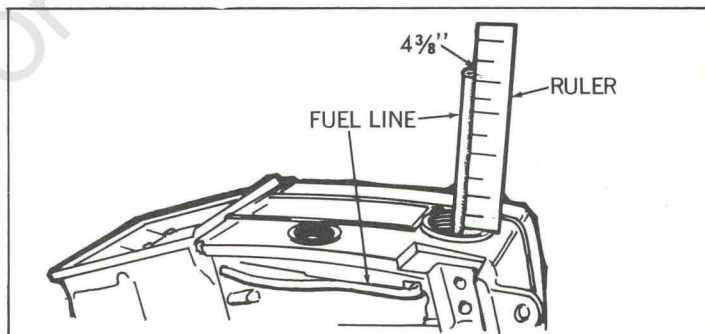
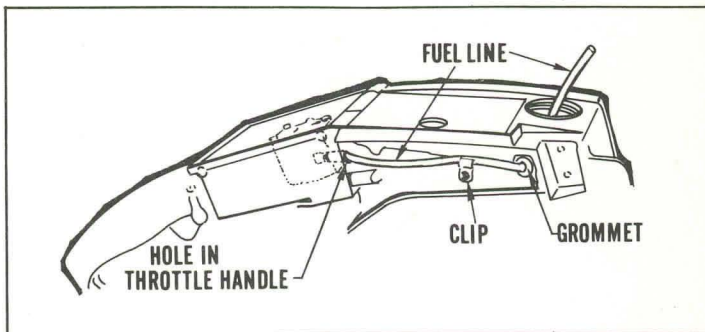
3. Units with the small diameter fuel line hole in the carburetor chamber should use the "String" method for feeding the new line through the hole.
 - a) Double a piece of strong, thin string and thread the loose ends through the hole from inside the carburetor chamber.

- c) Pull until the carburetor seats against the manifold.
4. Oil grommet 68046 and push it into place in the outlet hole in the fuel tank. Double a piece of strong, thin string and thread the loose ends through the grommet and into the fuel tank. Grab the loose ends and bring them out through the fuel cap opening. Using the "string" method as described before, pull the fuel line into the tank and out the fuel filler opening.

5. Pull until the line measures 4-3/8" from the top of the opening to the end of the line.

NOTE: The fuel line should be free of any sharp bends or kinks that would restrict fuel flow. This would especially occur at the grommets.

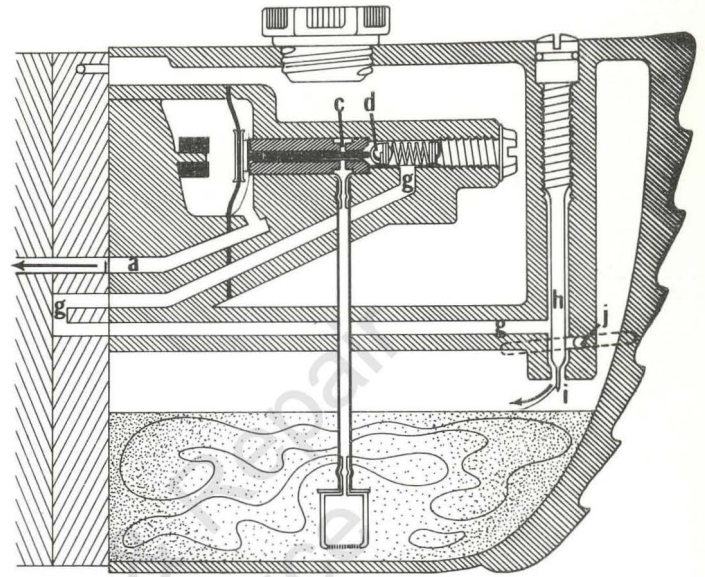
FIGURE 2

INTAKE STROKE:

On the engine downstroke, positive pulse pressure applied to the plunger diaphragm through pulse channel a) moves the diaphragm in direction of the bumper b) creating low pressure in pump cavity c). Check ball d) remains seated, preserving a low pressure condition inside cavity c). Oil drawn in through the pick-up screen e) flows through pick-up tube f) into pump inlet chamber c).

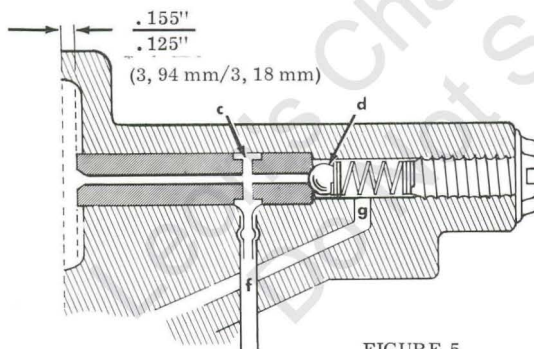
2. Examine the oil pick-up screen and the flexible tube. A leak here shows up as low or foamy output.
3. REMOVE PUMP BODY SCREWS AND DISASSEMBLE THE PUMP.
4. Use "Inhibisol" or another non-toxic spray can type solvent and medium pressure (not over 30 psi) compressed air to clean oil, dirt and chips out of the pump passages.
5. Check that the rubber bumper is all the way "home" on the post on the crankcase, but not below the post surface. Measure the clearances between mounting flange face and both bumper and post (see Fig. 4).
