TECHNICAL SERVICE BULLETIN

NO. 182-001**SUBJECT:** GUIDE BAR INSERT KIT #A-96612**AFFECTS:** 360 CHAIN SAW

INSTALLATION OF GUIDE BAR INSERT FOR 360 CHAIN SAWS

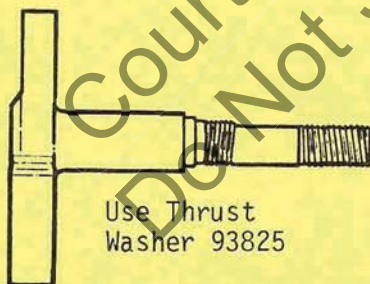
A96418A

1. To improve unit performance and durability a new piston design A95882-A is available for all 330 chain saws. This new piston incorporates narrow piston rings number 96510. When "thick ring" pistons A95882 are no longer available the part number will be superseded by A95882-A. Note that the "thick" piston rings 93823 are still available.
2. Also, the crankshaft was redesigned in the thrust washer area to increase crankshaft durability. This change required a redesign of the thrust washers. The new washers are part number 94860. Old thrust washers 93825 are still available for servicing crankshafts made before this change. All new crankshafts A96418-B will include thrust washers. See picture below.

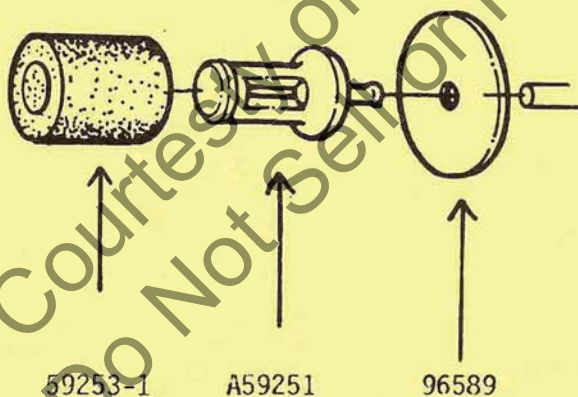
1. The fuel cap material has been changed to prevent deterioration that may occur when gasohol is used. Also, an extra thread was added for better sealing. The new part number is A93420-A.
2. A new rim sprocket 95058 is available from Service Parts. This new rim will supersede sprocket 63284. Both sprockets are 3/8 inch pitch and have seven drive link slots.
3. Plastic washer 96589 has been added to the fuel filter to keep the filter from "hanging up" inside the fuel tank. See picture below.

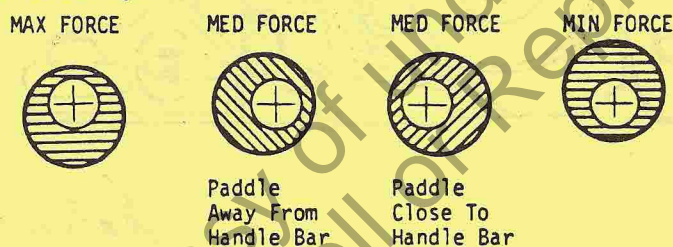
The sketches below show the cam in four positions. Dimensions are somewhat exaggerated and the hexagon head is omitted to show the cam positions clearly.

At MAX FORCE and at MIN FORCE adjustments, the paddle to handle distance is identical and intermediate.

As shown by the two center sketches, intermediate actuating forces may be selected with the paddle moving away from, or toward the handle bar.

The actuating force and the distance between the handle bar and the chain brake paddle on the model 240 SL are adjustable. Adjustments are made by rotating the brake lever cam, PN 96170, illustrated as item 12 on page 6 of the illustrated parts list number 17601.

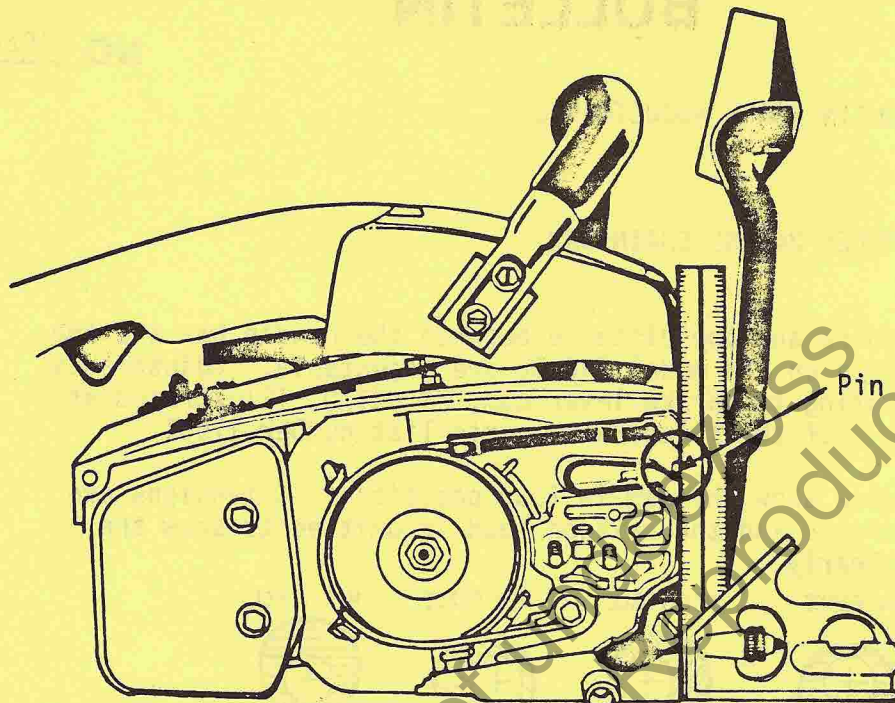
Normal factory adjustment locates the lock pin of the brake lever arm on a vertical line, tangent to the front of the guide bar pad as shown below.

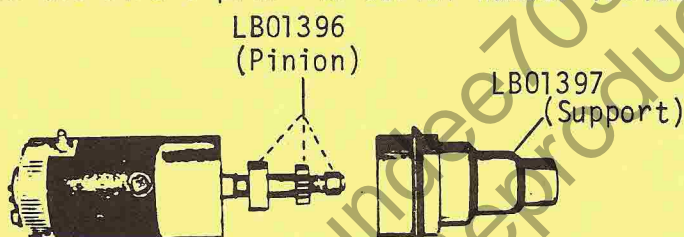
The support (LB-01397) and pinion (LB-01396) for the Prestolite starting motors are now available through service parts. This starter was used on the DTP3-1 prior to serial number 1794629.

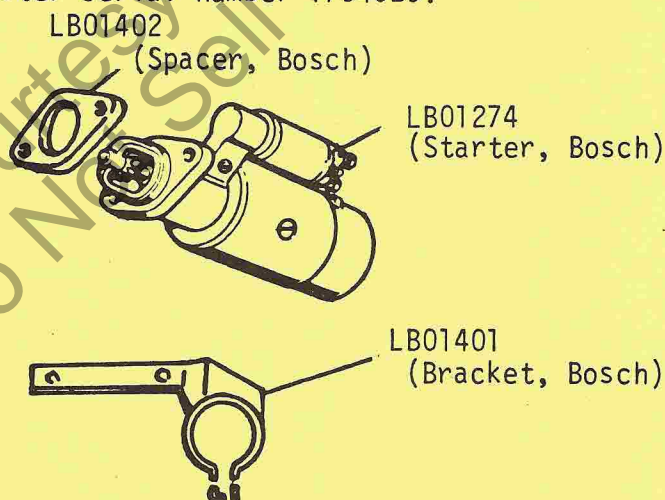
The Bosch starters have a spacer (LB-01402) and a different bracket (LB-01401) that are used on all 177D38-1. These parts are also used on all DTP3-1 pumps after serial number 1794629.
