SUBJECT: CORRECTION TO TECHNICAL SERVICE BULLETIN 184-014**AFFECTS:** ST-160, ST-180 STRING TRIMMERS

On Technical Service Bulletin 184-014, the illustration of assembly shows the wrong sequence. Please follow the revised illustration below when assembling the shield (94409) and second flat washer (84099).

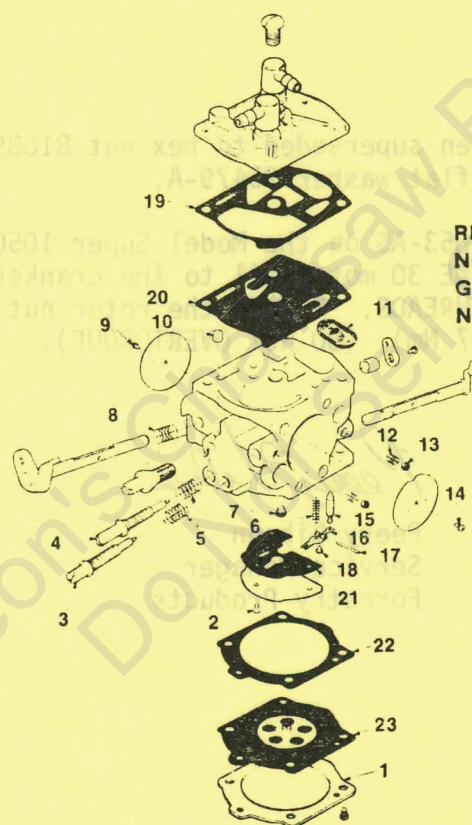
**CARBURETOR
(WS-22) Walbro
A-97102**

- 1) 410 chain saws(beginning with Lot # E074) were manufactured with carburetor A-97102 (Walbro WS-22). This carburetor (also used on the DM-40 saw) incorporates an internal air bleed circuit for improved idling and acceleration. Refer to the illustration below when ordering repair parts for this carburetor.

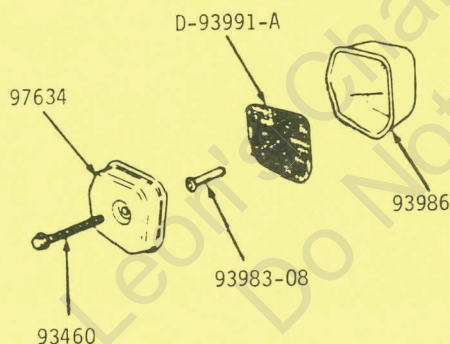
- 4) Fuel cap (starting with Lot # G031) - Fuel cap A-94495 with umbrella check valve 94531-1 has been superseded by the 240/245 style cap with duck bill check valve 69451. The part number of the new fuel cap is A-96957-A.
- 5) Muffler assembly (starting with Lot # G014) - The short spacer 93989 and long spacer 93990 have been replaced by a single, longer spacer 93983-08. This spacer required enlarging the center hole in the spark screen to facilitate assembly. The part number of the new complete muffler assembly is A-97963 (see diagram below).

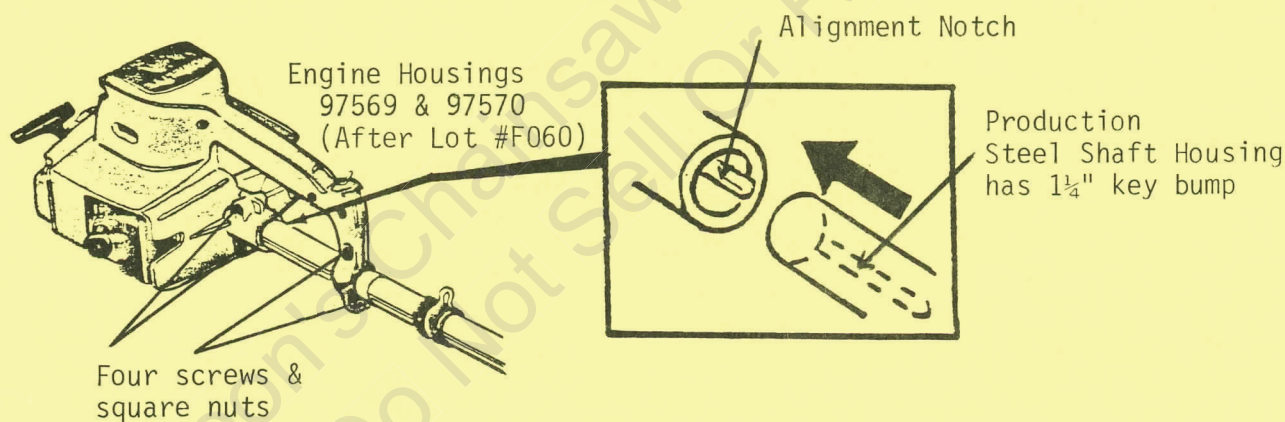
FIGURE 1

The production steel shaft housing has a $1\frac{1}{4}$ " long key bump at the engine end which aligns with a notch in the engine housing (see Figure 1). This shaft housing, however, will only fit units made after Lot #F060 (1984) which were produced with engine housings 97569 and 97570.

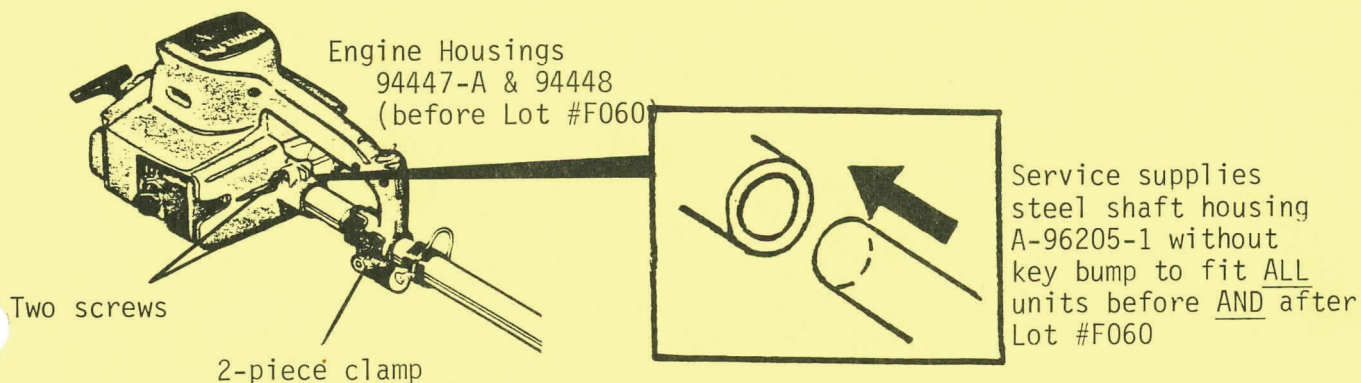
FIGURE 2

Service parts will supply a steel shaft housing (A-96205-1) without the key bump which will allow it to fit ALL ST-200 and ST-210 units. (see Figure 2)

- 2) A small quantity of packages marked A-96205-A contain the production steel shaft housings with the $1\frac{1}{4}$ " key bump. Please identify the housings in your stock and take note that they will only fit trimmers produced AFTER LOT #F060 (1984).

Driveshaft housing A-96205-A is superseded by A-96205-1. Refer to item #1 on the front page of this bulletin.

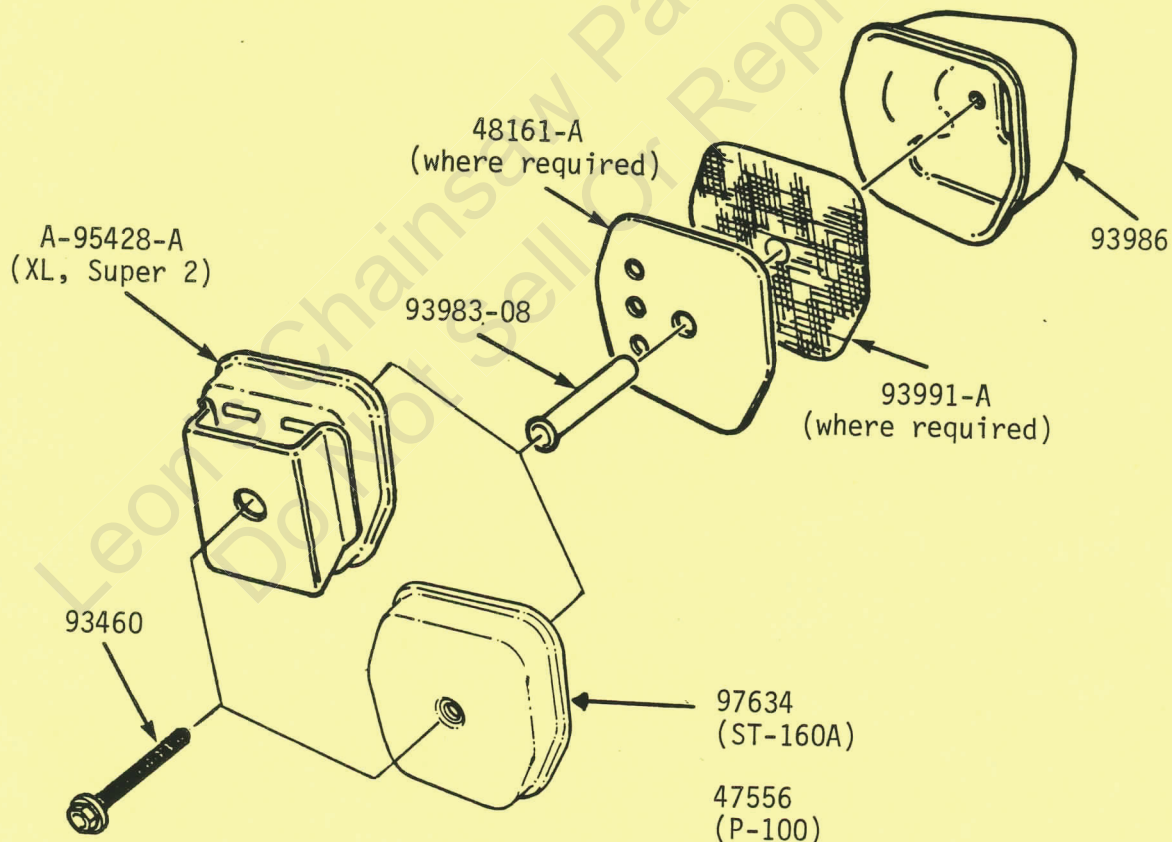
The muffler assemblies have been revised on the subject model units. Both the short and long spacers have been replaced with a single, longer spacer P/N 93983-08. This single spacer required enlarging the center hole in the spark screen (where required) and baffle (where required) to facilitate assembly.

Refer to the illustration below when ordering parts for the revised muffler assemblies.

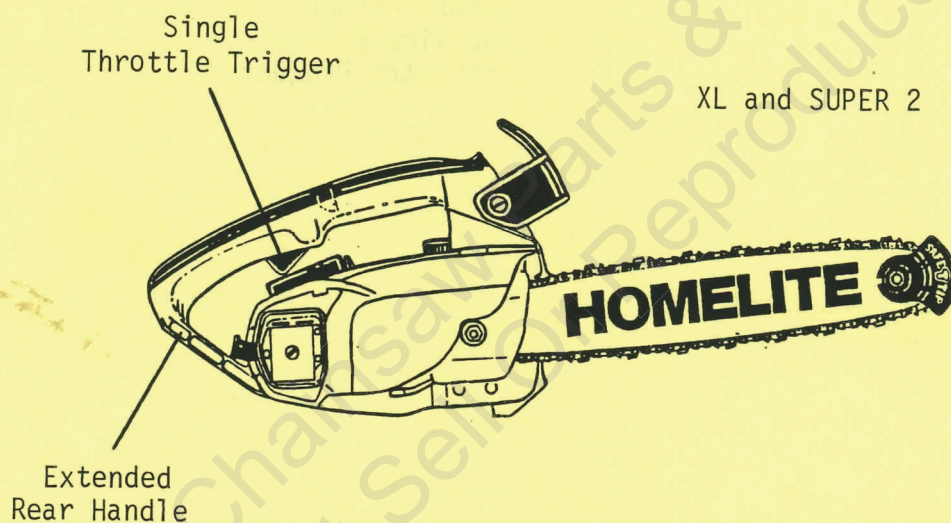
FIGURE 1

- 1) The models XL and Super 2 chainsaws now utilize the identical nylon engine and starter housings. The engine housing has an extended rear handle with a single throttle trigger (see figure 1).

Since many of the trigger and handle components are not interchangeable, service will supply an engine housing consisting of the following parts:
