BULLETIN 186-001 286-001 NO. 386-001

SUBJECT: TECHNICAL SERVICE BULLETIN LISTING

1985 TECHNICAL SERVICE BULLETINS

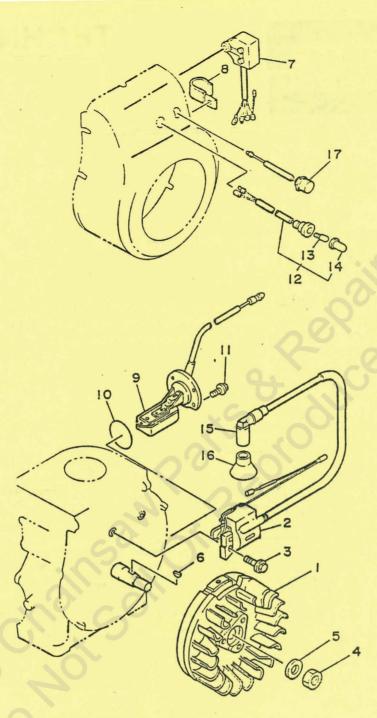
We have found that users of units with Oilgard systems are trying to make unnecessary repairs and adjustments to the engine when it stops running for no apparent reason. This failure to run may be due to low oil level in the crankcase which will prevent the engine from starting.

before making any adjustments or repairs.
