TECHNICAL SERVICE BULLETIN

NO. 180-001

AFFECTS: 360-A0

SUBJECT: 70729 OIL SEAL

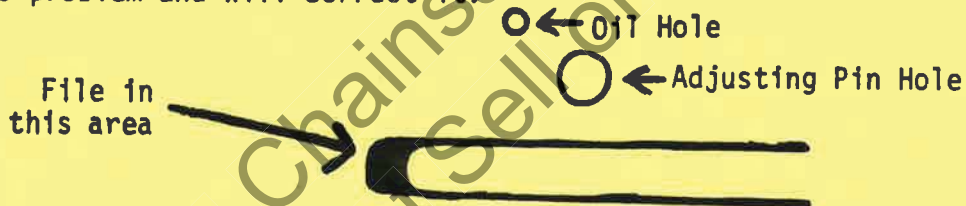
We have had reports that the 38-C50-81 chain is too short and will not fit the BG-14001-A2 bow guide. We have determined that the problem lies in the bow and not the chain.

If you have this problem, simply file out the guide bar slot 1/4". See illustration below. The metal in this area is soft and will file easily. **DO NOT** add a drive link to the chain. The vendor has been made aware of this problem and will correct it.

NOTE: It is usually necessary to add an extra inner guide bar shim (70399) when installing a bow guide on a 550. This will assure proper alignment between the bow guide and the sprocket.

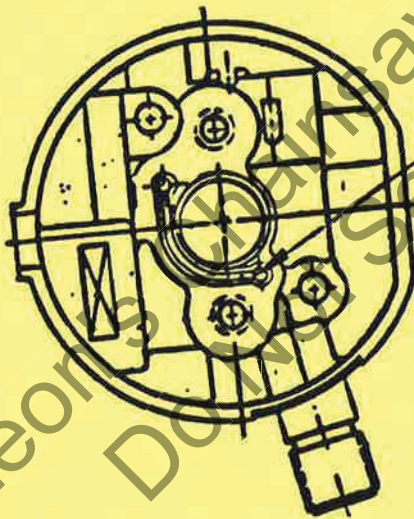
Blockage
Here

Some A-95327 carburetor housings have been found that have a thin wall of plastic material in the fuel transfer passage (See picture below for location).

This blockage will cause a unit to starve for fuel. These parts have been found in service parts stock in the field. Service parts stock at the B.D.C. has been checked and all incorrect parts have been removed.

Please check your stock. If any housings are found with this wall, it can be broken out with a sharp object.

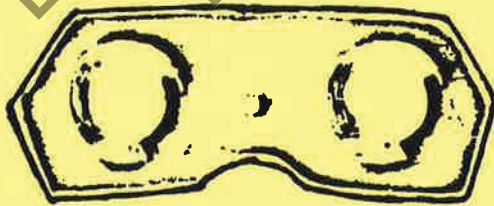
G-SERIES

The following parts in the G-series, for 404 pitch chain with tie straps shaped like the one pictured below in the "G" series column, will be superseded by the "K" series which will repair both G & K series chain with the exception of the cutters.

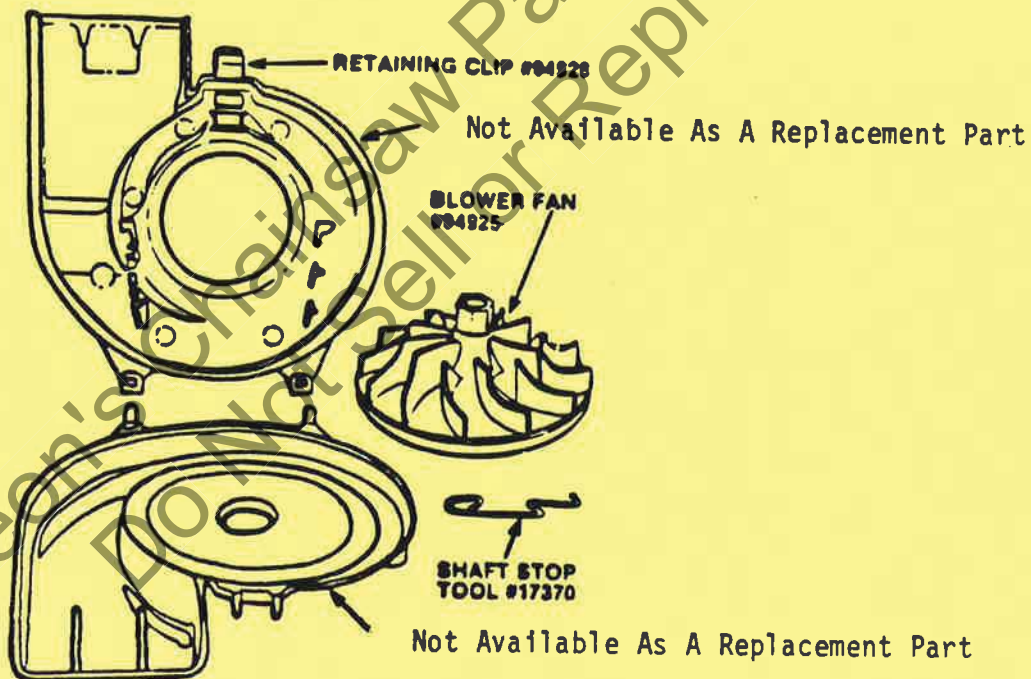
COMPLETE ASSEMBLY #A-93597

1. Instruction sheet #17400, included with the ST-100 blower, shows the blower housing as being available separately. This is a misprint. Refer to the parts list below when ordering parts.

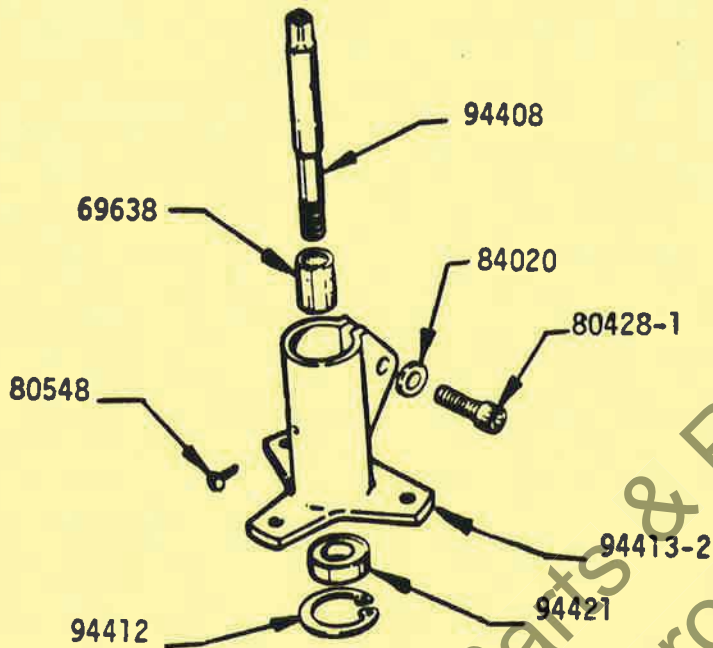
COMPLETE ASSEMBLY #A-95800

2. The ST-200 lower head housing and related parts as shown in figure 4 of the ST-200 parts list #17435 is now available as an assembly. The part number is A-95800. Refer to the parts list on the back of this page when ordering parts.

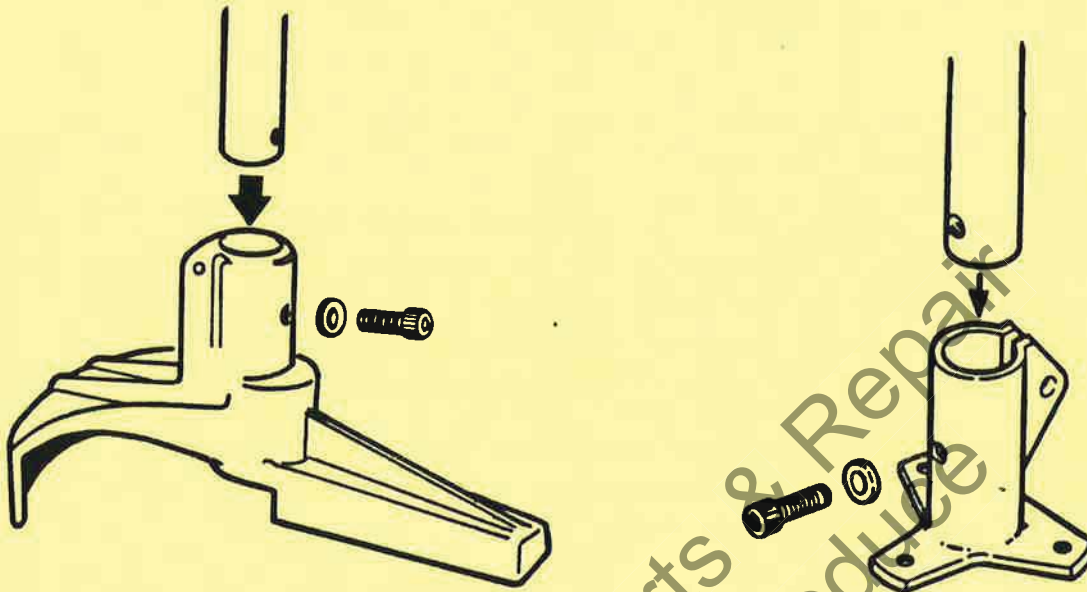
5. Install the bushing in the drive tube. The beveled edge of the bushing goes in first. If the bushing will not slide in the drive tube, tap it in with a plastic mallet. The bushing should not protrude from the drive tube.
6. If the head assembly does not have a large hole in the front of the housing, drill the existing hole out with a 9/32 drill bit (7mm).

7. Make sure the metal chips are cleaned out of the assembly before reinstalling the drive tube.
8. Install the tube into the lower head assembly until it bottoms. Align the hole in the head assembly with the hole in the drive tube.

9. Install the flat washer onto the socket head screw. Install the screw into the tube. Torque the screw to 80-100 inch-pounds (9.04-11.3 Nm).
10. Tighten the clamp screw on the back of the housing. Torque the screw to 80-100 inch-pounds (9.04-11.3 Nm).

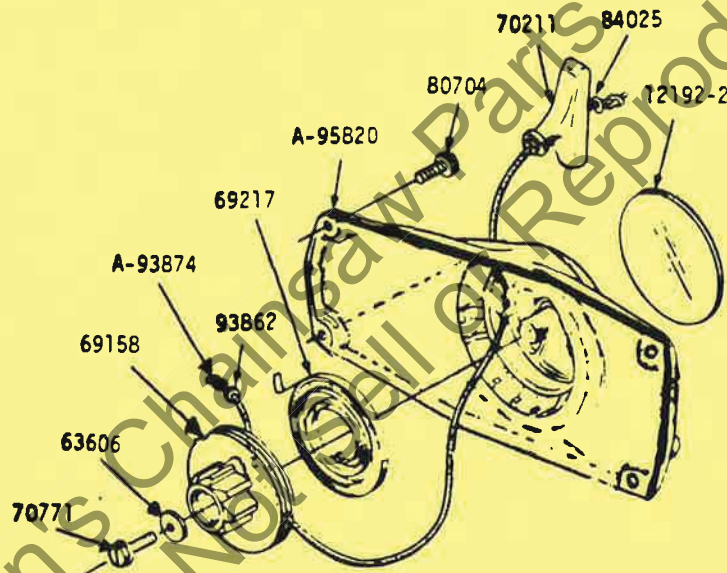
A new starter assembly is being introduced for the SEZ-A0. This new assembly uses a "fiberglass reinforced nylon" starter housing. All new units will have this system. Refer to the parts list below when ordering parts.

This system requires new starter pawls for the rotor. That new part number is 94336. The same rotor, springs, and studs will be used on both the new and old systems. Only the pawls have changed.

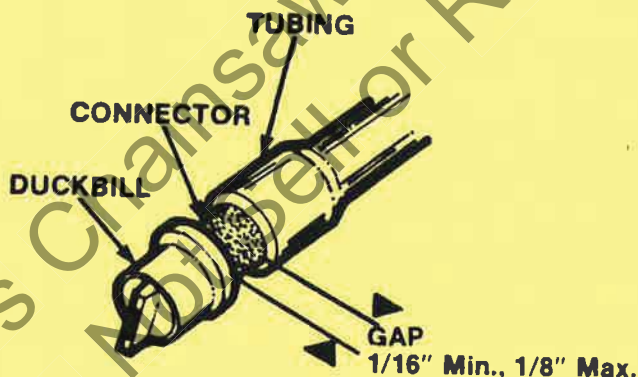
We have found some XL's that build too much pressure in the oil tank. This pressure forces excessive oil to the guide bar.

If a customer complains of too much oil being used during cutting, check the duck bill valve (69451); it may be against the pressure line. Pull the valve away from the line and expose at least 1/16, but not more than 1/8 of the connector (69656-1A).

This will allow the pressure in the tank to "bleed" back through the porous connector, when the unit is returned to idle or shut off, preventing too much pressure from building in the tank. See picture below.

REMINDER: Do not fill the oil tank above the pressure line. Oil can seep through the porous connector and into the engine, causing "hydraulic lock" and preventing cranking. Should the engine refuse to turn over remove the spark plug to break the hydraulic lock. Then crank the engine several times to dispel the oil. Clean the spark plug thoroughly before you reinstall it.

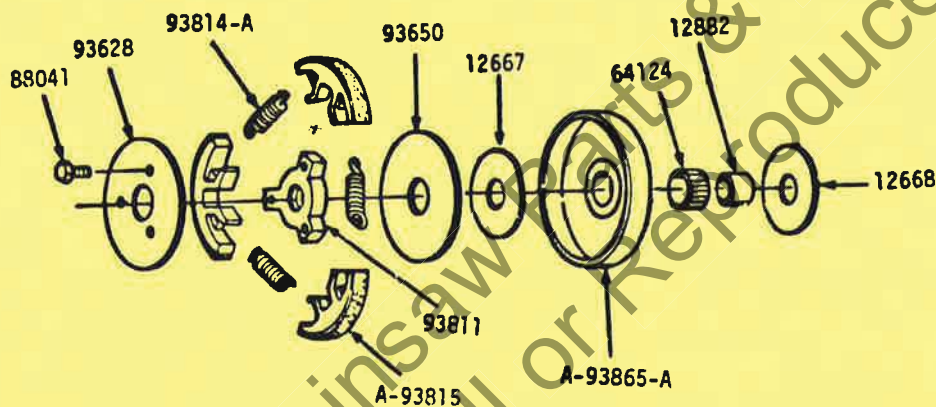
1. The 750-A0 is now being built with the new three shoe lined clutch. Refer to the parts list below when ordering parts.

The parts shown above are also available in a conversion kit, part #A-94157.

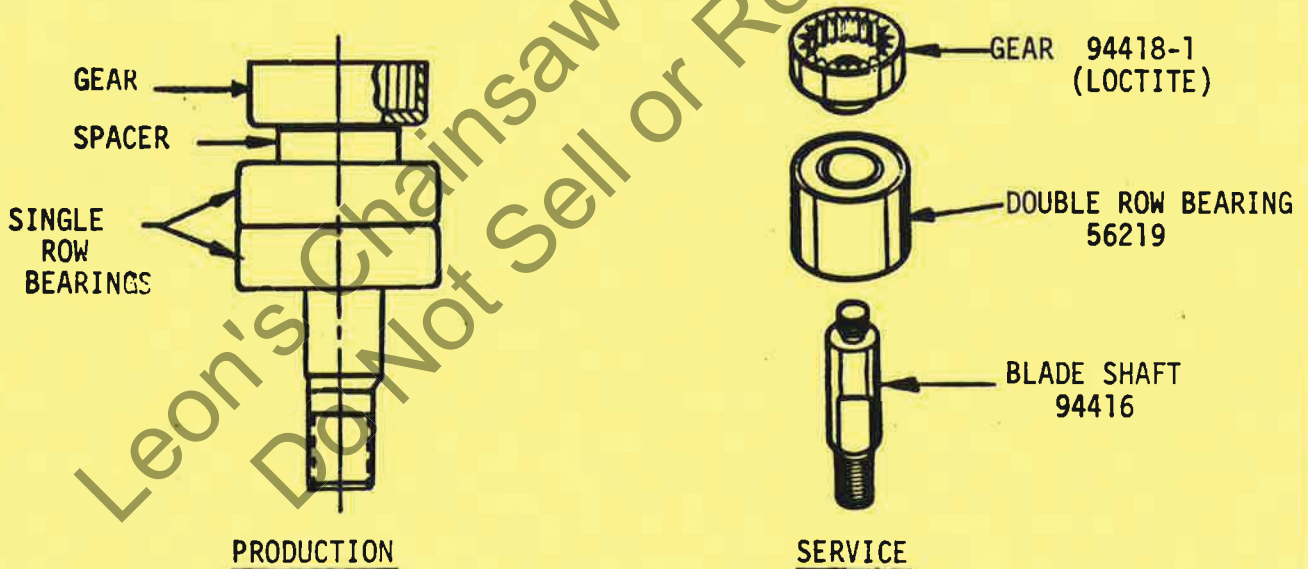
We will continue to service the gear heads with the double row bearing as shown below.

NOTE: A serial number sticker has recently been added to the brushcutter gear head. Please use this number when you are filling out warranty claim forms or referring to gear head service problems.

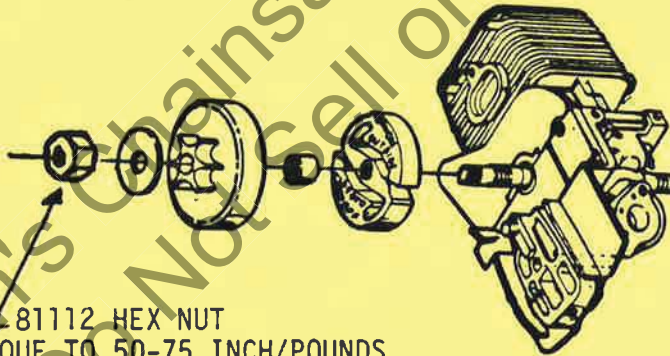
The retaining ring and groove on the clutch end of the above mentioned crankshaft is being replaced by a threaded end and a hex nut (see picture).

Units produced with a serial number of X0290XXXX and above will have this change.

Service will continue to supply the crankshaft with grooved clutch ends until the supply is exhausted. Then crankshafts with threaded clutch ends will be supplied.

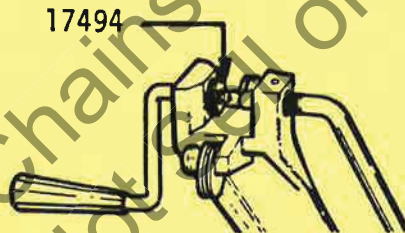
B. The anvil drive bushing for the spinner crank is now available. The part number is 17494. (See picture below).

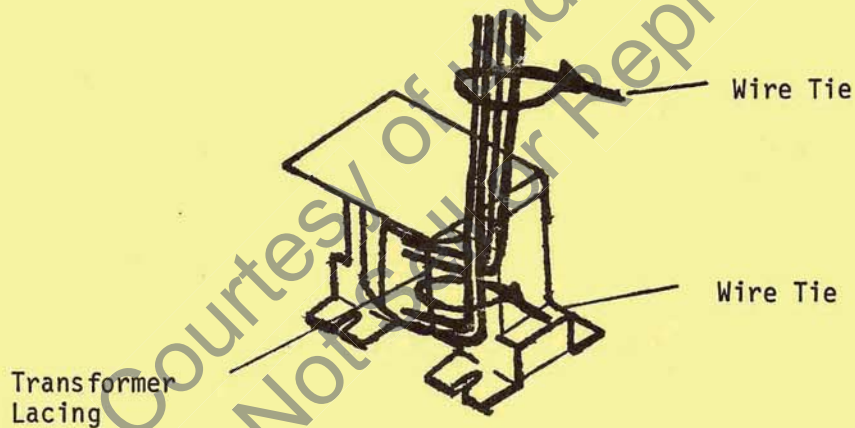
SUBJECT: WIRES SHORTING ON G SERIES GENERATORS

To prevent the transformer wires from shorting on the stator, a wire tie must be installed on the transformer as shown in the picture below. The wire tie will tie the lower wires to the transformer lacing. A second wire tie should be installed on the wire to keep them bundled as illustrated.
